January 15th, 2023

Re: Follow-up Report Spill #2022556 – Spill of 50L of Sewage at the Meliadine Gold Project

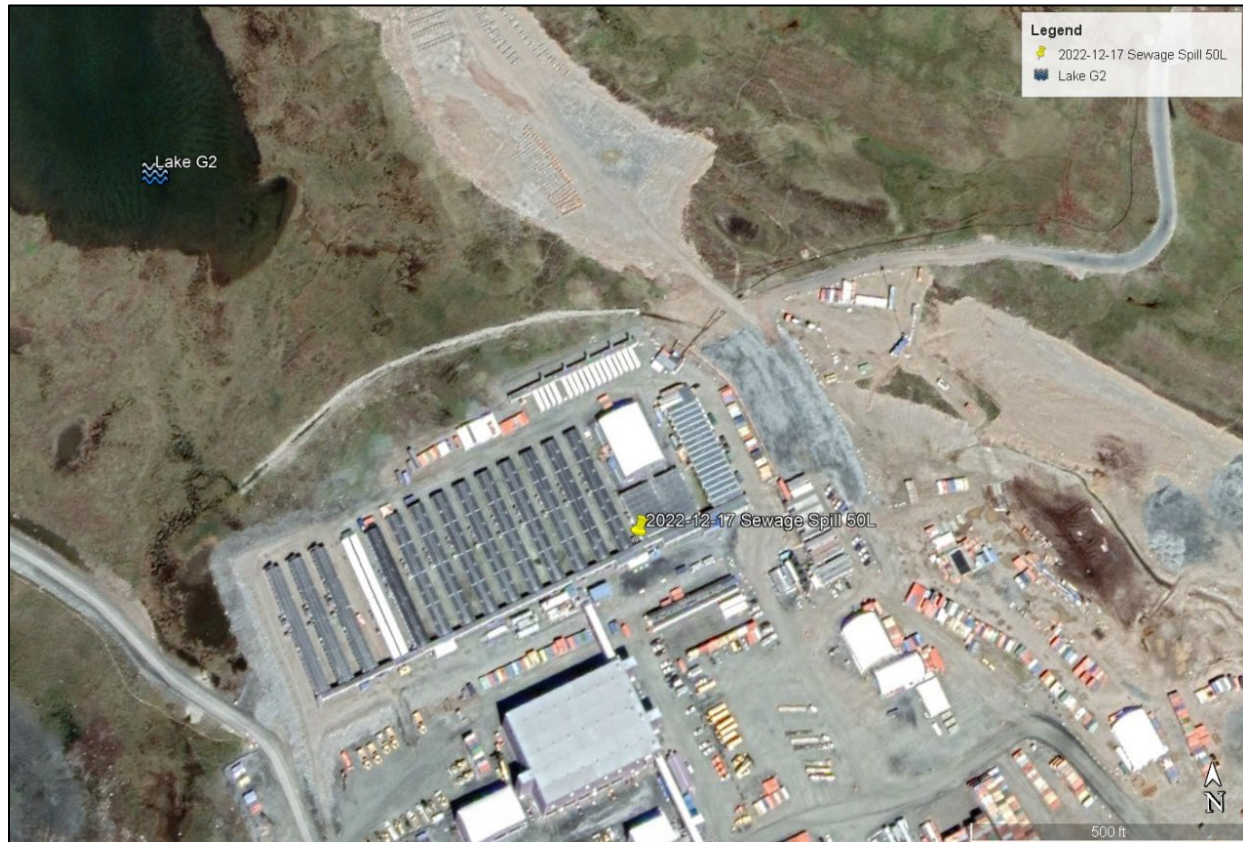
On December 17th, 2022, at approximately 8:00 am, an estimated 50L of sewage was spilled to the industrial pad due to an equipment failure at the main camp lift station causing it to overflow. The spilled sewage collected directly underneath the lift station enclosure. No water bodies were impacted by this spill. The closest water body (G2) is approximately 280 meters north, as seen in Figure 1.

Figure 1: Location of the sewage spill and proximity to water bodies.
