Re: Follow-up Report Spill #2022559 – Release of 40L of Sewage at the Meliadine Gold Project

Description of Incident

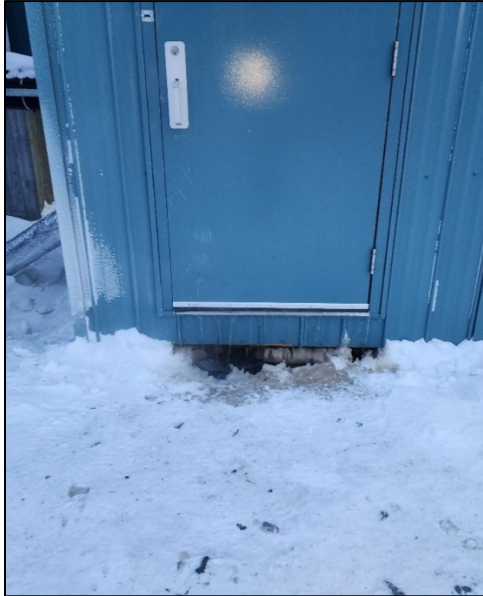
On December 22nd, 2022, at approximately 10:00 am, an estimated 40L of sewage was spilled on the industrial pad from a damaged distribution line from the power plant lift station. The line sustained damage due to freezing. No water bodies were impacted by this spill. The closest water body (G2) is approximately 520 meters north-northwest, as seen in Figure 1.

Photos 1: Sewage spill outside life station.

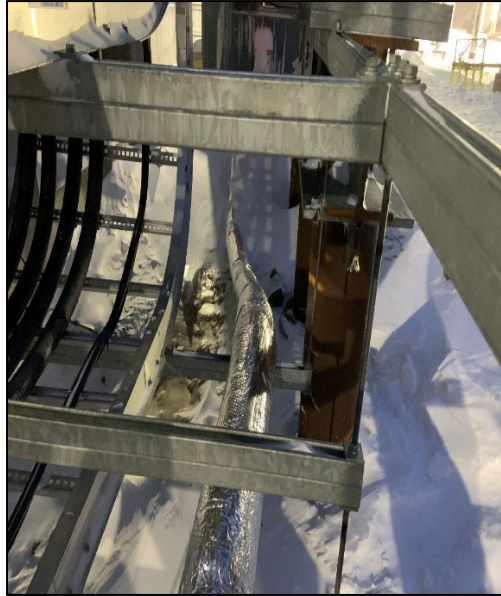
Photos 2: Sewage spill under infrastructure.

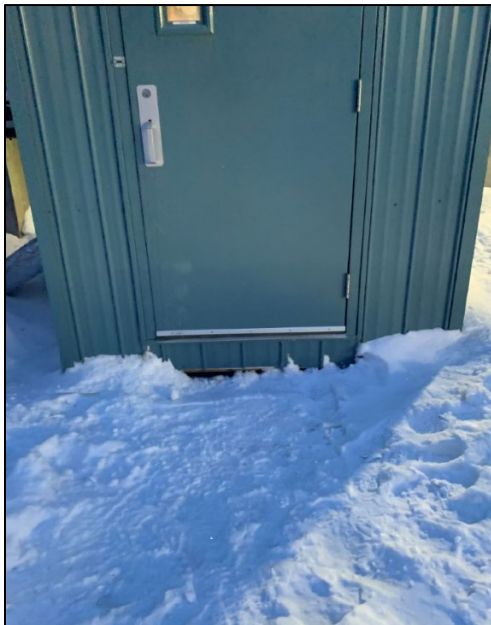
Photo 3: Sewage spill location post clean up.

While conducting a routine site inspection the Power Plant Operator noticed the lift station was overflowing onto the ground. Upon discovery, the operator immediately called the Energy and Infrastructure (E&I) Maintenance Supervisor. E&I Maintenance quickly responded by closing washrooms that discharge into the lift station and bringing a vacuum truck to empty the lift station. Hand tools were used to clean up the frozen material. The material was brought to Landfarm A as per the Landfarm Management Plan.

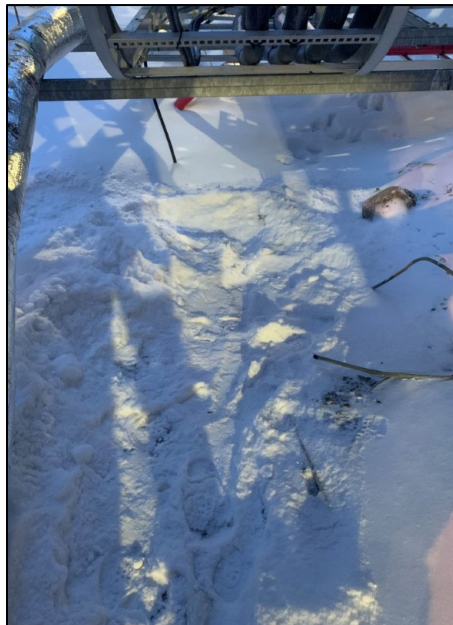
Photo 4: Sewage spill location post clean up.
