February 9th, 2023

Re: Follow-up Report Spill #2023-011 – Spill of 7 m³ of Sewage at the Meliadine Gold Project

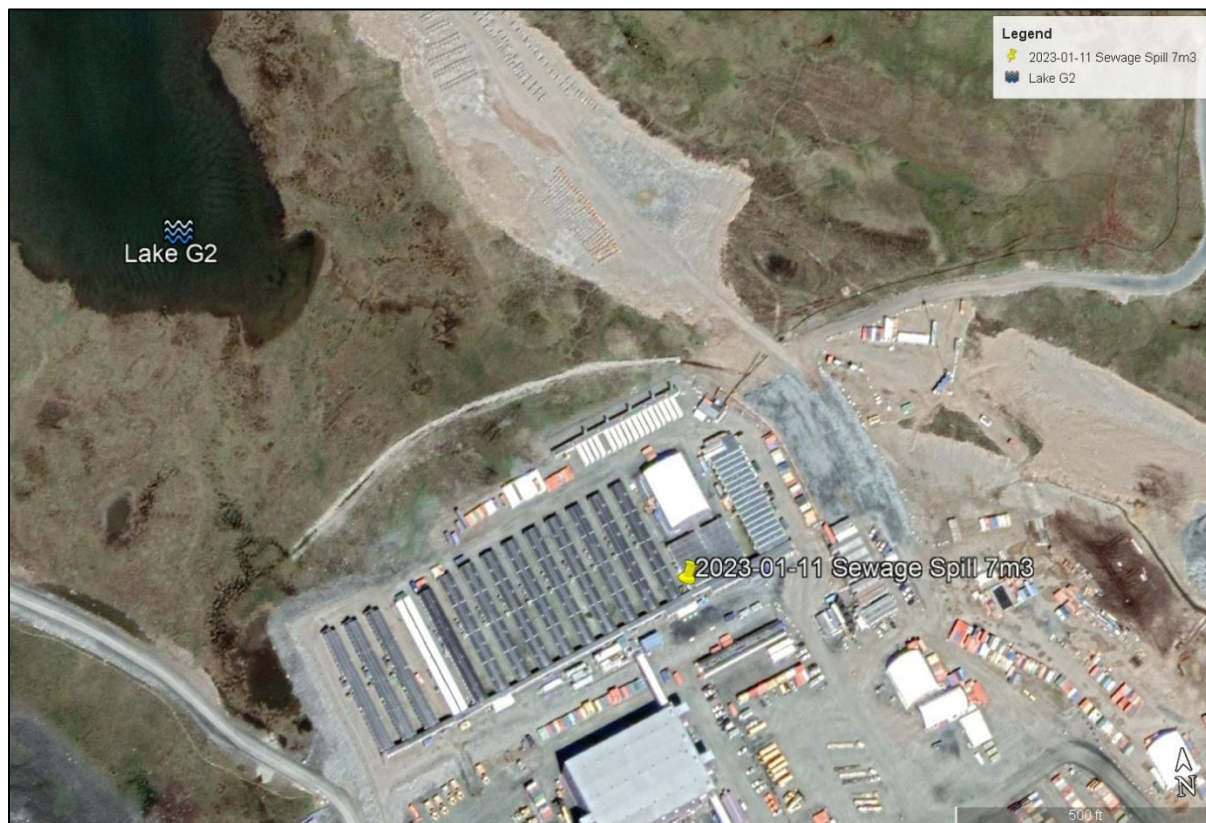
On January 11th, 2023, at approximately 8:00 am, an estimated 7 m³ of sewage was spilled to the industrial pad due to an equipment failure at the main camp lift station causing it to overflow. A worker discovered the spill occurring and notified their supervisor. The spilled sewage migrated south and collected in the multiple service building (MSB) parking lot. No water bodies were impacted by this spill. The closest water body (G2) is approximately 280 meters north, as seen in Figure 1.

Figure 1: Location of the sewage spill and proximity to water bodies.
