March 9th, 2023

Re: Follow-up Report Spill #2023-047 – Release of 450 L of Sodium hydroxide at the Meliadine Gold Project

Description of Incident

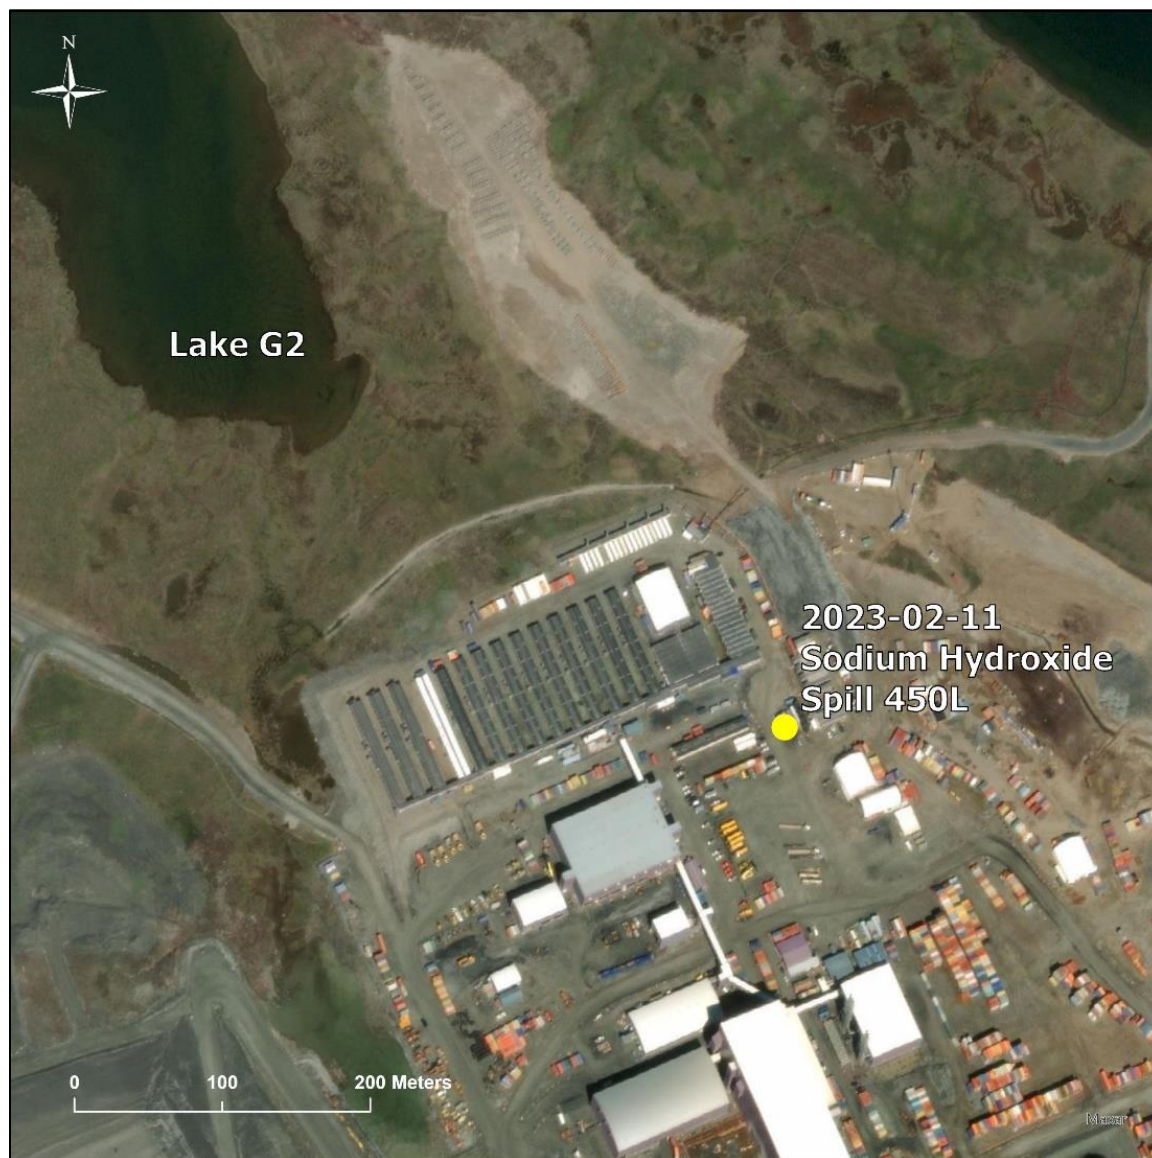
On February 11th, 2023, at approximately 3:30 am, an estimated 450 L of sodium hydroxide was spilled on the industrial pad beneath the sewage treatment plant (STP) due to a cracked PVC fitting. A 6 cm hole inside the STP floor allowed for the free liquid to drain to the ground below. The spilled sodium hydroxide collected directly underneath the STP, which was contained to the local area. No water bodies were impacted by this spill. The closest water body (G2) is approximately 370 meters north, as seen in Figure 1.

Figure 1: Location of the sodium hydroxide spill and proximity to water bodies.

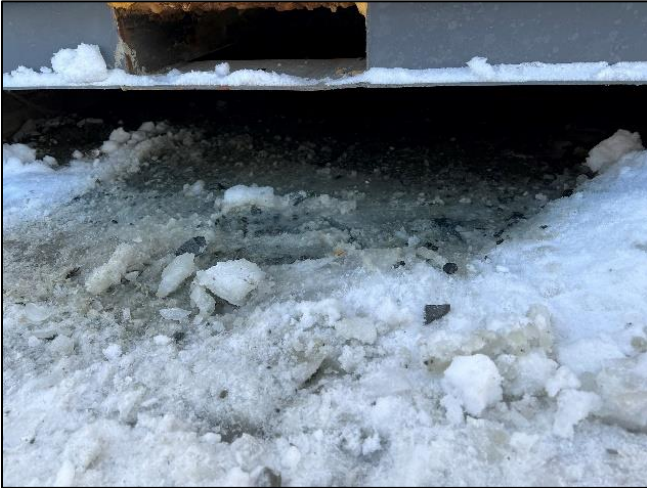
Upon observing the spill, the operator shut off the manual valve on the reservoir to stop the spill and deployed chemical spill pads to absorb the spilled material. The operator then reported the spill to their supervisor. The spill was contained underneath the STP as heat from building created a layer of ice under and around the infrastructure containing the spill to that area.

Photo 1: Contaminated ice and snow.

As per the spill contingency plan, a neutralizer was used on the sodium hydroxide to adjust the pH of the free liquid to a neutral pH. An industrial vacuum was later used to collect the remaining free liquid which was then transferred into a plastic tote. All contaminated spill rags, free liquid and contaminated ice/snow were brought to the Mill's reagent storage area where it's stored as hazardous waste and will be shipped offsite for disposal.

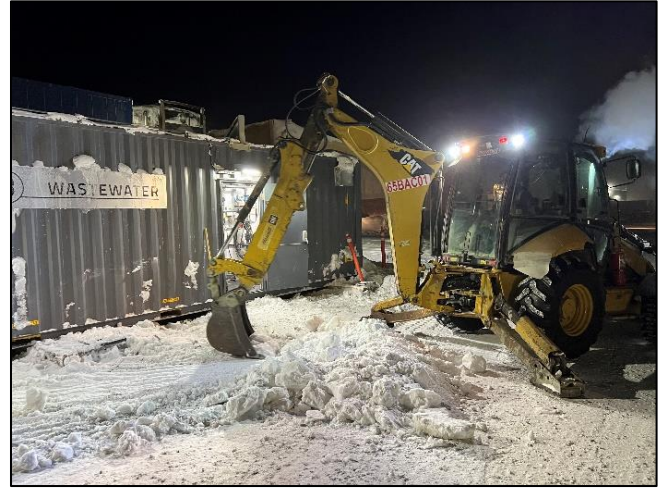
Photo 2: Spill remediation efforts.

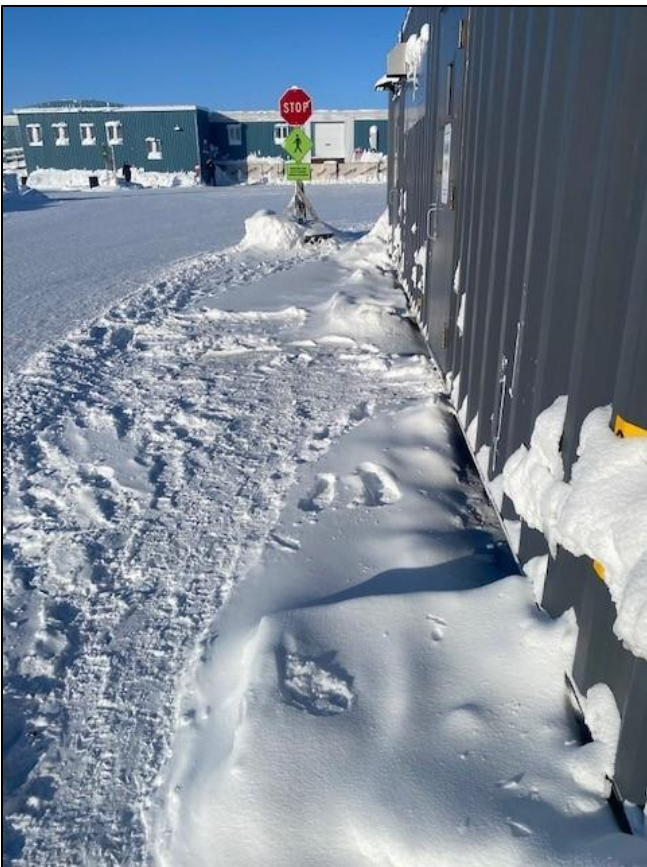
Photo 3: Spill remediation area.

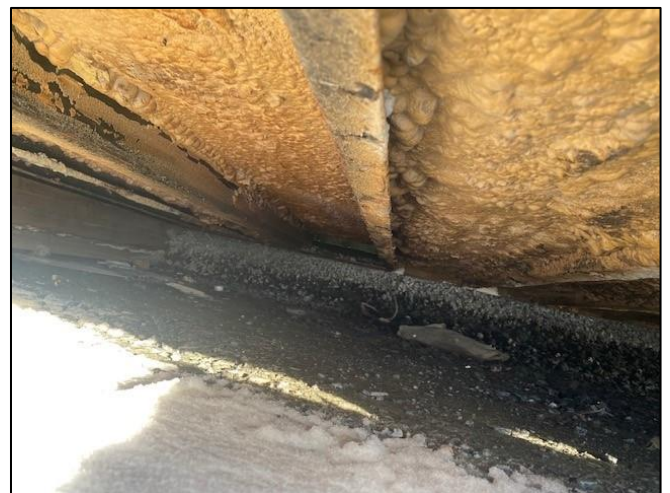
Photo 4: Spill remediation area.
