## **Re: Follow-up Report Spill #2023-057 – Release of 25L of Sewage at the Meliadine Gold Project**

### **Description of Incident**

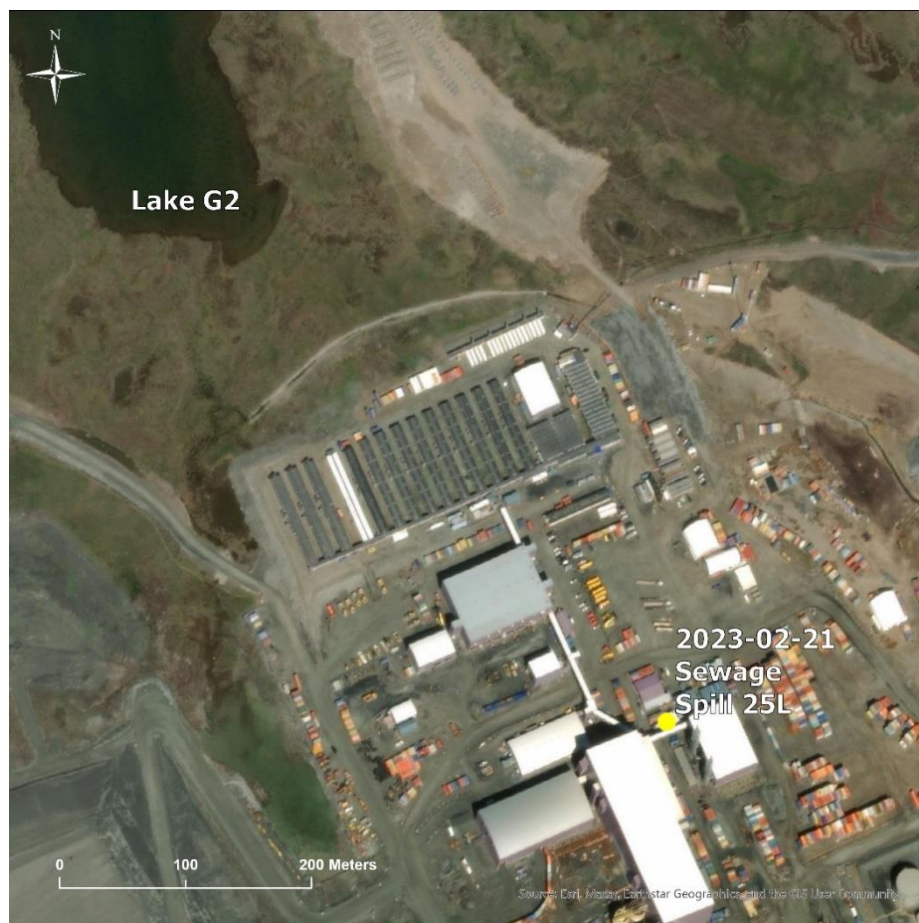
On February 21<sup>st</sup>, 2023, at approximately 4:00 pm, an estimated 25L of sewage was spilled onto the industrial pad at the Power Plant lift station. The vacuum truck was at the site setup to perform a routine removal of sewage from the Power Plant lift station. When the valve to the pump at the vacuum truck was opened the 3" suction hose split spraying sewage on the ground. The spill was cleaned up with a backhoe and the material placed in a drum to be moved Landfarm A. No water bodies were impacted by this spill. The closest water body (G2) is approximately 500 meters northwest, as seen in Figure 1. Please note that this is a correction from the initial report which indicated H15 was the nearest waterbody; H15 is part of our site water management plan.

**Figure 1:** Location of the sewage spill and proximity to water bodies.

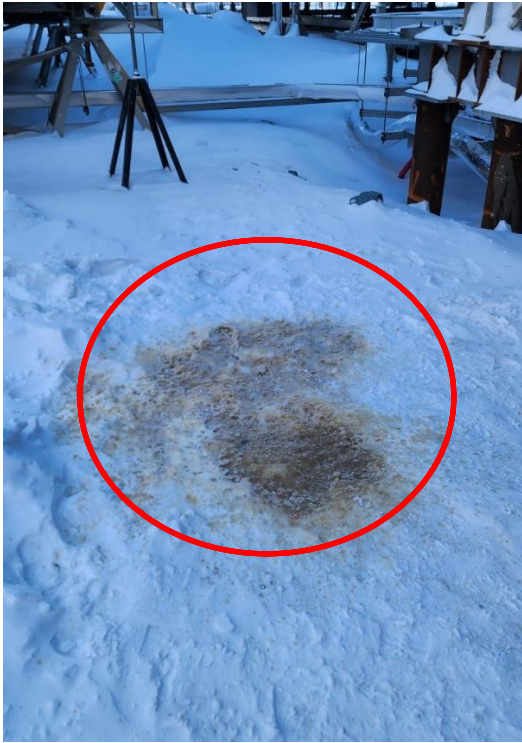
- Cold weather caused the vacuum truck hose to become brittle and crack during operation.

**Photo 1:** Sewage spill location.

The operators closed the valve on the sucker truck and stopped the vacuum. Their supervisor called in a backhoe to scrape the spill up. The contaminated snow and ice was excavated and brought to Landfarm A as per the Spill Contingency Plan.

- Vacuum truck operators instructed to thoroughly inspect the vacuum truck hose to ensure the integrity of the hose before each use.

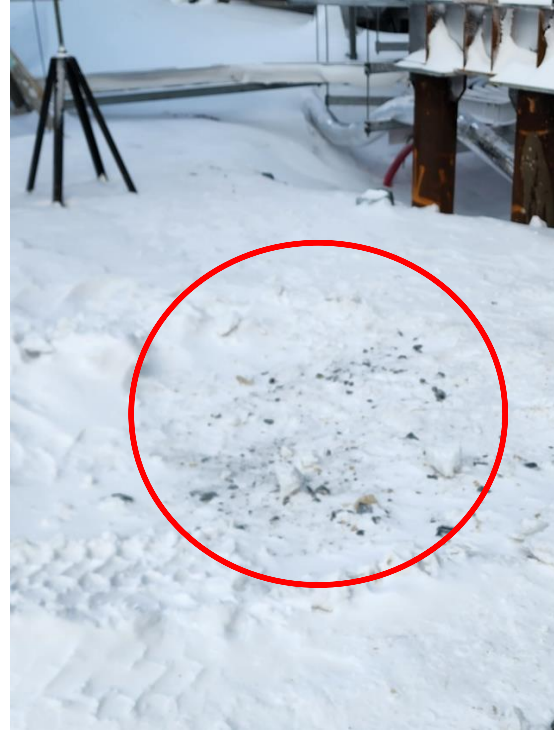
**Photo 2:** Sewage spill post remediation.
