April 17<sup>th</sup>, 2023

## **Re: Follow-up Report Spill #2023-124 – Release of 2 L of Sewage at the Meliadine Gold Mine**

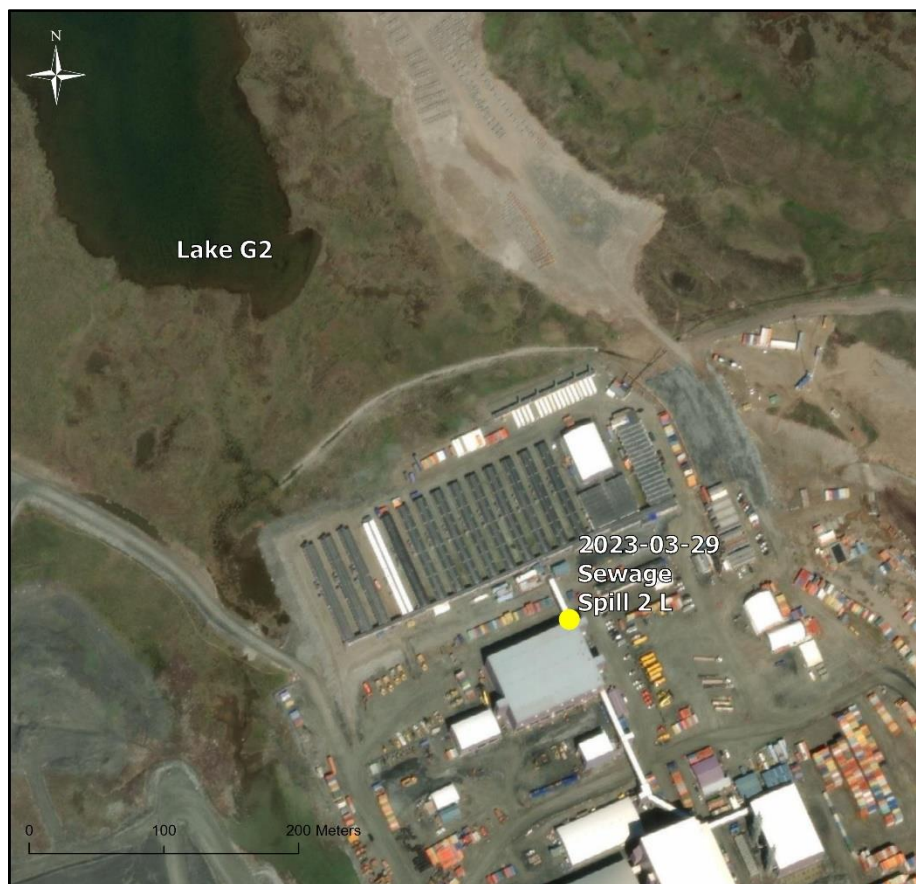
On March 29<sup>th</sup>, 2023, at approximately 13:25 pm, an estimated 2 L of sewage was spilled onto the industrial pad due to a condensation buildup in the air intake pipe of the vacuum truck. The contaminated material was cleaned up with a loader and the material has been placed in Landfarm A. The initial NT/NU Spill Report indicated that 5 L of sewage was released but after further assessment it was determined that 2 L was released. No water bodies were impacted by this spill. The closest water body (G2) is approximately 325 meters northwest, as seen in Figure 1.

**Figure 1:** Location of the sewage spill and proximity to water bodies.

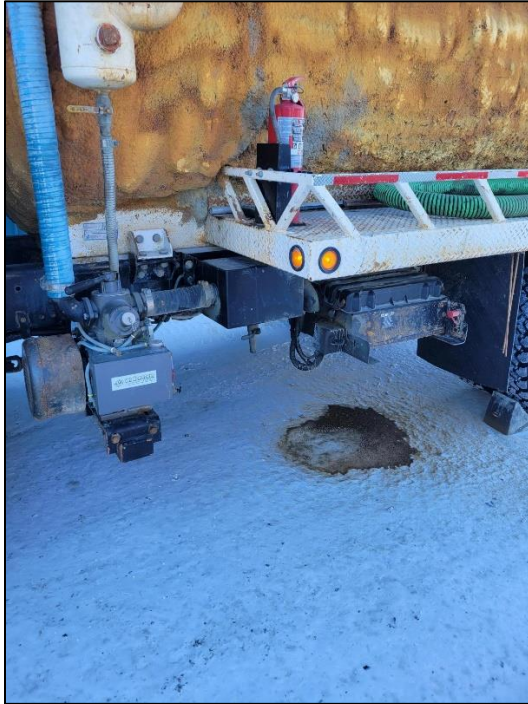
- Operational procedure was missing a step indicating to bleed the air vent on the vacuum truck at the end of each shift.

**Photo 1:** Sewage spill location.

- Procedure update to incorporate the bleeding of the Vacuum truck at the end of each shift.
- Procedure updated to include a secondary containment installed under the air intake pipe while vacuum truck is in use.
- Procedure has been reviewed with all operators and is scheduled to be reviewed with other crew.

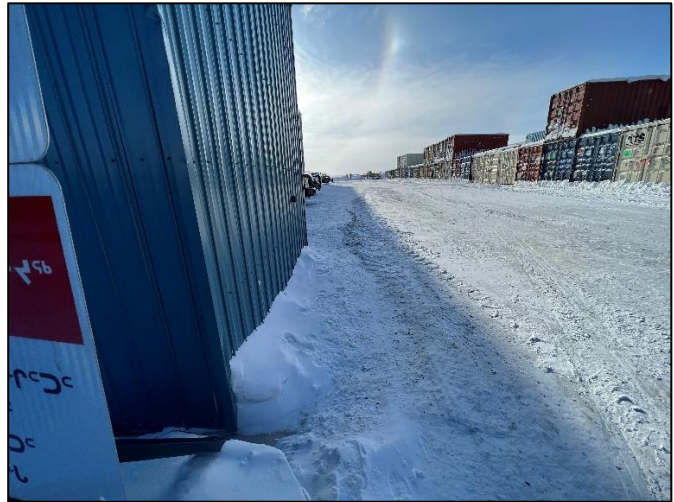
**Photo 2:** Sewage spill post remediation.

The operator notified his supervisor of the incident. The supervisor then contacted the environment department to assess the spill. The contaminated ice and gravel were excavated and brought to Landfarm A as per the Spill Contingency Plan.
