March 21st, 2023

Re: Follow-up Report Spill #2023-073 – Release of 9 m³ of Sewage at the Meliadine Gold Mine

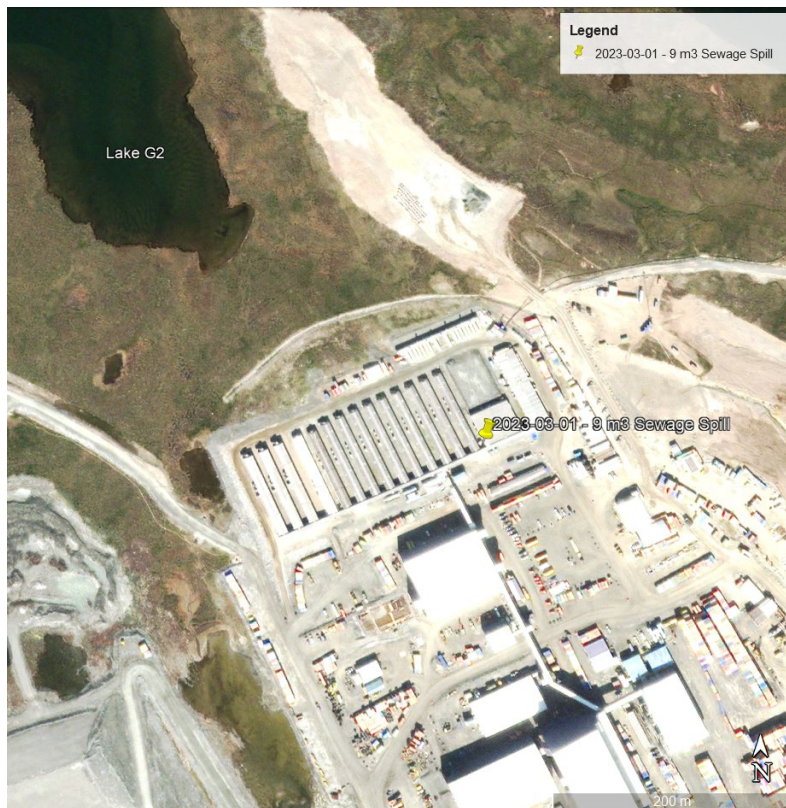
On March 1st, 2023, at approximately 5:30 am, an estimated 9 m³ of sewage was spilled to the industrial pad due to an equipment failure at the main camp lift station causing it to overflow. The original report indicated that this spill occurred at 8:00 am, following the assessment it was identified that the spill began at approximately 5:30 am. The spilled sewage migrated south and collected in the multiple service building (MSB) parking lot where it was contained, and cleanup was initiated. No water bodies were impacted by this spill. The closest water body (G2) is approximately 280 meters north, as seen in Figure 1.

Figure 1: Location of the sewage spill and proximity to water bodies.

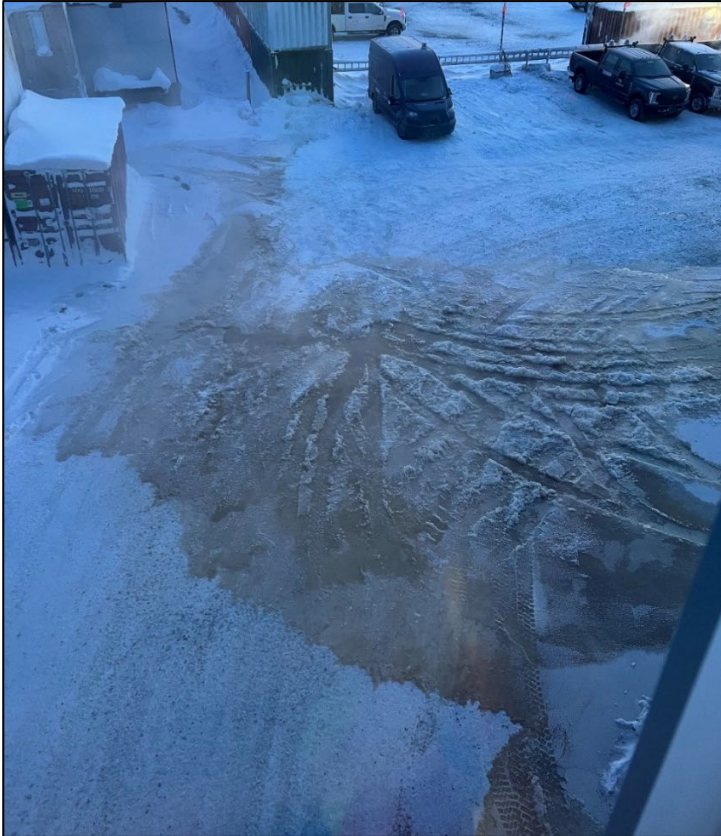
- The float level detection system failed, resulting in the overflow.

Photo 1: Sewage spill location.

- Installation of an ultrasonic level sensor to ensure reliable lift station levels. Completed March 15th, 2023.

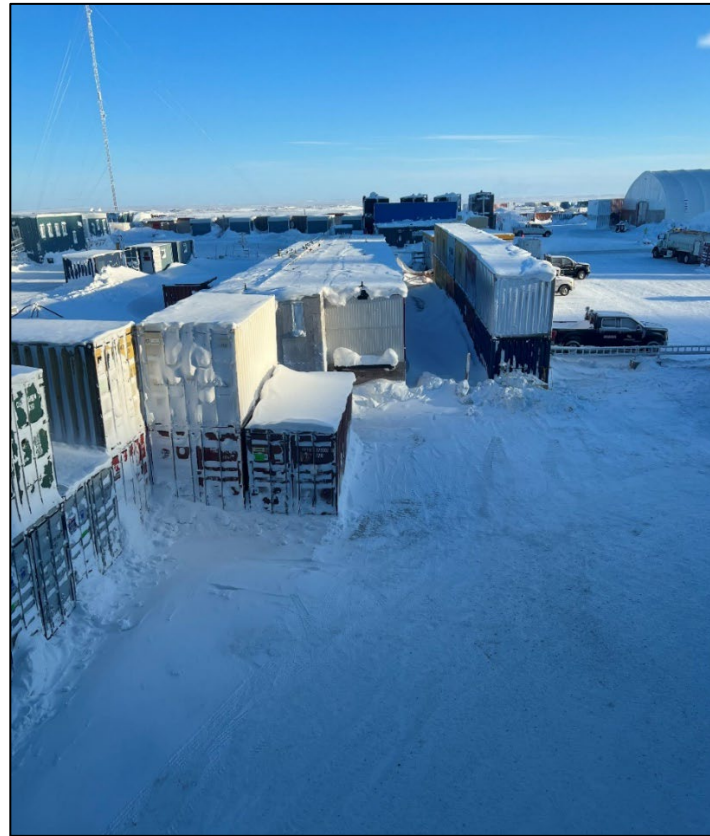
Photo 2: Sewage spill post remediation.

The Energy and Infrastructure Maintenance supervisor was notified that the spill was occurring and switched the pumping system into manual mode to lower the lift station level and stop the release. The impacted area was scrapped using an excavator, and approximately 40 m³ of sewage-impacted snow and ice was recovered. Due to the large volume of material that was generated from the spill remediation, Agnico Eagle requested authorization from CIRNAC, in consultation with KivIA, to transfer the sewage-impacted snow and ice within the Tiriganiaq Pit 2. A one-time authorization was granted on February 17th, 2023.
