May 4th, 2023

Re: Follow-up Report Spill #2023-139 – Release of 20 L of Sewage at the Meliadine Gold Mine

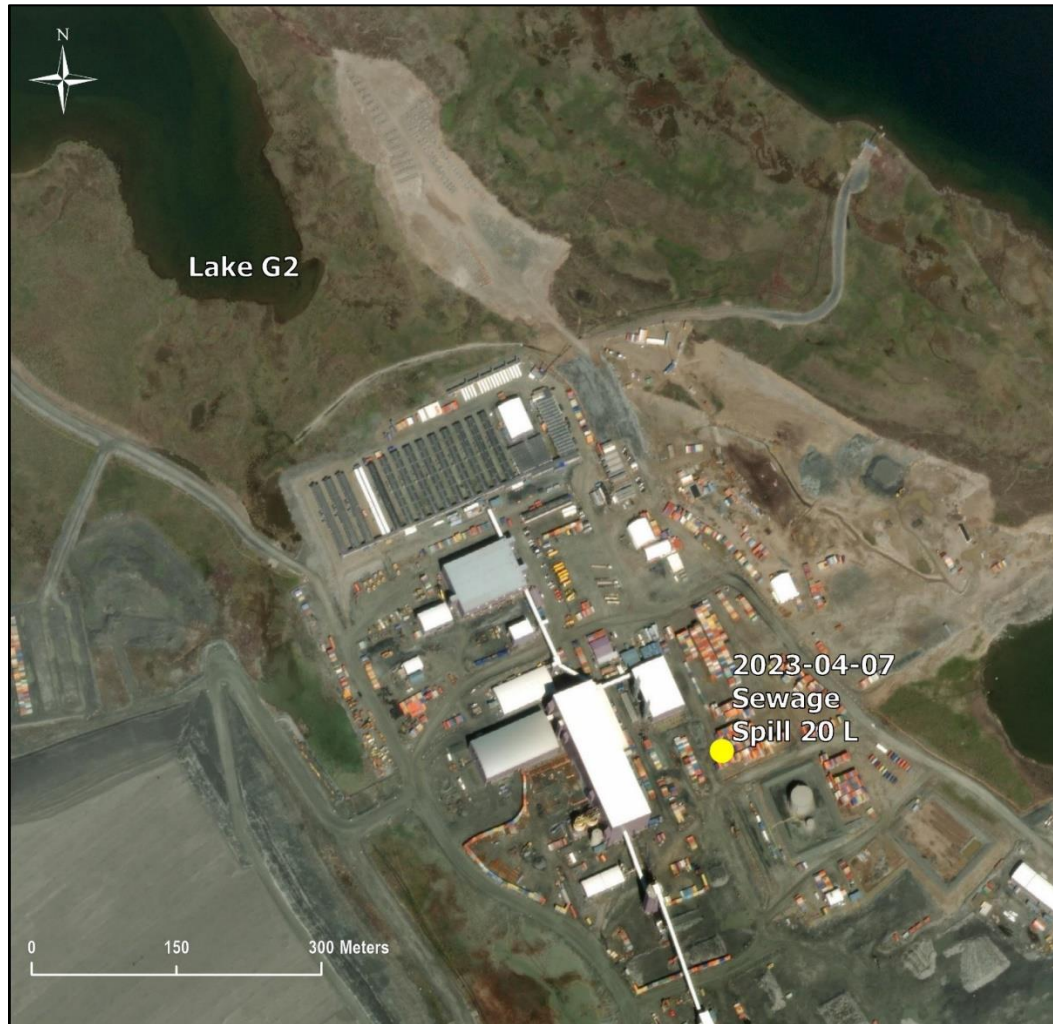
Figure 1: Location of the sewage spill and proximity to water bodies.

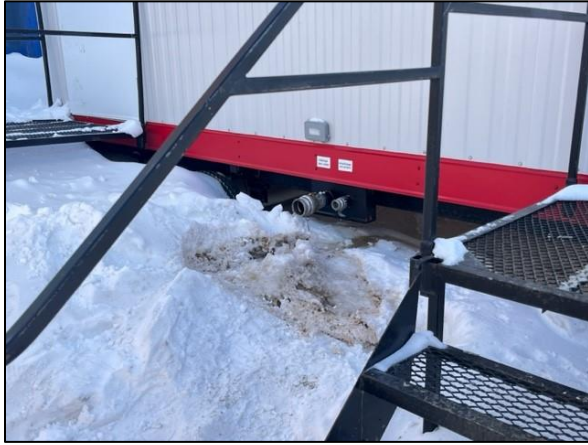
On April 7th, 2023, at approximately 13:30pm, an estimated 20 L of sewage was spilled onto the industrial pad by the powerplant wash car due to a miscommunication between the vacuum truck operators. During normal operations, both vacuum truck operators failed to confirm if hose was connected to the truck prior to transferring material from the lift station. No water bodies were impacted by this spill. The closest water body (G2) is approximately 595 meters northwest, as seen in Figure 1.

- Lack of communication between operators. Both employees had radios but did not use them to confirm that the hose between the lift station and the vacuum truck was secure before the sewage transfer.

Photo 1: 20 L Sewage spill at powerplant washcar.

- Reviewed procedure and put emphasis on the importance of communication when conducting a sewage transfer.
- Reiterated the importance of always confirming the hose connection before starting the vacuum truck.

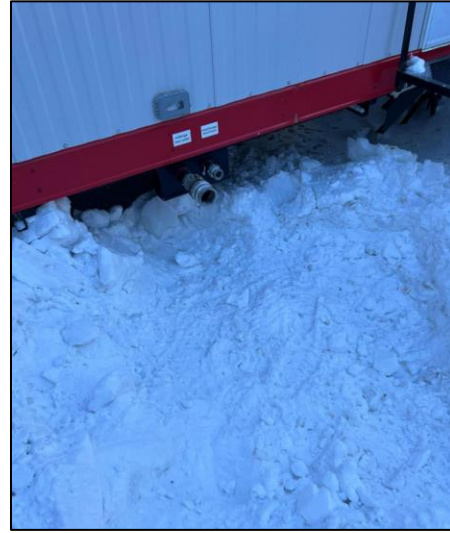
Photo 2: 20 L Sewage spill post remediation.

The operator notified his supervisor of the incident. The supervisor then contacted the environment department to assess the spill. The sewage-impacted snow was excavated and brought to Landfarm A as per the Spill Contingency Plan.
