May 27<sup>th</sup>, 2023

## Re: Follow-up Report Spill #2023-183 – Release of 10 L of Sewage at the Meliadine Gold Mine

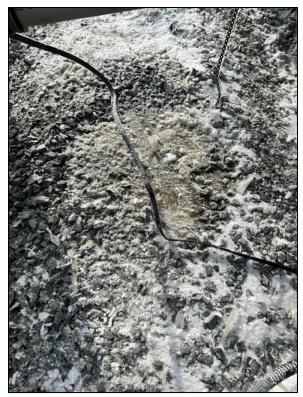
On May 4<sup>th</sup>, 2023, at approximately 23:00, an estimated 10 L of sewage was spilled onto the fusion pad by the fusion pad wash car due to a fracture in the sewage line. No water bodies were impacted by this spill. The closest water body (J6) is approximately 108 meters south, as seen in Figure 1.

• The heat tracing system on the sewage piping had been damaged, leading to the heat trace failing and causing the sewage pipe to freeze and fracture.

**Photos 1**: Sewage spill location.

The operator notified his supervisor of the incident. The supervisor then contacted the environment department to assess the spill. The sewage-impacted gravel and ice was excavated and brought to Landfarm A as per the Spill Contingency Plan.

A Saniflo toilet system was installed which connects directly to each toilet, eliminating
the need for an external holding tank and piping. The sewage line is now more
protected from the weather elements and if a spill occurs, it will be contained within
the trailer unit.

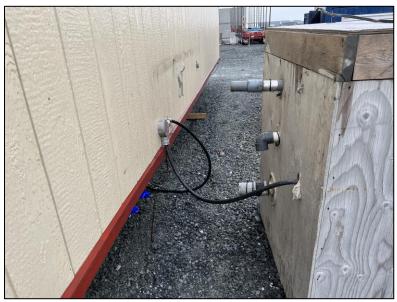
Photos 2: Spill location post remediation.
