June 15, 2023

Re: Follow-up Report Spill #2023-213 – Release of 15 L of Sewage at the Meliadine Gold Mine

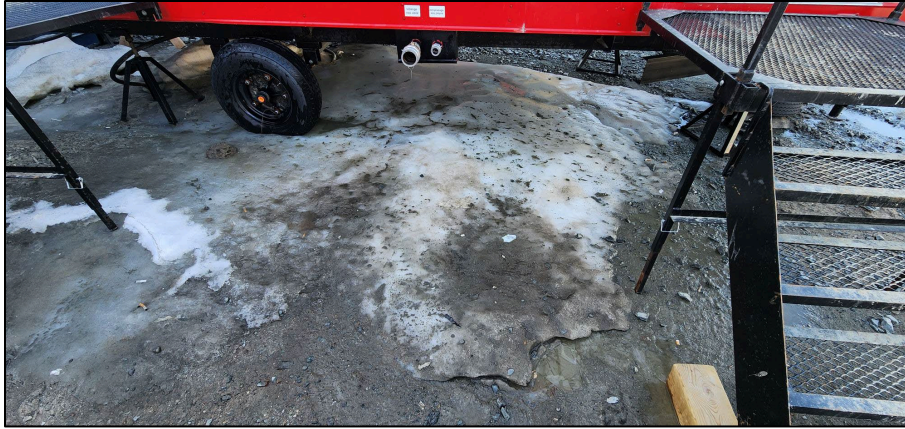
On May 22nd, 2023, at approximately 07:30, an estimated 15 L of sewage was spilled onto the industrial pad by the temporary power plant wash car due to a connection failure. No water bodies were impacted by this spill. The closest water body (G2) is approximately 565 meters west, as seen in Figure 1.

- Missing gasket on the camlock which connects the vacuum truck to the wash car.
- The vacuum truck hose was not properly inspected prior to use.

Photos 1: Sewage spill location.

- A new gasket was installed within the camlock to prevent future leaks.
- The supervisor met with employees to review the importance of performing complete checks on their equipment/tools before proceeding with their jobs.

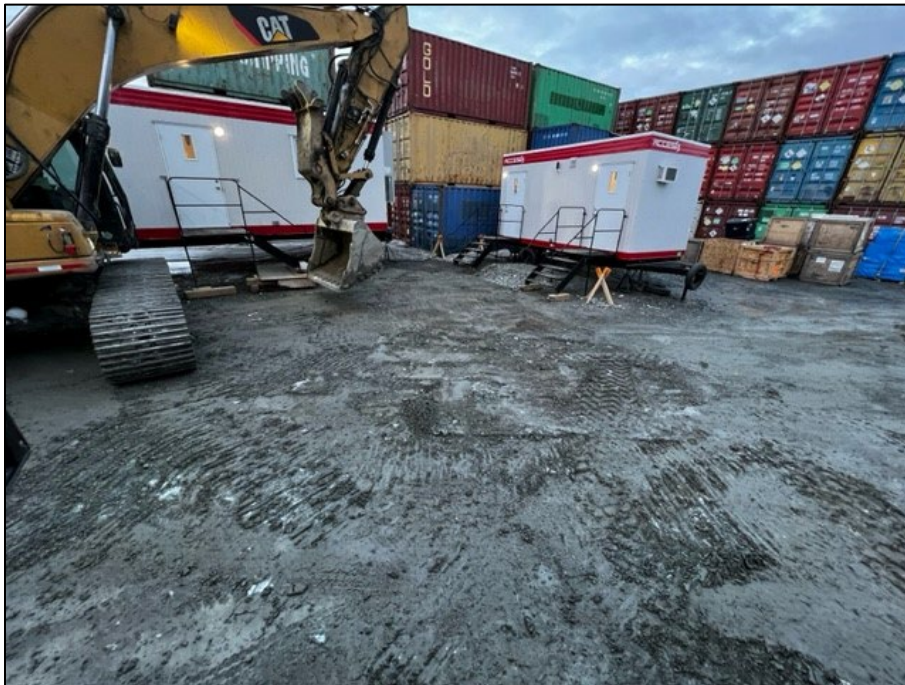
Photos 2: Spill location post remediation.

The operator notified his supervisor of the incident. The supervisor then contacted the environment department to assess the spill. The sewage-impacted gravel and ice was excavated and brought to Landfarm A as per the Spill Contingency Plan.
