June 16, 2023

Re: Follow-up Report Spill #2023-211 – Release of 200 L of Sewage at the Meliadine Gold Mine

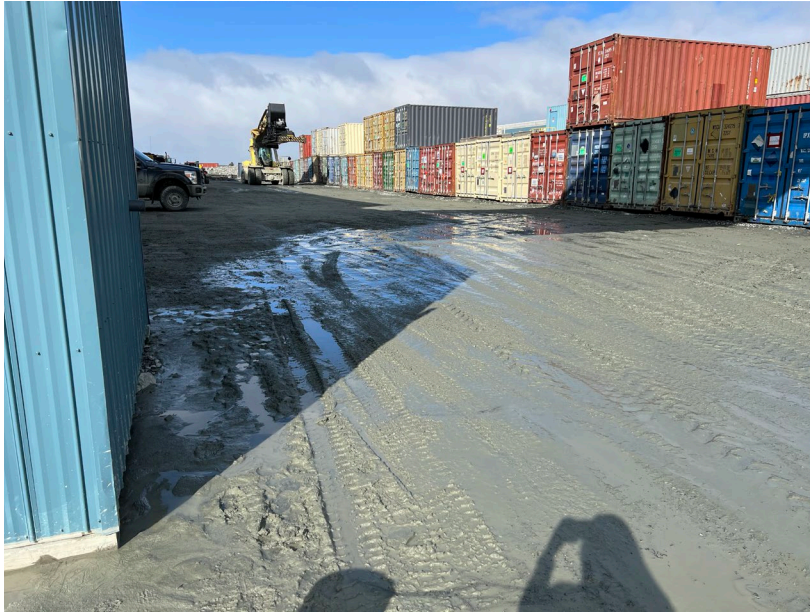
On May 22nd, 2023, at approximately 12:30 am, an estimated 200 L of sewage was spilled to the industrial pad due to faulty levels indicator at the MSB lift station causing it to overflow. A worker discovered the spill occurring and notified his supervisor.

- The float detection system failed, resulting in the overflow.

Photos 1: Sewage spill location.

- Installation of a new float mechanism.
- An improved ultrasonic level sensor has been ordered and will be installed in this list station.
