June 21st, 2023

Re: Follow-up Report Spill #2023-215 – Release of 1 m³ of kitchen grey water at the Meliadine Gold Mine

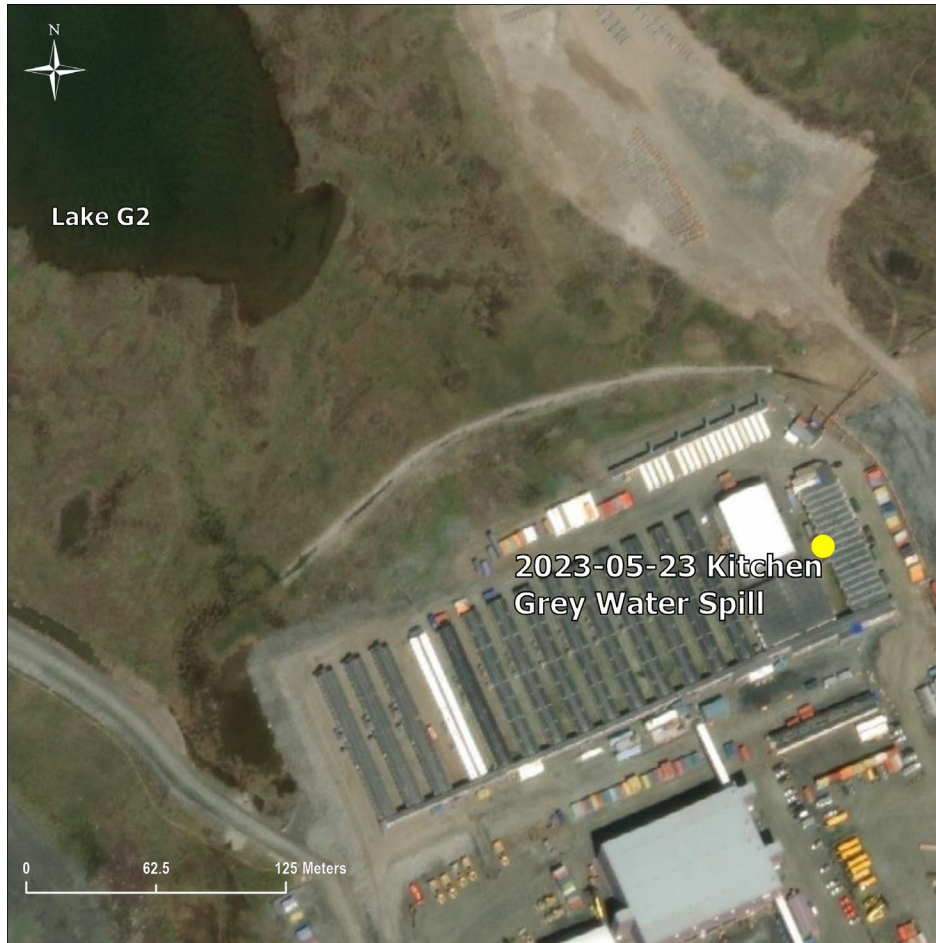
No water bodies were impacted by this spill. The closest water body (G2) is approximately 277 meters northwest, as seen in Figure 1.

Figure 1: Location of the grey water spill and proximity to water bodies.
