July 4<sup>th</sup>, 2023

## **Re: Follow-up Report Spill #2023-243 – Release of 10 L of Sewage at the Meliadine Gold Project**

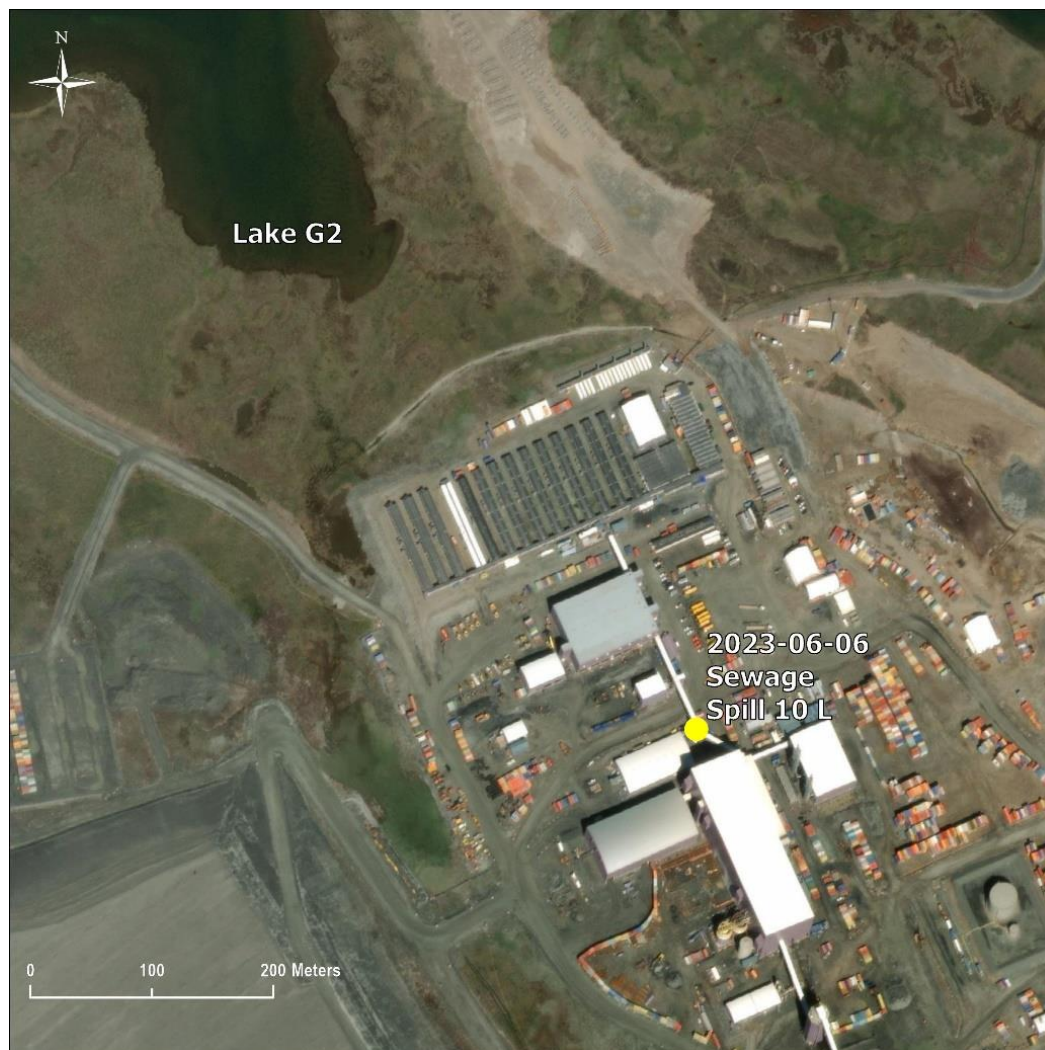
On June 6<sup>th</sup>, 2023, at approximately 7:30 am, an estimated 10 L of sewage was spilled onto the industrial pad at the Assay Lab lift station. During a routine lift station inspection an employee noticed that the lift station overflowing and manually initiated the pump to lower the level. The spilled sewage was contained to the local area. No water bodies were impacted by this spill. The closest water body (G2) is approximately 450 meters north, as seen in Figure 1.

**Figure 1:** Location of the sewage spill and proximity to water bodies.

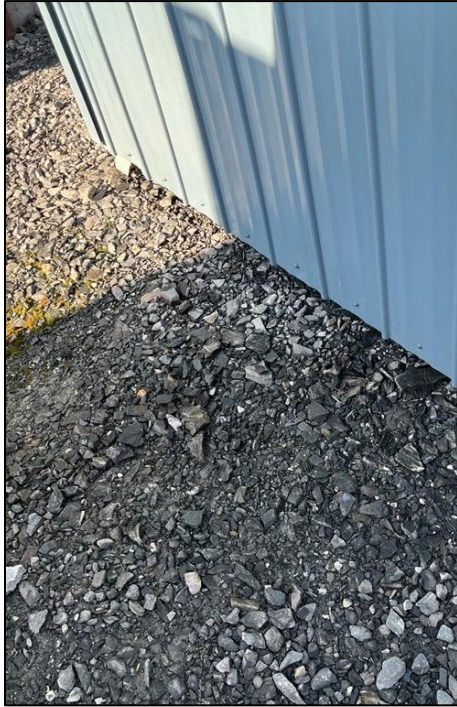
- The float system was damaged due to accumulation of oil, grease and debris.
- The float was stuck in the up position triggering the pump to run to failure.

**Photo 1:** Sewage spill location.

- The float system was replaced.
- Plumbers have been instructed to inspect the float system during their regular preventive maintenance checks. This proactive approach aims to identify and address any instances where a float may be stuck in the raised activated position.

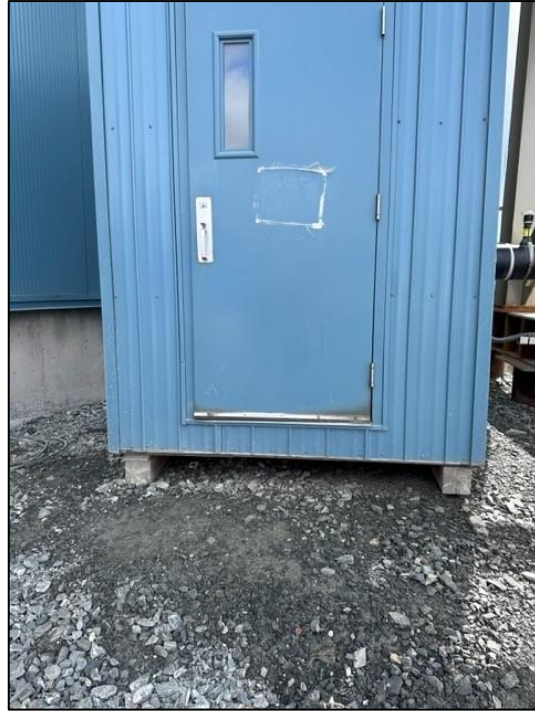
**Photo 2:** Sewage spill post remediation.

The employee switched the pump from the automatic to the manual setting to lower the level of the tank and prevent further spillage. Absorbent pads were used to collect most of the free liquid on the ground. However, a residual amount of material accumulated underneath the lift station enclosure and is inaccessible. This area will be remediated upon decommissioning of the lift station enclosure.
