August 22nd, 2023

Re: Follow-up Report Spill # 2023-331 – Release of 125 L of Sewage at the Meliadine Gold Project

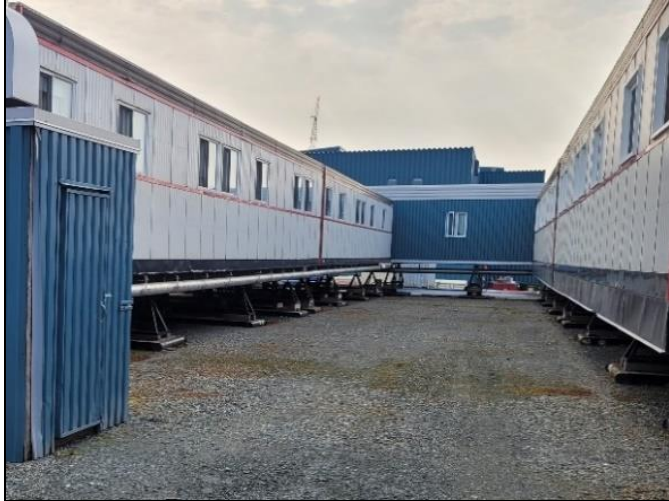
On August 4th, 2023, at approximately 6:00 pm, an estimated 125 L of sewage was spilled onto the industrial pad at the wing 8 lift station. The Energy and Infrastructure department was notified of an overflow occurring at wing 8 lift station. A plumber was dispatched to address the situation and restore the system to its intended operational state. The spilled sewage was contained to the immediate local area, and no water bodies were impacted by the spill. The closest water body (Lake G2) is approximately 208 meters northwest, as seen in Figure 1.

Photo 1: Sewage spill location.

Upon arrival to wing 8 lift station, the plumber switched the pump from the automatic to the manual setting to lower the level of the tank and prevent further spillage. A vacuum truck was used to clean the free liquid on the ground. The ground surface was hand excavated and the recovered material was brought to Landfarm A as per the Spill Contingency Plan.

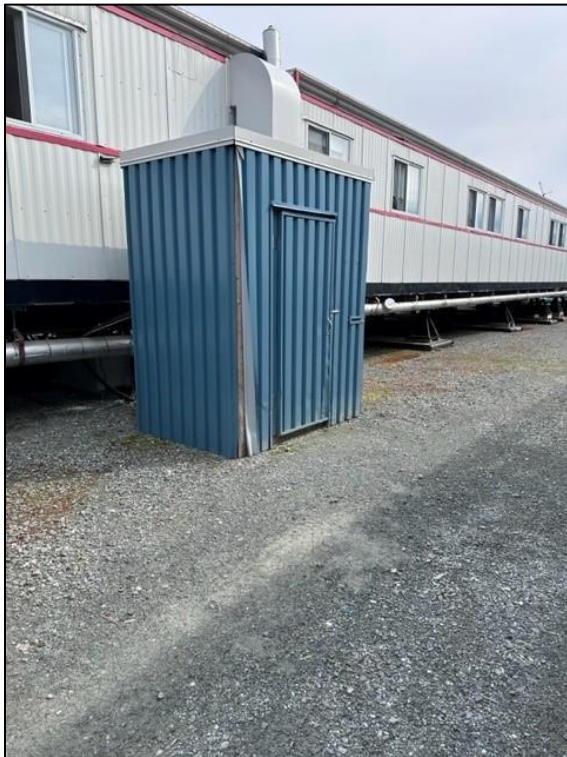
Photo 2: Sewage spill location post-remediation.
