October 19, 2023

## **Re: Follow-up Report Spill #2023-402 – Release of 40 L of Sewage at the Meliadine Gold Mine**

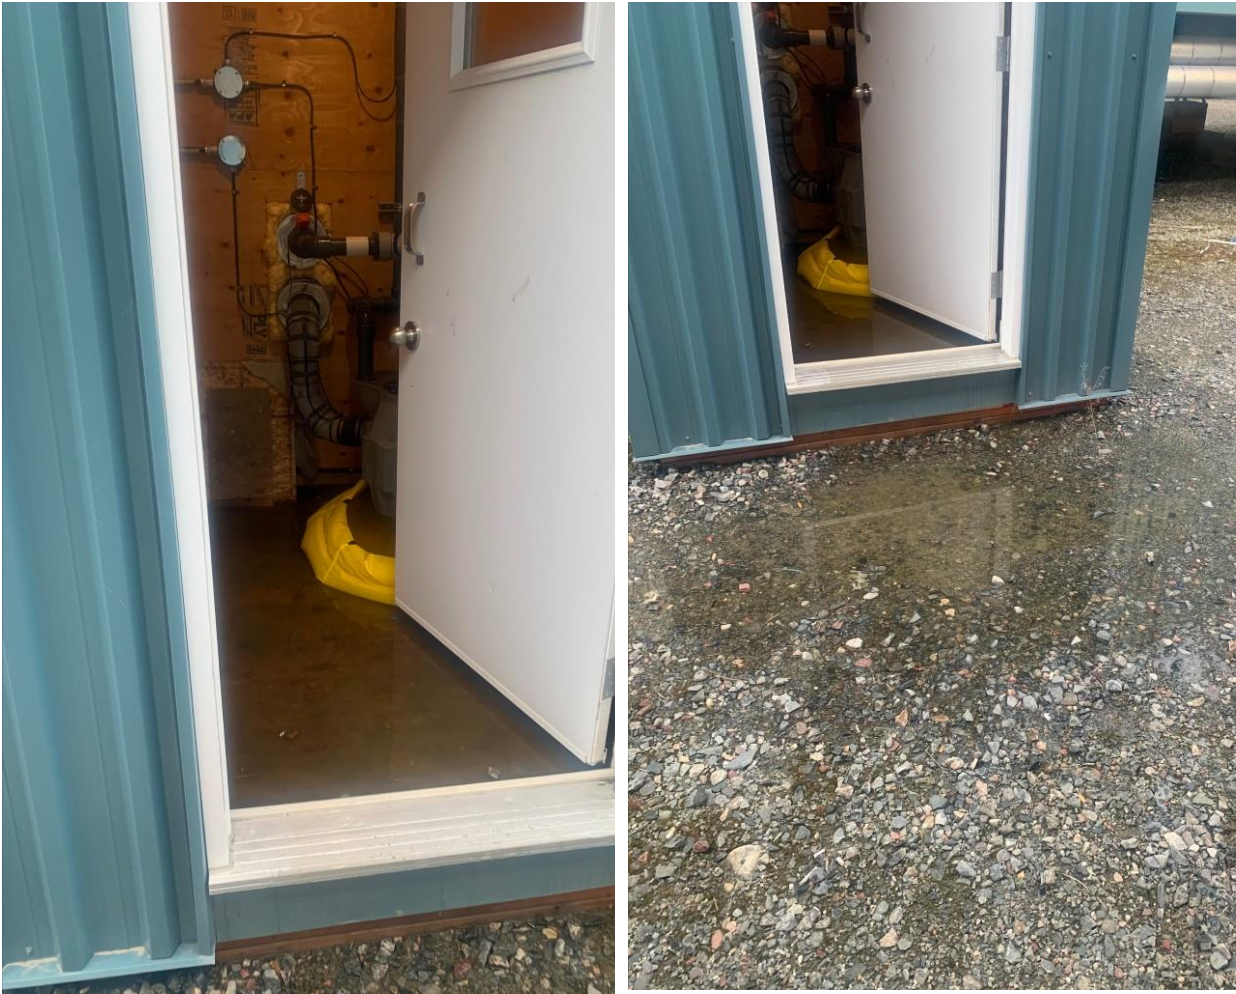
On September 20<sup>th</sup>, 2023, at approximately 18:00, an estimated 40 L of sewage was spilled onto the industrial pad by wing 13 lift station. The pump was unplugged during routine lift station maintenance at wing 13 and was not plugged back in during the restart, causing the spill. No water bodies were impacted by this spill. The closest water body (Lake G2) is approximately 200 meters northwest, as seen in Figure 1.

- Investigation determined that the pumps were left unplugged after routine maintenance was completed.

**Photos 1 and 2:** Sewage spill location.

- During the daily inspection of the lift stations, staff will verify that float pumps are plugged into the PDC-230 after any maintenance event; this has been added to the daily maintenance check list.

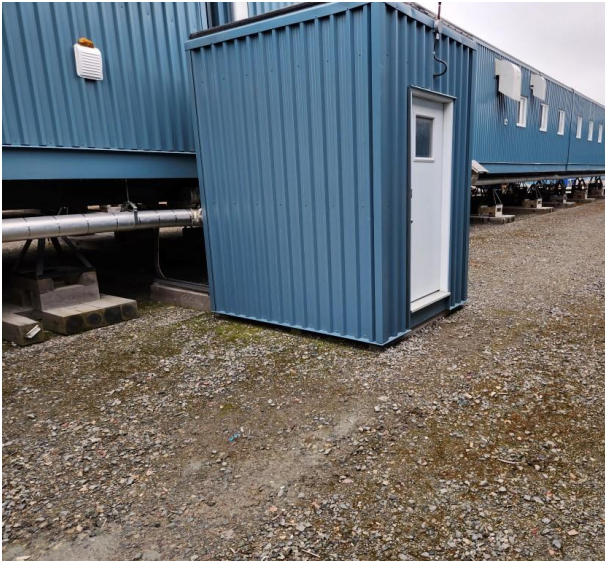
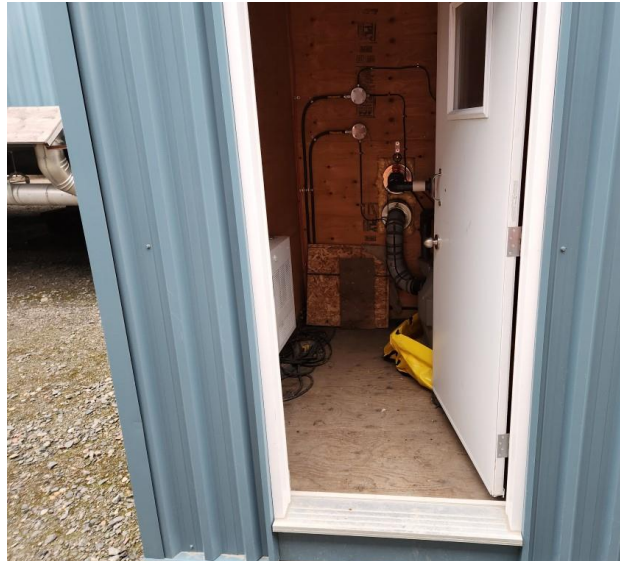
**Photos 3 and 4:** Spill location post remediation.

E&I Maintenance observed that the high-water level strobe light was on around 18:00 at wing 13. This prompted the dispatch of personnel to investigate the situation at wing 13 lift station. Upon arrival, personnel noticed the spill and closed the water source to prevent any further spillage. A vacuum truck was brought up to pump the water in the basin and the secondary containment. Spill pads were laid out to soak up any remaining wastewater on the ground. These pads were then disposed of in the incinerator. The ground surface was also hand excavated, and the recovered material was brought to Landfarm A as per the Spill Contingency Plan.
