**Re: Follow-up Report Spill #2023-436 – Release of 10 L of Sewage at the Meliadine Gold Mine**

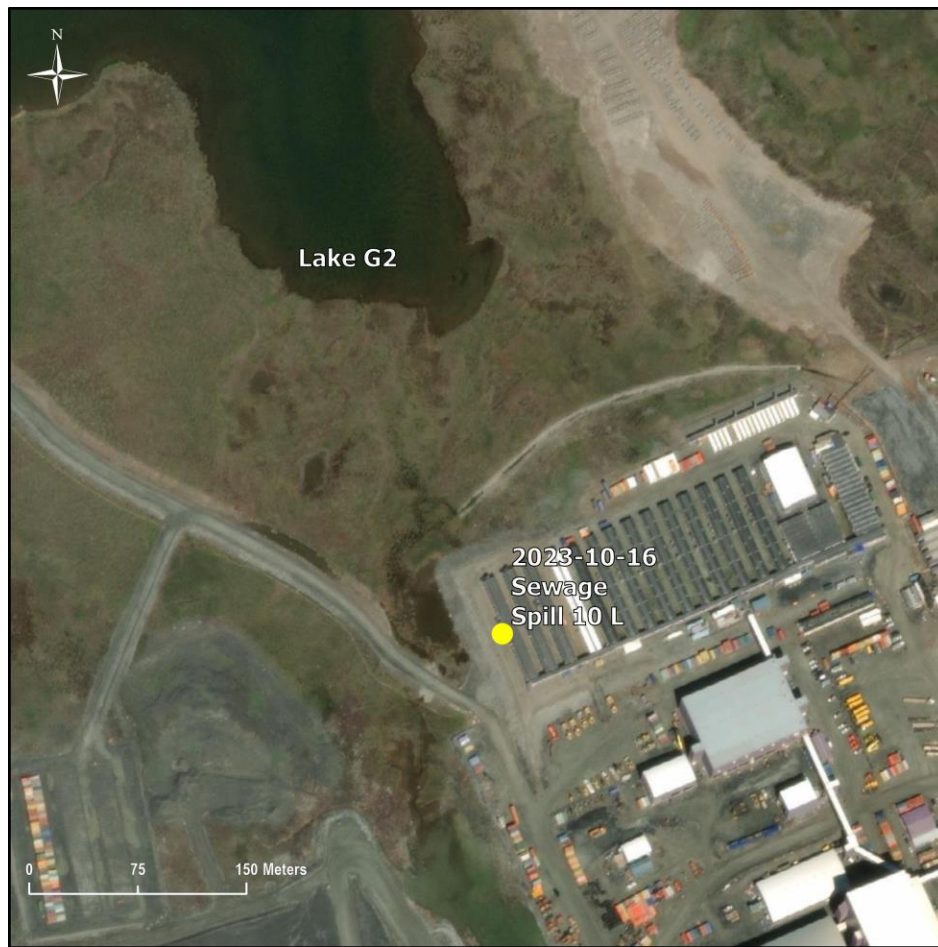
On October 16<sup>th</sup>, 2023, at approximately 17:00, an estimated 10 L of sewage was spilled onto the industrial pad by wing 14 lift station. A transfer pump failed due to blockage at the intake of the pumps, resulting in the sewage spill. No water bodies were impacted by this spill. The closest water body (Lake G2) is approximately 195 m northwest, as seen in Figure 1.

**Figure 1:** Location of the sewage spill and proximity to water bodies.

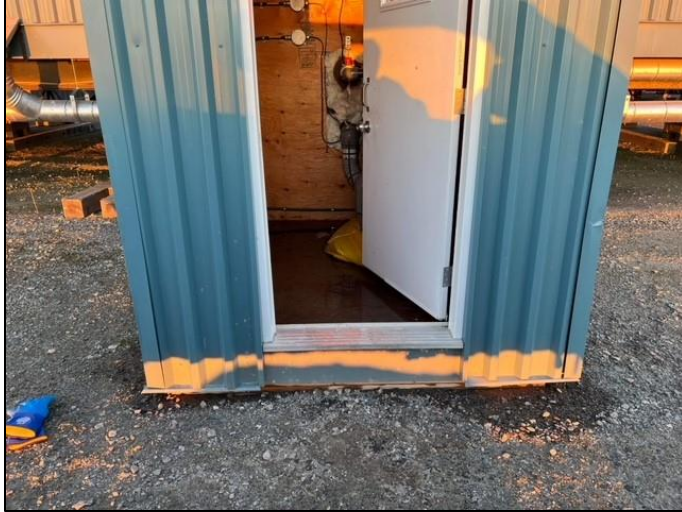
- Investigation determined that personal hygienic products obstructed the intake of the float pump, causing the pump to fail.

**Photos 1:** Sewage spill location.

- All employees in wing 14 were met individually by their supervisor, and they were briefed on the importance of not flushing personal hygienic products in the bathroom.
- Site-wide notification was also sent in the Meliadine minute for supervisors to talk with their team about the importance of putting personal hygienic products in the garbage.

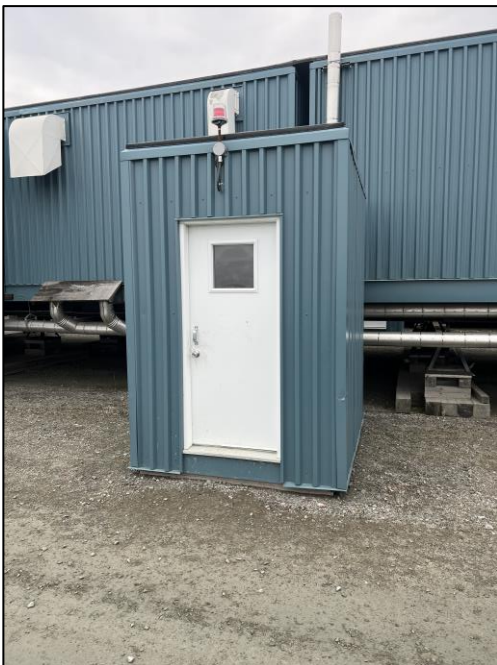
**Photos 2:** Spill location post remediation.

During a routine inspection of the site sewage system, an employee from the Energy and Infrastructure (E&I) maintenance department noticed that the high-water level strobe had been activated at wing 14 at 16:50. Upon inspection, the employee observed the presence of sewage effluent outside the lift station enclosure. In response, a vacuum truck was promptly dispatched to pump out the water accumulated in the lift station basin. The ground surface was hand excavated, and the recovered material was brought to Landfarm A as per the Spill Contingency Plan. The employee inspected the transfer pump and discovered a personal hygienic product obstructing the intake and had caused the pump to burn out. The personal hygienic product was then removed from the pump system, the pump was replaced, and the system was back on full functionality the same day.
