December 4th, 2023

Re: Follow-up Report Spill #2023-462 – MEL-SR-1 Surface Water Runoff at the Meliadine Gold Mine, Itivia Site

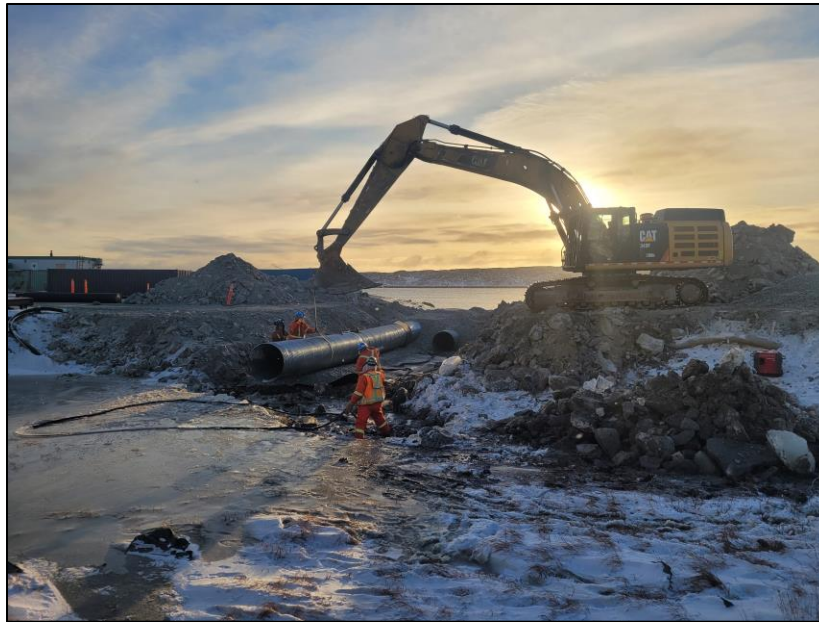
facilitate the placement of riprap on the upstream side of the partially installed culverts, an area of ice and soil was excavated, resulting in the upwelling of unfrozen water present beneath the ice.

A submersible pump was installed in the excavation upstream of the culverts to dewater the area, and the discharge stream was directed into one of the partially installed culverts (Figure 2). Approximately 6 m³ of water was pumped from the excavation.

Figure 2: Dewatering of excavated area upstream of new Itivia culverts.

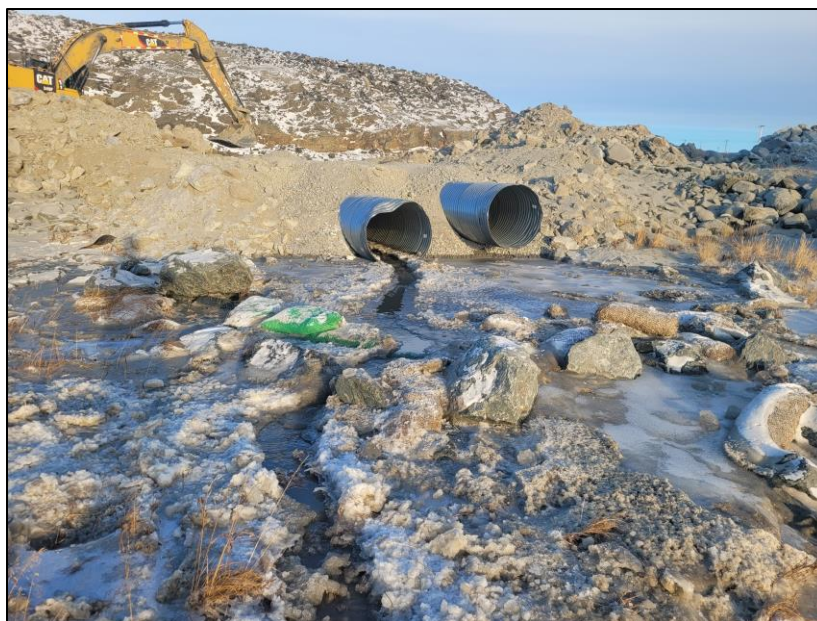
A water sample was collected from runoff at station MEL-SR-1, downstream of the culverts (Figure 3), November 4th. The sample was brought back to the mine site and measured for turbidity, yielding a reading of 69.7 NTU. The sample was internally analyzed for TSS at the mine site Assay Laboratory and results reported a TSS concentration of 43.5 mg/L, well below the 100 mg/L-TSS effluent quality limit identified in Part D, Item 18 of the Licence.

Figure 3: Discharge of pump dewatering downstream of Itivia culverts.

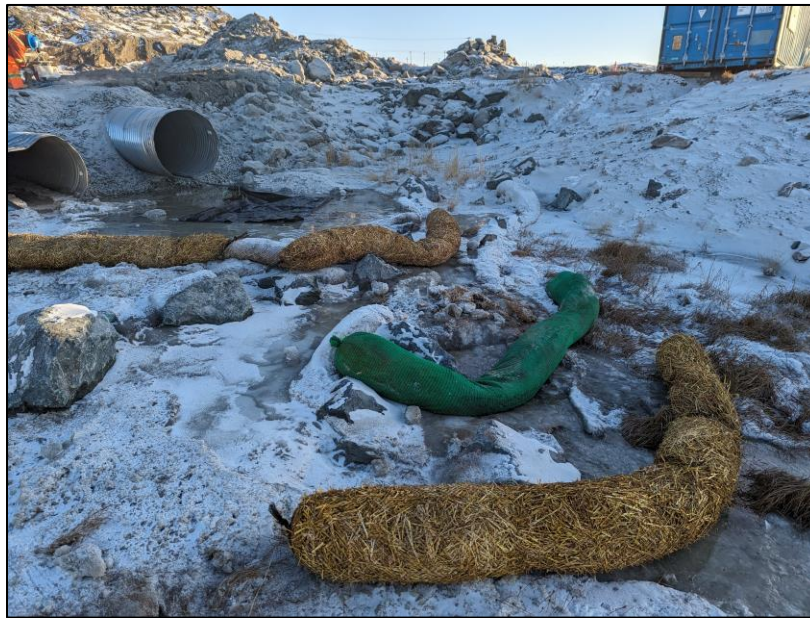
Figure 4: Sediment dewatering bag and straw/wood chip wattles installed downstream.

Following the resumption of pumping, a series of turbidity measurements were collected at MEL-SR-1, downstream of the culverts, and their results are indicative of efficient sedimentation control measures.

On November 5th, 2023, a sediment dewatering bag was installed on the end of the pump discharge hose, and straw and woodchip wattles were installed downstream of the culvert prior to resuming dewatering (Figure 4).
