December 5th, 2023

Re: Follow-up Report Spill #2023-464 – Release of 50 L of Sewage at the Meliadine Gold Mine

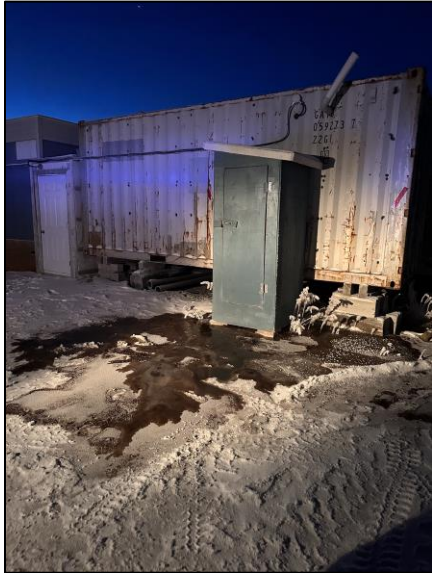
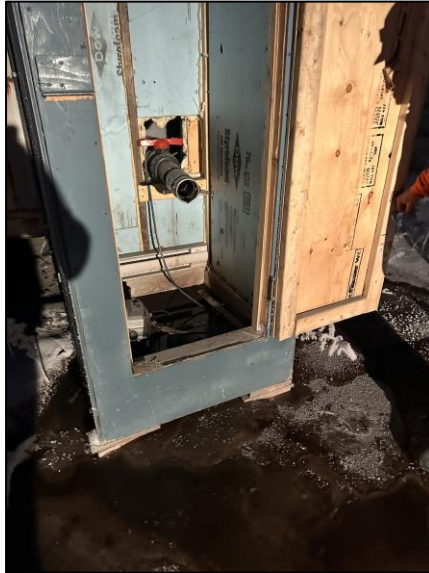
On November 6th, 2023, at approximately 06:30, an estimated 50 L of sewage was spilled onto the ground at the Orbit Garant holding tank. The facility was serviced but its valve was inadvertently left partially open, allowing for sewage to leak from the valve into the enclosure. No water bodies were impacted by this spill. The closest water body (Lake H5A) is approximately 650 m northeast, as seen in Figure 1.

- The spill occurrence was attributed to human oversight, specifically, the operators who last serviced the holding tank and removed sewage failed to secure the valve in the closed position.

Photos 1 & 2: Sewage spill location.

Upon detection of the spill, a member of the Energy & Infrastructure (E&I) department closed the valve stopping the leak. Following this, E&I personnel used a vacuum truck to remove free liquid within the secondary containment and the ground surface. E&I personnel then hand-excavated the area to recover the contaminated material. Snowfall occurred later in the morning; a loader was utilized to perform a final scraping in the affected area. The material collected was transported to Landfarm A as per the Spill Contingency Plan.

- Staff were met by supervisors and reiterated the importance of having both operators working on the vacuum truck verify each other's work, reducing the likelihood of a future spill occurrence of this nature.
- The supervisors conveyed to the operators the importance of careful attention in their tasks, emphasizing the critical necessity of not rushing to complete tasks.

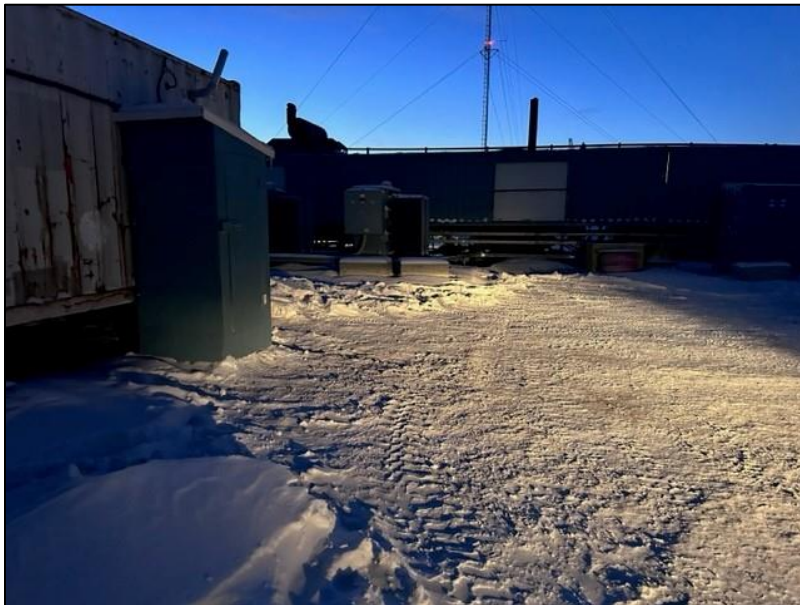
Photos 3: Spill location post remediation.
