December 6th, 2023

Re: Follow-up Report Spill #2023-469 – Release of 50 L of Sewage at the Meliadine Gold Mine

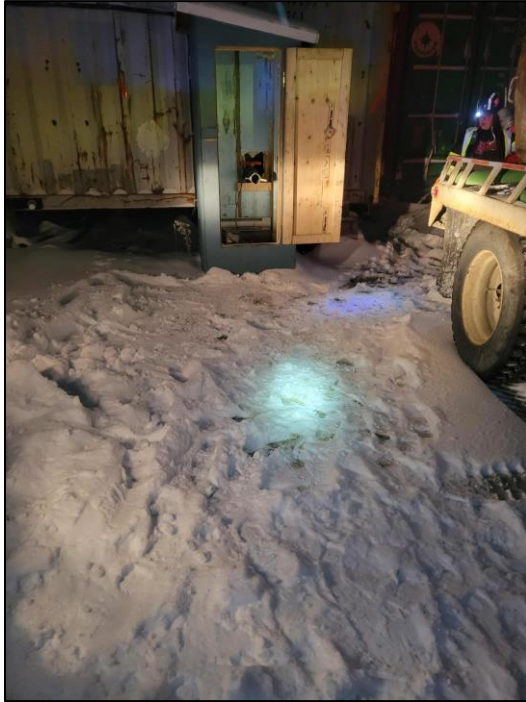
On November 11th, 2023, at approximately 06:00, an estimated 50 L of sewage was spilled onto the ground by Orbit Garant holding tank. The Energy and Infrastructure (E&I) department discovered a leak resulting from a malfunctioning valve. The closest water body (Lake H5A) is approximately 650 m northeast, as seen in Figure 1.

- A broken valve caused the spill to occur.

Photos 1: Sewage spill location.

The leak was discovered by E&I personnel during a routine daily facility inspection. In response, a plumber was called to replace the malfunctioning valve and install a camlock cap as an additional precaution. Subsequently, E&I personnel hand-excavated the area to recover the contaminated material and transported the material to Landfarm A as per the Spill Contingency Plan.

- Secondary containment inside the Orbit holding tank to be replaced by the end of 2023 to increase holding capacity.
- Installation of camlock caps to all lift station and holding tank connections by the end of 2023 to prevent sewage from exiting the line in the event of a valve malfunction.

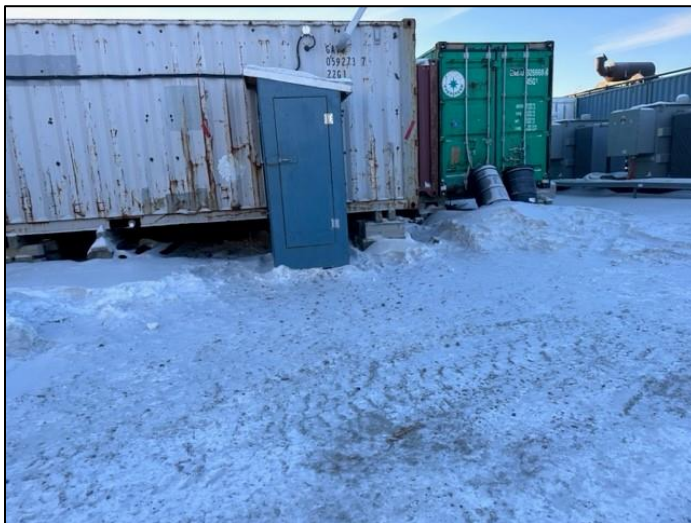
Photos 2: Spill location post remediation.
