December 28th, 2023

Re: Follow-up Report Spill #2023-509 – Release of 4m³ of Sewage at the Meliadine Gold Mine

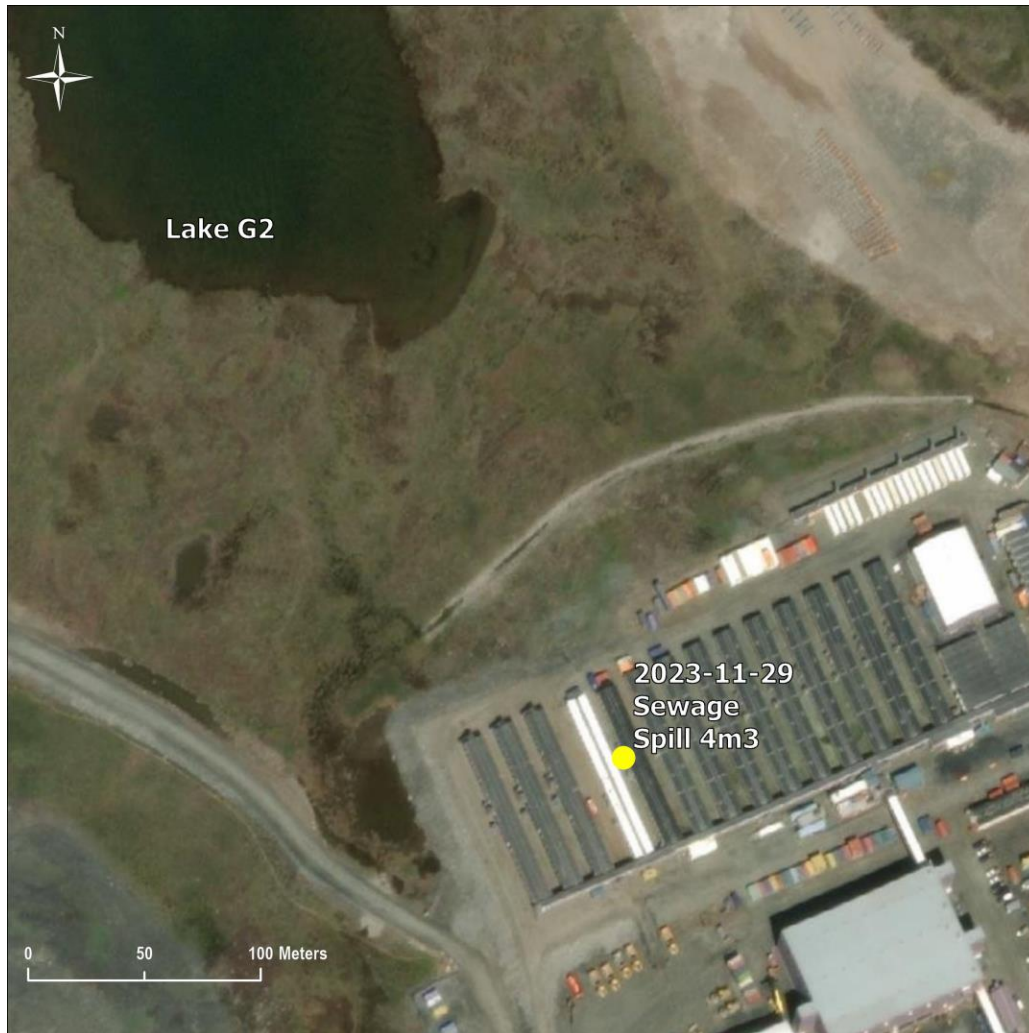
On November 29th, 2023, at 13:00, approximately 4m³ of sewage was inadvertently released to the camp pad due to a damaged sewage distribution line between the accommodations and the Wing 10 lift station. Snow accumulation caused a crack due to direct stress on the line. The nearest water body of water, Lake G2, is located about 250 m northwest as seen in Figure 1.

Figure 1: Location of the sewage spill and proximity to water bodies.

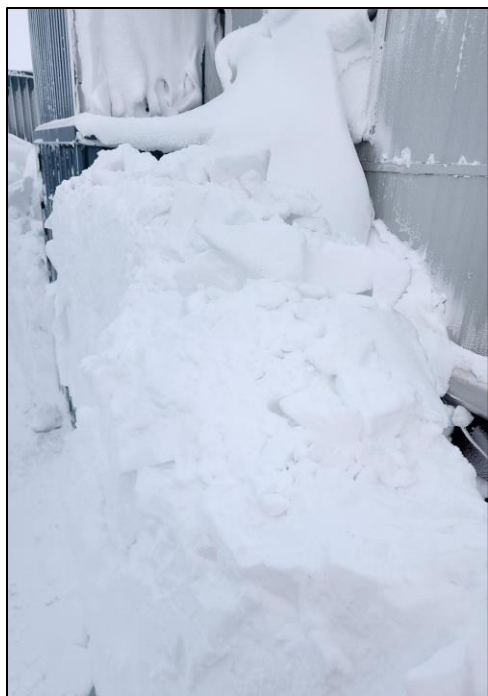
- Insufficient support beneath the sewage line.

Photo 1: Sewage spill location.

- Installation of additional sewage line support brackets.
- Audit to be conducted on all the accommodation wing sewage distribution lines to determine if this risk is present elsewhere.
- Install a protective canopy over the lift station sewage intake and discharge lines to prevent snow accumulation on the infrastructure.

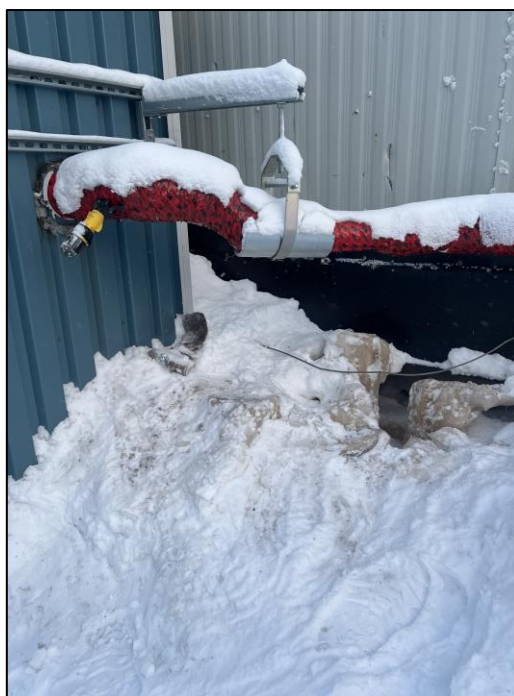
Photo 2: Spill location post snow removal.

Temporary insulation was installed around the repaired section of the distribution line. A work order was created to complete the final insulation of the line and will be completed in the coming days.

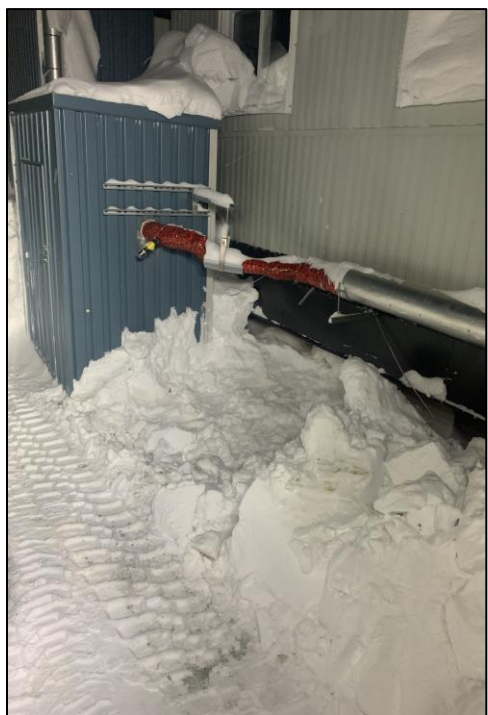
Photo 3: Spill location post remediation.

The leak was discovered by Energy & Infrastructure (E&I) personnel during snow removal activities after a recent blizzard event. An equipment operator immediately notified their supervisor of the leak and personnel were sent to assess and conduct the necessary repairs. Once the snow was removed and area was made accessible, the damaged section of the line was replaced, and an additional support bracket was installed in this location. Subsequently, E&I personnel excavated the area with a backhoe to recover sewage impacted snow and transported the material to Landfarm A as per the Spill Contingency Plan.
