## **Re: Follow-up Report Spill #2023-517 – Release of 10 L of Sewage at the Meliadine Gold Mine**

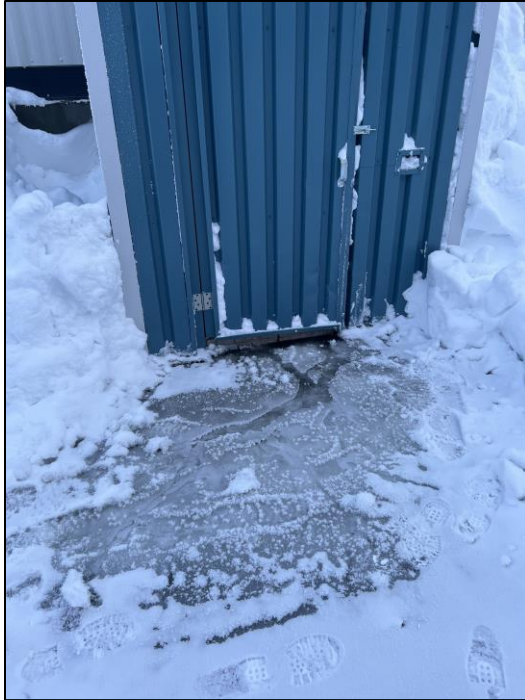
On December 11<sup>th</sup>, 2023, at approximately 11:30, an estimated 10 L of sewage was spilled onto the industrial pad at the wing 4 lift station. Due to a site power outage, the transfer pump did not engage allowing the lift station holding tank to overflow. No water bodies were impacted by the spill. The closest water body (Lake G2) is approximately 220 m northwest, as seen in Figure 1.

- A site wide power outage resulted in the wing 4 lift station losing power and overflowing. Washrooms and laundry machines in wing 4 were in use at the time of the power outage. The water and sewage generated exceeded the capacity of the lift station holding tank.

**Photo 1:** Sewage spill location.

- In the event of a power outage the water supply at the camp accommodation wings will be immediately shut off to prevent lift station overflows from occurring. This will also provide the Energy and Infrastructure department adequate time to systematically inspect and bring sewage system back online.

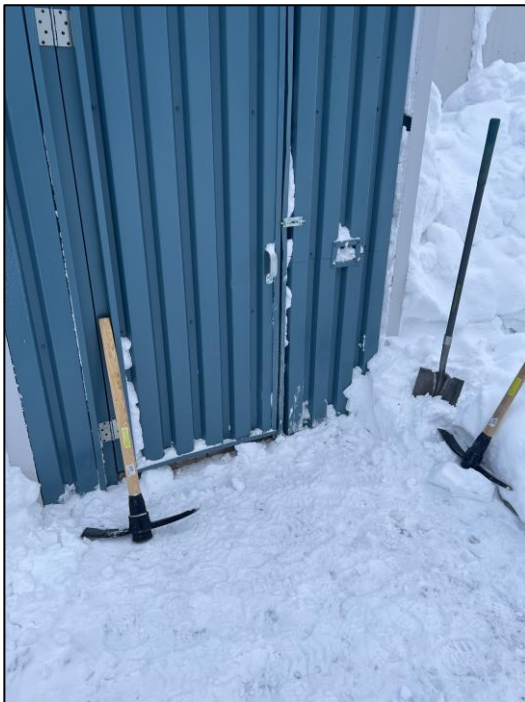
**Photo 2:** Spill location post remediation.

Once power was restored, the environment department conducted an inspection of the site sewage system. During this inspection, an employee observed the presence of sewage outside the wing 4 lift station enclosure. Upon further inspection, the secondary containment was observed to be full and had overflowed. In response, a vacuum truck was dispatched to pump out the sewage that accumulated in the lift station secondary containment. The ground surface was hand excavated, and the recovered material was brought to Landfarm A as per the Spill Contingency Plan.
