January 9th, 2024

Re: Follow-up Report Spill #2023-518 – Release of 10 L of Sewage at the Meliadine Gold Mine

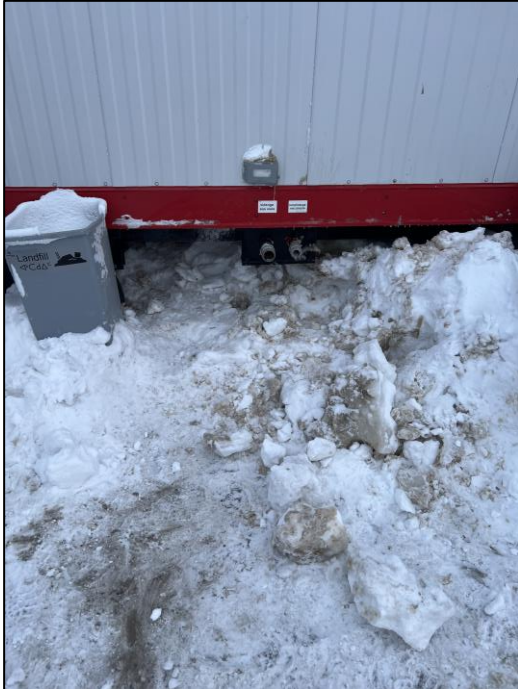
On December 11th, 2023, at approximately 12:30, an estimated 10 L of sewage was spilled onto the industrial pad by the west exhaust raise. Residual sewage in vacuum truck transfer hose was released when disconnecting the hose from a wash car holding tank, resulting in the sewage spill. No water bodies were impacted by this spill. The closest water body (Lake B5) is approximately 260 m southwest, as seen in Figure 1.

- The vacuum truck operator failed to fully empty the transfer hose prior to disconnecting the hose from the holding tank.

Photo 1: Sewage spill location.

The operator of the vacuum truck contacted their supervisor and the Environment department soon after the spill event occurred. The Environment department promptly responded to the spill and upon arrival, the ground surface was hand excavated, and the recovered material was brought to Landfarm A as per the Spill Contingency Plan.

- The procedure was reviewed with sewage truck operator.
- Secondary containment (drip tray) will be used when disconnecting hose from holding tank.
- Assess the equipment for optimization opportunities to reduce the chances for human error.

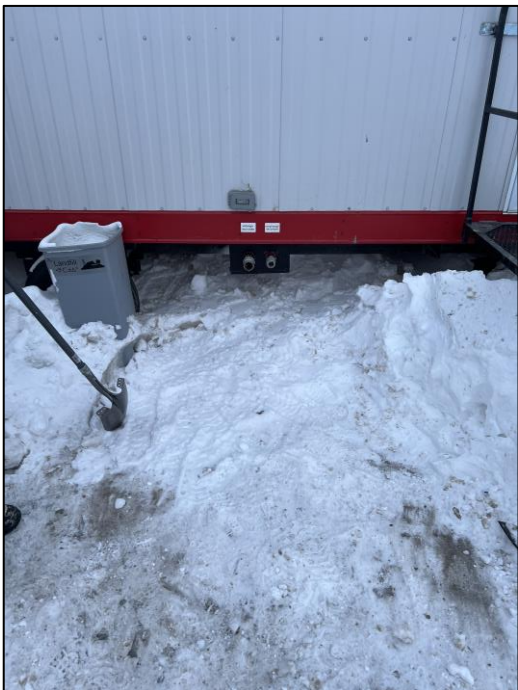
Photo 2: Spill location post remediation.
