January 9th, 2024

Re: Follow-up Report Spill #2023-520 – Release of 5 L of Sewage at the Meliadine Gold Mine

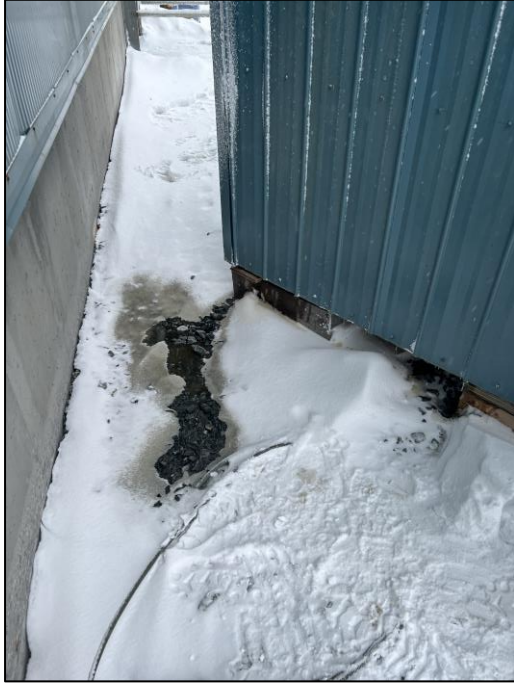
On December 13th, 2023, at approximately 12:15, an estimated 5 L of sewage was spilled onto the industrial pad at the mill lift station. The transfer pump failed to empty the lift station holding tank, resulting in sewage overflowing and causing the spill. No water bodies were impacted by this spill. The closest water body (Lake G2) is approximately 500 m northwest, as seen in Figure 1.

- A blockage in pump 1 caused the pump to fail. Although the pump intake was blocked, the pump was still running which did not signal pump 2 to engage.

Photo 1: Sewage spill location.

- The electrical department installed a “high-high” level sensor at the mill lift station. If this sensor is triggered both pumps will engage to draw down the sewage level within the holding tank.
- The installation of a stronger audible/visual alarm is planned to be installed on the exterior of the lift station in the coming weeks.

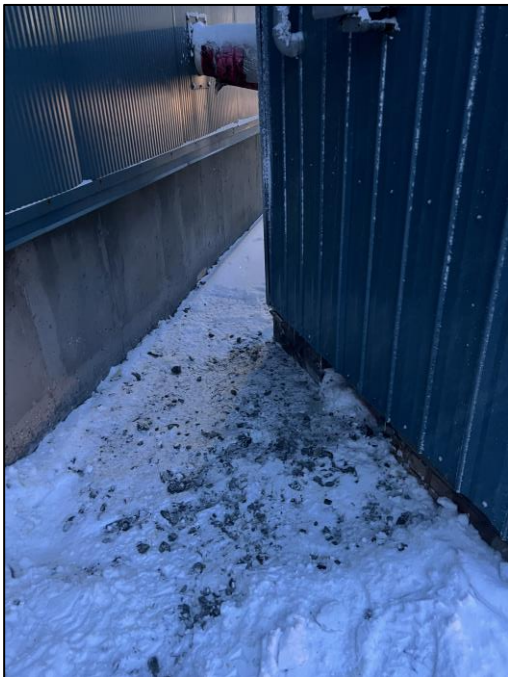
An electrician working in the area observed the lift station alarm. The employee is familiar with the lift station infrastructure and in response, they manually initiated the backup pump to draw down the sewage level and prevent further spillage. The employee observed the presence of sewage effluent outside the lift station enclosure and immediately contacted the environment department. The ground surface was hand excavated, and the recovered material was brought to Landfarm A as per the Spill Contingency Plan.

Photo 2: Spill location post remediation.
