January 20, 2024

**Re: Follow-up Report Spill #2023-536 – Release of 150 L of Sewage at the Meliadine Gold Mine**

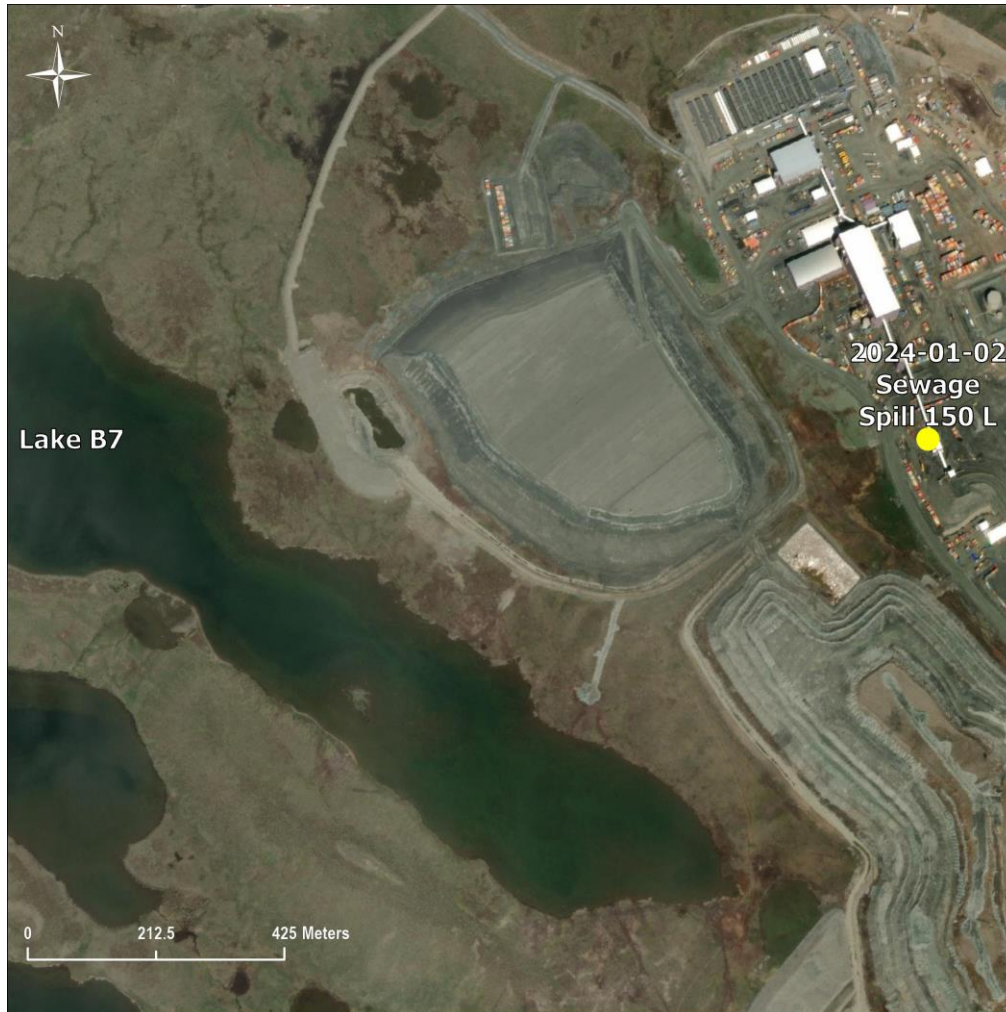
No natural water bodies were impacted, since the closest water body (Lake B7) is approximately 720 m southeast, as seen in Figure 1.

**Figure 1:** Location of the sewage spill and proximity to water bodies.

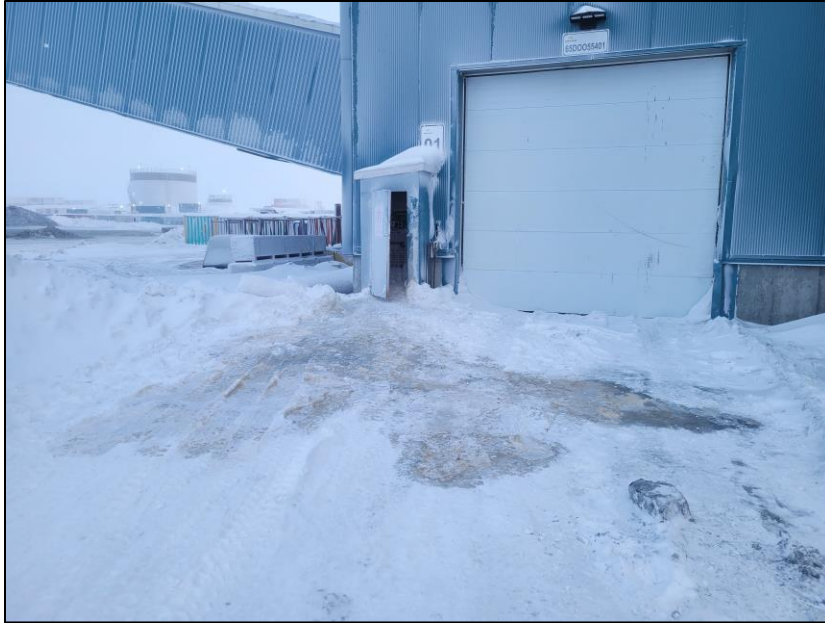
On January 2<sup>nd</sup>, 2024, at approximately 08:30, an estimated 150 L of sewage was spilled onto the ground by the crusher water transfer outlets. A Kivalliq Contractors Group (KCG) employee filled the crusher lavatory's freshwater tank using a water truck. While the KCG employee was refilling the water tank using the water tank inlet, sewage started to come out of the sewage tank outlet and spilled onto the industrial pad.

**Photos 1:** Sewage spill location.

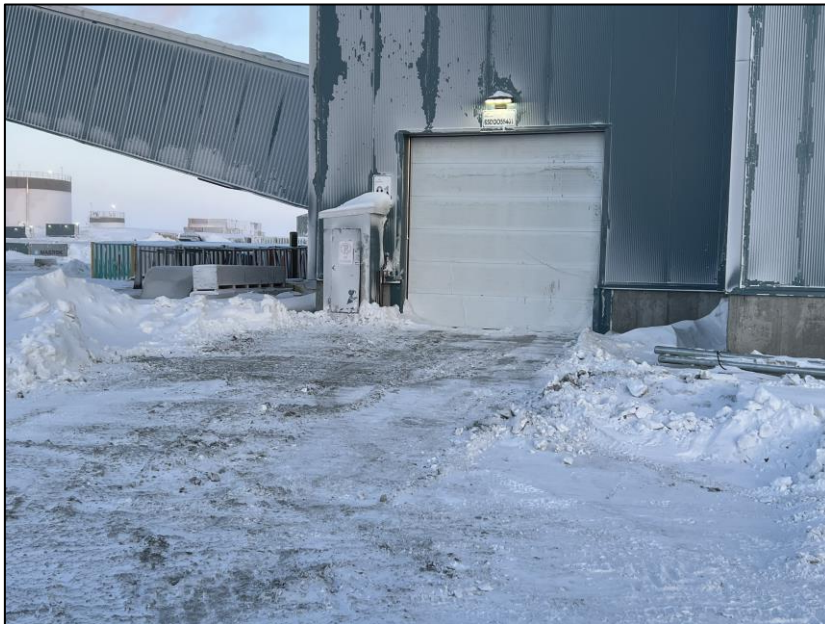
**Photo 2:** Spill location post remediation.

In response, the employee immediately stopped the water truck pump to prevent further spillage. The employee reported the event to their supervisor, who then reported to the spill to the Environment department. The Environment department responded to the spill to advise on spill response and remediation. Subsequently, the Energy & Infrastructure (E&I) personnel excavated the area to recover the sewage impacted material and transported the material to Landfarm A as per the Spill Contingency Plan.
