January 20th, 2024

**Re: Follow-up Report Spill #2023-539 – Release of 100 L of Sewage at the Meliadine Gold Mine**

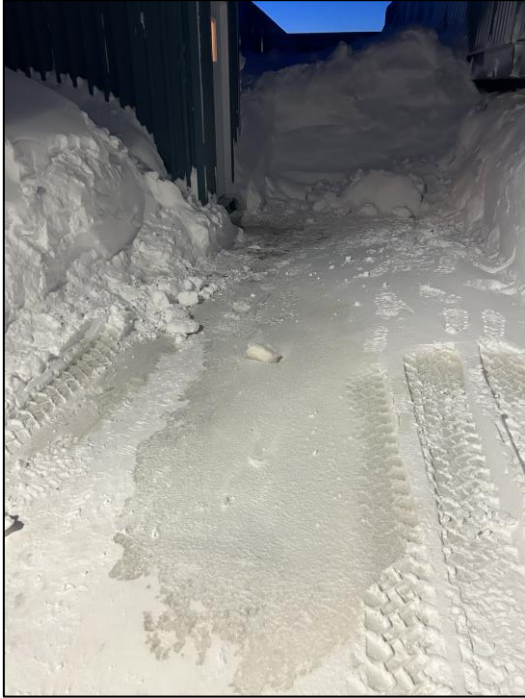
On January 7<sup>th</sup>, 2024, at approximately 06:30, an estimated 100 L of sewage was spilled onto the industrial pad at the Wing 12 lift station. A paper towel was flushed down a toilet in Wing 12, causing the primary sewage transfer pump to fail and the holding tank to overflow, resulting in the spill. Additionally, the secondary sewage transfer pump failed to initiate due to an electrical issue.

An incident assessment was conducted soon after the incident occurred to determine the root cause and contributing factors. The assessment concluded with the following:

- Paper towel was flushed down a toilet in Wing 12, resulting in the sewage transfer pump failure.
- The secondary sewage transfer pump failed to initiate due to an electrical issue with the control box for the pumps and floats.

**Photo 1:** Sewage spill location.

An Energy and Infrastructure maintenance employee arrived at the scene and manually initiated the secondary transfer pump to stop the spill. Subsequently, the paper towel discovered to have disabled the primary transfer pump was removed, and the pump was reinstated.

A vacuum truck was dispatched to pump out the sewage that accumulated in the lift station secondary containment. The spilled material was excavated with a backhoe, and the recovered material was transferred to Landfarm A as per the Spill Contingency Plan.

- Additional signs indicating that certain items cannot be flushed down the toilets were posted in the wings.
- The control box for the Wing 12 secondary sewage transfer pump was replaced.

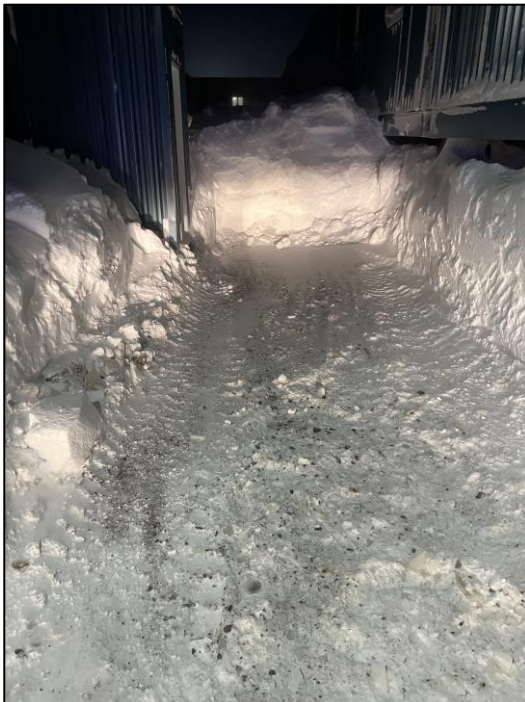
**Photo 2:** Spill location post remediation.
