February 11th, 2024

Re: Follow-up Report Spill #2024-016 – Release of 5 L of Sewage at the Meliadine Gold Mine

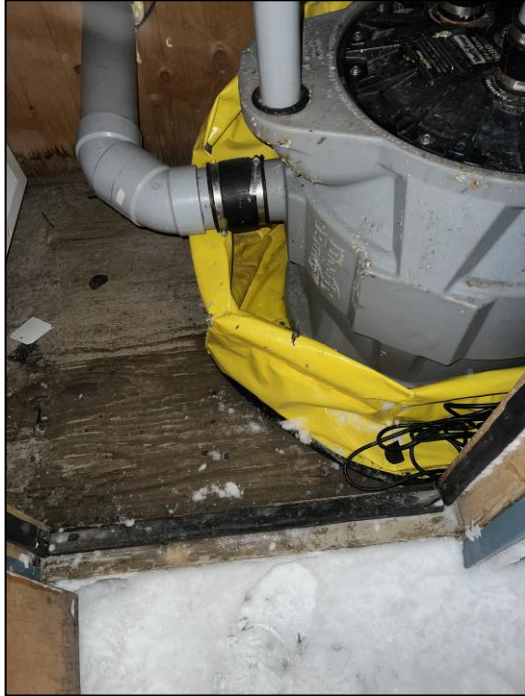
On January 14th, 2024, at approximately 5:00am, an estimated 5 L of sewage was spilled onto the industrial pad at the wing 6 lift station. The lift station float level switches were coated in brown paper towel preventing them from engaging the sewage transfer pump. This caused the lift station to overflow, resulting in the spill.

- The transfer pump float level switches were coated in brown paper towel preventing them from engaging the sewage transfer pump.

Photo 1: Sewage spill location.

When the spill was discovered by an Energy and Infrastructure (E&I) Maintenance employee during their routine inspection, they manually restarted the lift station sewage transfer pump, stopping the spill. The float level switches were cleaned to prevent another spill from occurring. The sewage impacted area was hand excavated and the recovered material was brought to Landfarm A as per the Spill Contingency Plan.

- Infographic posters were installed in the accommodation wing bathrooms, advising employees to not flush prohibited materials such as brown paper towels.
- A site wide announcement was also distributed, outlining what items are flushable and what items are not. This announcement was reviewed in the daily morning meetings by heads of each department and their direct reports.

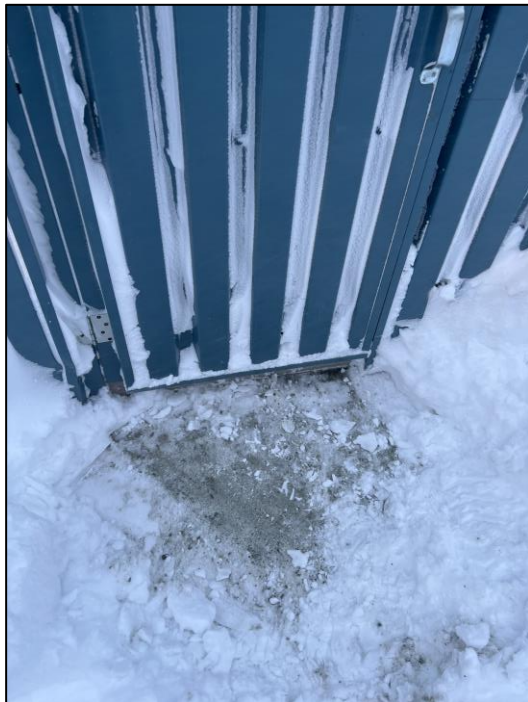
Photo 2: Spill location post remediation.
