**Re: Follow-up Report Spill #2024-112 – Release of 120 L of Greywater at the Meliadine Gold Mine**

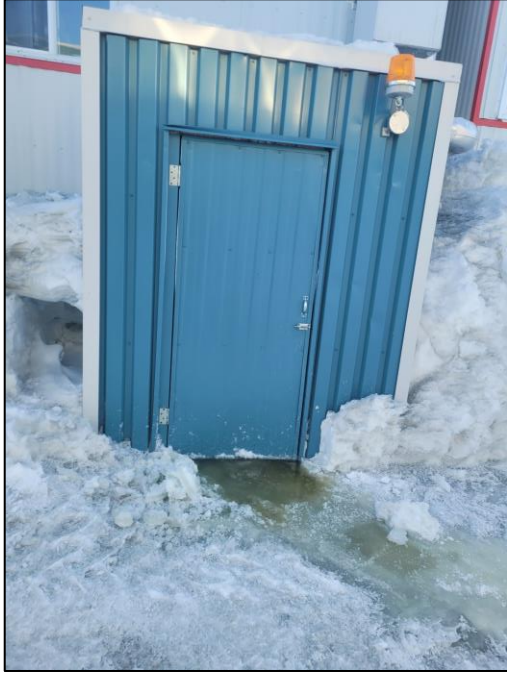
On April 19<sup>th</sup>, 2024, at approximately 6:00am, an estimated 120 L of greywater spilled onto the ground underneath accommodation Wing 9. The spill was caused by a joint failure on drainpipe beneath the floor of the janitorial sink. An employee identified the spill during a routine inspection around the Wing 9 lift station.

- The piping glue on the drainpipe joint dried over time and no primer was applied before gluing the pipe when it was installed.

**Photo 1:** Greywater spill location.

When the spill was discovered by an Energy and Infrastructure (E&I) Maintenance employee during their routine inspection, they isolated the water supply in the wing to prevent further spillage. The employee contacted their supervisor and the Environment Department to report the spill. A site visit was conducted by the Environment and E&I departments to determine the root cause and commence the clean-up process. The snowpack under the wing was removed, the impacted area was excavated, and the recovered material was brought to Landfarm A and the Waste Rock Storage Facility 3 (WRSF3), as per the Spill Contingency Plan. The janitorial sink drainpipe was then cleaned, primed, and glued back to prevent future failures.

- Inspections of these pieces of piping will be added to E&I maintenance quarterly inspection procedure. To provide access to these pieces and facilitate their inspection, E&I maintenance will install ports with doors on the side of the wings before the end of the year.

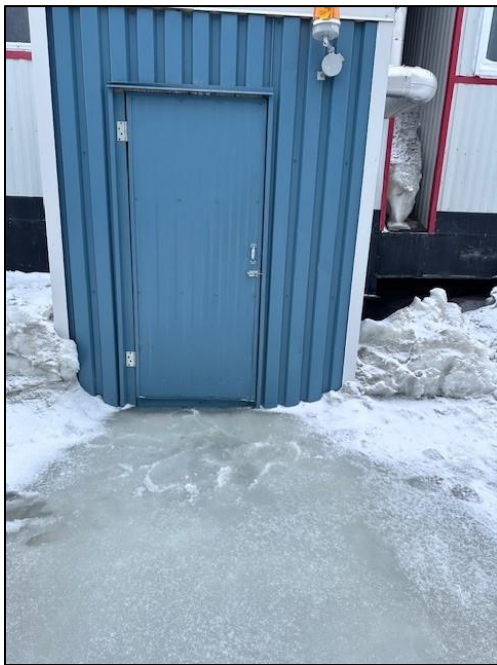
**Photo 2:** Spill location post remediation (ice/water is from snow melt).
