July 30th, 2024

Kyle Amsel
Water Resource Officer
Kivalliq Region, Field Operations Unit
Crown-Indigenous Relations and Northern Affairs Canada
Rankin Inlet, NU
XOC OGO

Re: Follow-up Report Spill #2024-217 – Release of 1.5m³ of Sewage at the Meliadine Gold Mine

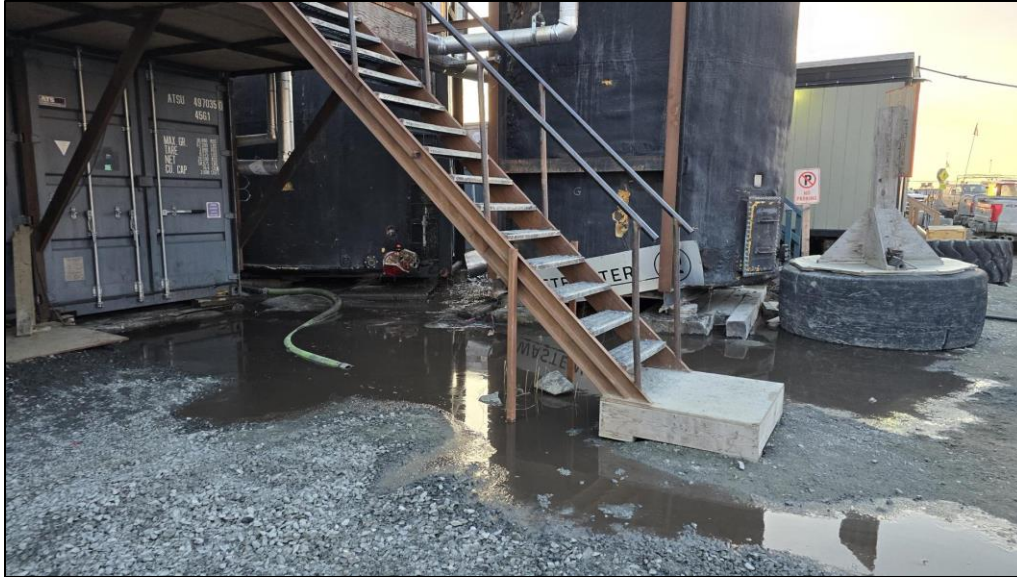
On June 6th, 2024, at approximately 04:30, an estimated 1.5m³ of sewage was spilled onto the industrial pad of the Sewage Treatment Plant (STP). An electrical relay failure in a pump system modified the normal sequencing of three valves, allowing these valves to be actuated in the wrong position. This caused treated effluent to be transported back into the aerobic tanks while they were receiving raw sewage for treatment, exceeding the aerobic tank capacity and resulting in an overflow from aerobic tank #2.

Photos 1: Sewage spill location.

Upon discovery of the spill, the STP operator notified their supervisor and manually closed the valve between the treated effluent tank and aerobic tank #2. The operator then lowered the aerobic tank #2 level with a vacuum truck to prevent further overflow. Instrumentation was called to replace the faulty electrical relay. Once the spill was under control, a vacuum truck was dispatched to collect the free-standing liquid inside and outside the STP. Additionally, the ground surface was excavated, and the recovered material was transported to Landfarm A in accordance with the Spill Contingency Plan.

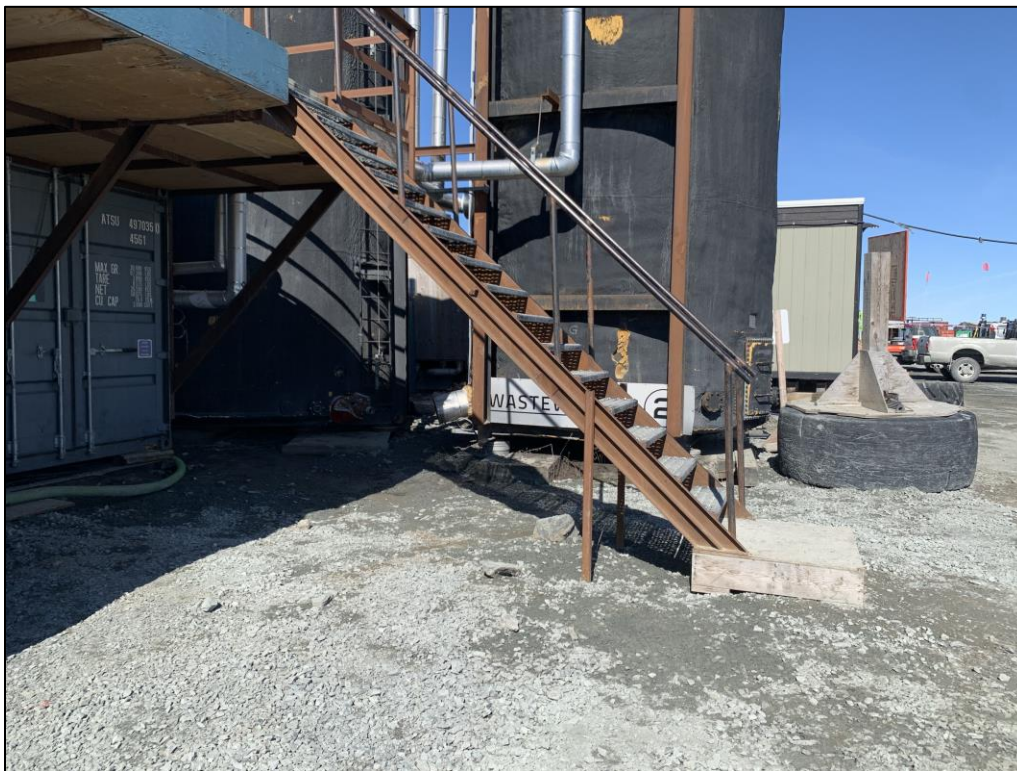
Photos 2: Sewage spill location post remediation.
