July 5<sup>th</sup>, 2024

## **Re: Follow-up Report Spill #2024-218 – Release of 50 L of Sewage at the Meliadine Gold Mine**

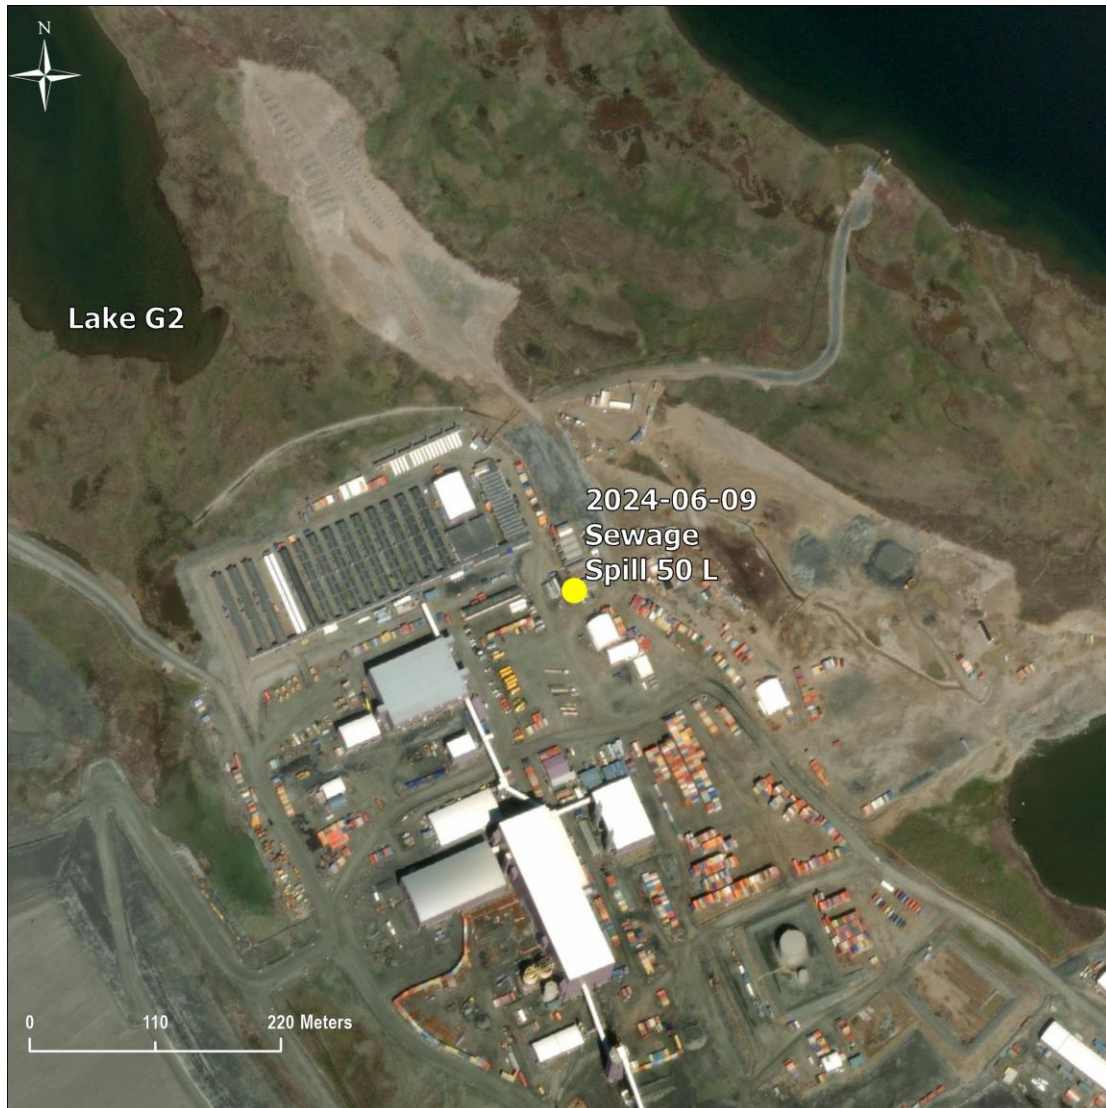
No water bodies were affected by the spill. The nearest water body, Lake G2, is approximately 375 meters northwest, as depicted in Figure 1.

**Figure 1:** Location of the sewage spill and proximity to water bodies.

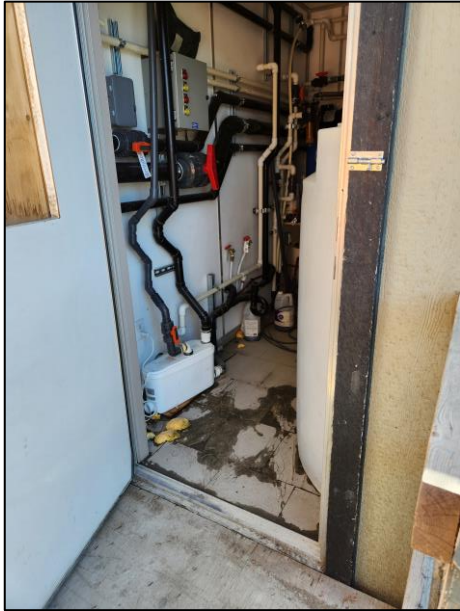
**Photo 1:** Spill location post remediation.

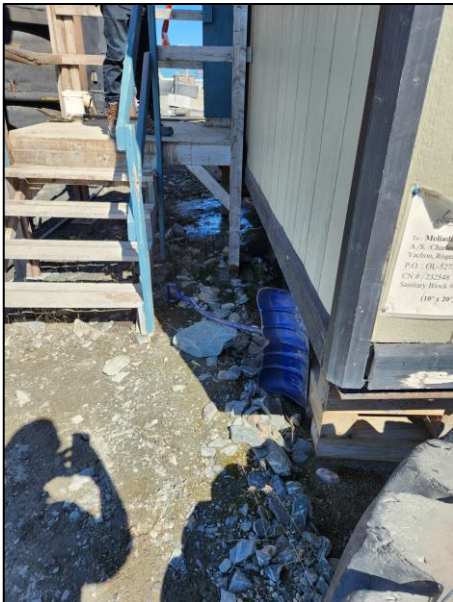
**Photo 2:** Spill location post remediation.
