**Re: Follow-up Report Spill #2024-234 – Release of 200 L of Hydraulic Oil at the Meliadine Gold Project**

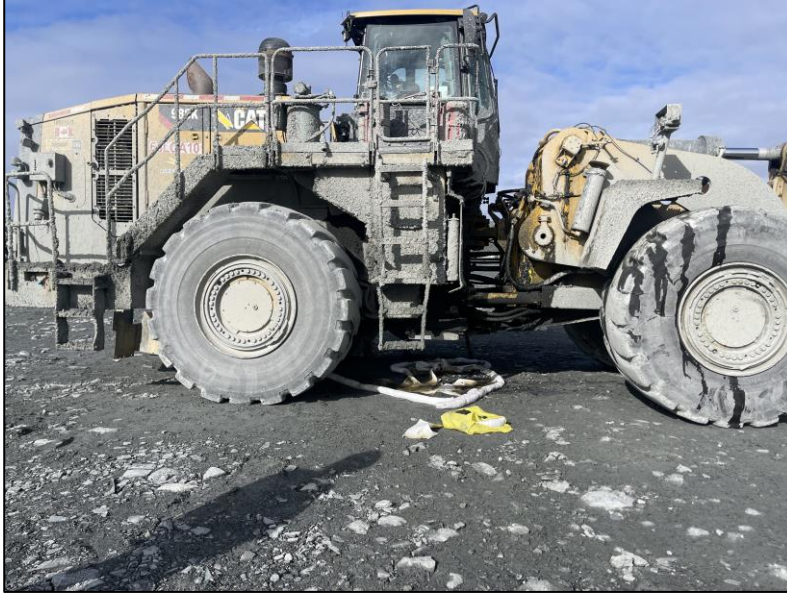
On June 19<sup>th</sup>, 2024, at approximately 8:00PM, a loader operator heard an unusual noise while working at the OP2 extension open pit marginal stockpile. Upon inspection, it was discovered that a hydraulic hose broke and a leak had occurred, resulting in the hydraulic tank being completely emptied on the ore pad.

- The hose fitting was not crimped to the required specification, so it could not withstand the rated pressure and shock resistance of the hose.

**Photo 1:** Hydraulic oil spill location at OP2.

The operator's immediate response was to shut down the loader. The operator then contacted their supervisor to report the incident. Spill absorbent pads were deployed to recover the pooling surface oil and contain the spill. The contaminated material was subsequently excavated and directed to the primary crusher for processing through the Process Plant.

- Both the Maintenance and Open Pit departments reviewed the crimping procedure in their safety meetings and emphasized the importance of inspecting the quality of the fitting.
- Quality control checks have been added in the crimping procedure.
- The specific crimper that was used for this hose was an older model that was not supposed to be used anymore. This crimper has now been locked out to prevent further use.
