July 21<sup>st</sup>, 2024

## **Re: Follow-up Report Spill #2024-236 – Release of 50 L of Sewage at the Meliadine Gold Mine**

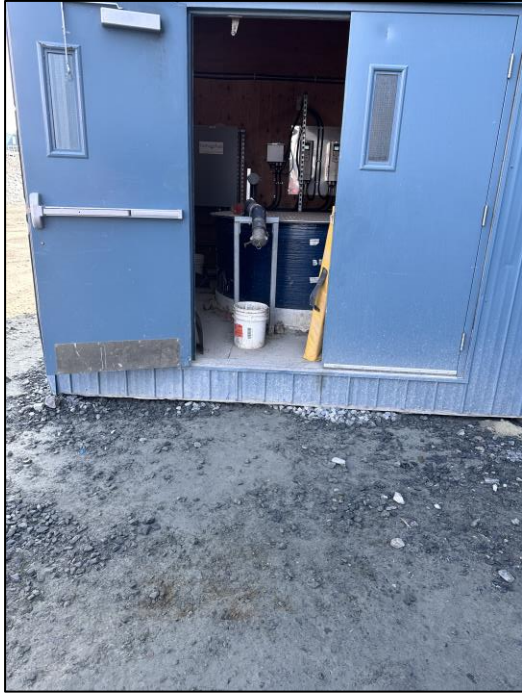
On June 23<sup>rd</sup>, 2024, at approximately 8:30 AM, an estimated 50 liters of sewage spilled onto the industrial pad at the Multi-Service Building (MSB) lift station. A brief power outage at the MSB caused the Variable Frequency Drives (VFDs) to malfunction, thus stopping the sump pumps. When the vacuum truck operators arrived to discharge sewage from the truck into the lift station, the tank overflowed from the inlet pipe, leading to the spill.

- The VFDs did not have the right control parameters, causing them to malfunction following the power outage. The VFDs start automatically when the high-level signal in the lift station switches from off to on. Since the high-level signal was already at the “on” position prior to the power outage, the VFDs did not detect the high-level signal.

**Photo 1:** Spill location prior to remediation

- The VFDs parameters were modified to ensure they would restart right away if the tanks were at a high level. The electrical team simulated a power outage to ensure these parameters would work and the test was successful.

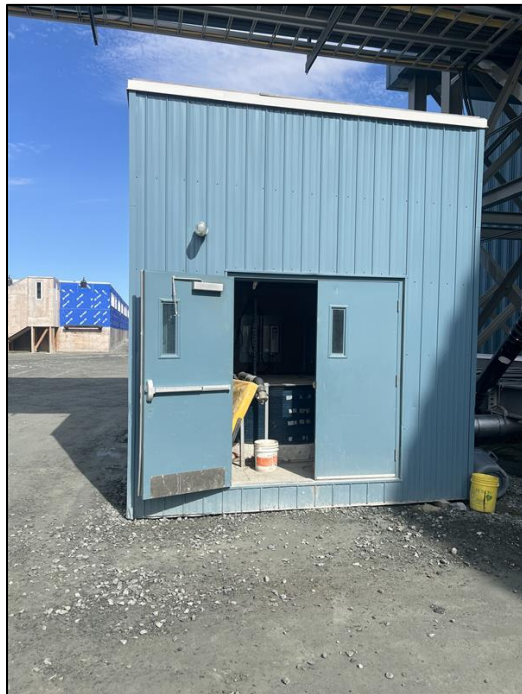
**Photo 2:** Spill location following remediation.

Upon seeing the pipe overflow, the vacuum truck operators took immediate action by promptly vacuuming the tank to contain the spill. Subsequently, the E&I Maintenance supervisor was alerted to the pump malfunction. Electricians were quickly dispatched to restart the system, ensuring the incident would not reoccur. The sewage impacted area was hand excavated and the recovered material was brought to Landfarm A as per the Spill Contingency Plan.
