December 6th, 2024

Re: Follow-up Report Spill #2024-417 – Release of 60 L of Sewage at the Meliadine Gold Project

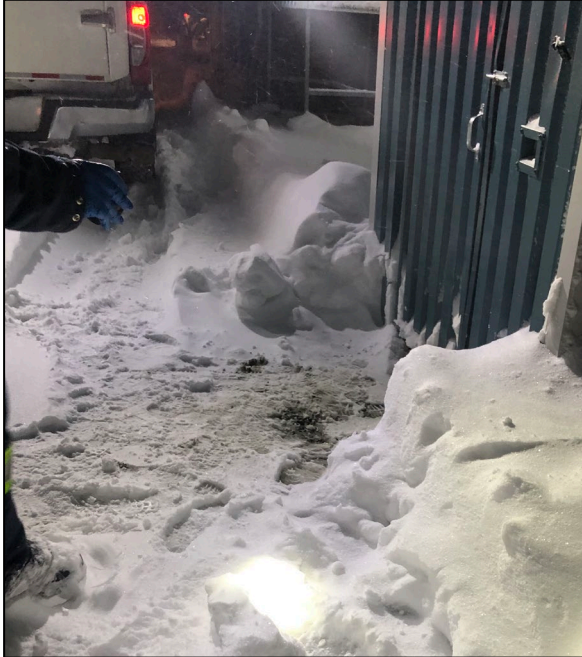
On November 9th, 2024, at approximately 20:00, E&I personnel responded to a high-level alarm at the Wing 4 lift station. Upon arrival, an estimated 60 L of sewage was observed to have spilled onto the industrial pad outside of the lift station.

- The Wing 4 lift station floats became entangled with loose electrical wiring inside the lift station resulting in the pumps not activating automatically. The plastic zip tie securing the wires broke due to wear and tear, leading to the entanglement and failure of the floats. Only a single, light-duty zip tie had been used to secure the wiring.
- The scheduled quarterly float preventative maintenance did not include inspection of some internal system components, such as the presence of loose wiring.

Photo 1: Sewage spill location.

The Energy and Infrastructure (E&I) Maintenance supervisor received an alert from the high-level alarm at the Wing 4 lift station and dispatched a plumber to investigate. Upon arrival, the plumber discovered the spill and manually initiated the lift station pumps to stop the spill. A vacuum truck was sent to empty the material inside the secondary containment. The contaminated material on the industrial pad was then excavated and transported to the Landfarm A, in accordance with the Spill Contingency Plan.

- The lift station wires were secured using heavy-duty zip ties. Multiple zip ties were installed as redundancy. The other lift stations' wiring will be inspected, and heavy-duty zip ties will be installed where necessary.
- The inspection of additional internal parts of the lift station was added to the procedure for the quarterly float preventative maintenance.

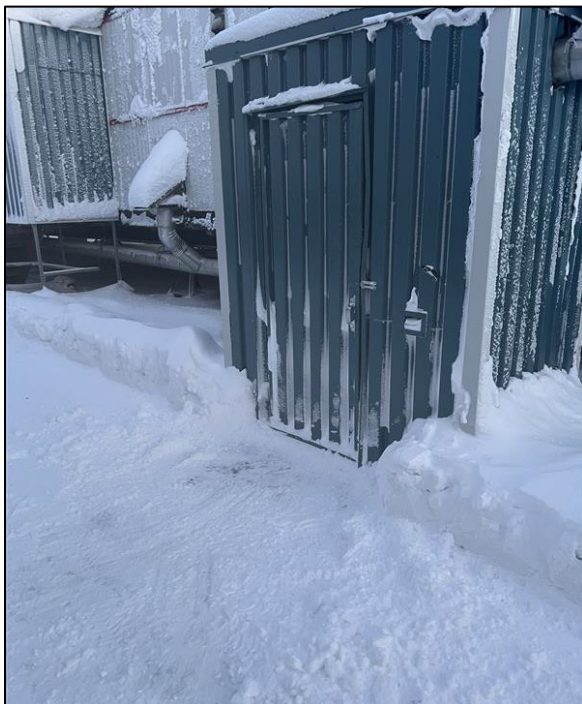
Photo 2: Spill location post remediation.
