January 11th, 2025

Re: Follow-up Report Spill #2024-474 – Release of 90 L of Sewage at the Meliadine Gold Project

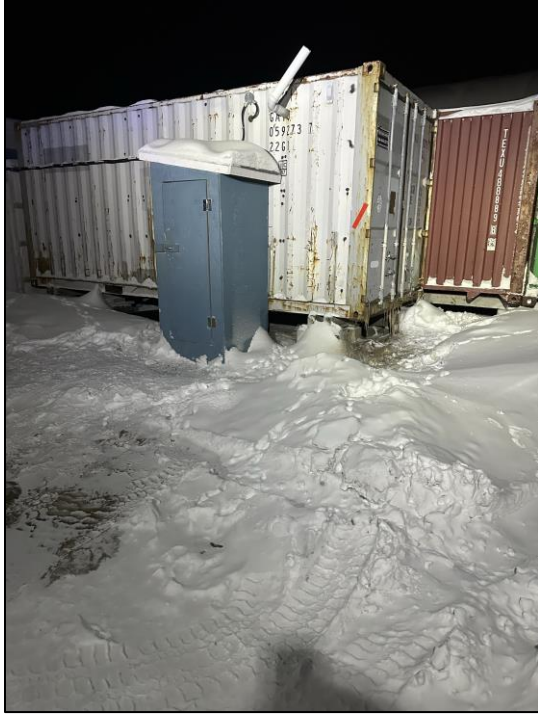
On December 20th, 2024, at approximately 06:00, Energy and Infrastructure (E&I) personnel were performing a routine inspection of lift stations around site. Upon arriving at the Orbit dome lift station (referred to as wash cart in the initial report), the employee noticed that sewage was leaking outside of the holding tank storage area. An estimated 90 L of sewage was frozen on the ground.

Photo 1: Sewage spill location.

Upon discovering the spill, the worker contacted their supervisor to notify them of the spill and upon inspection, discovered the holding tank was caved in and broken. Most of the spill occurred inside the holding tank storage area, while 90 L escaped to the ground outside. An excavator was sent to clean up the area and the damaged holding tank was replaced. The contaminated material spilled on the industrial pad was excavated and transported to Landfarm A, in accordance with the Spill Contingency Plan.

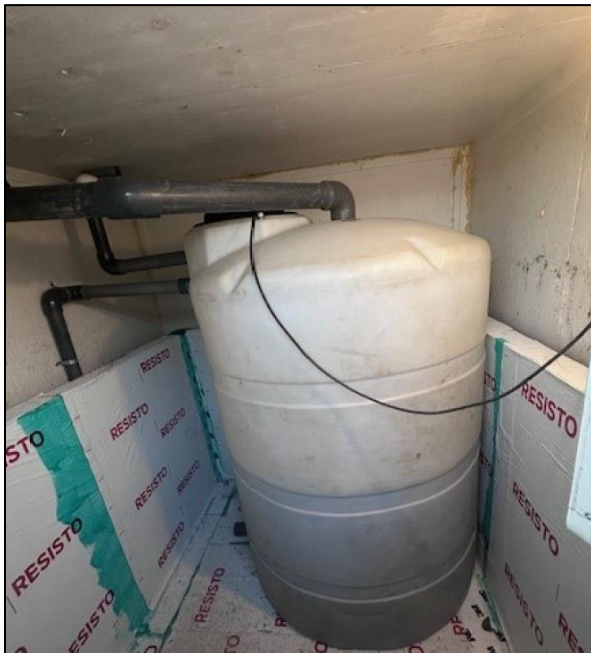
Photo 4: New sewage tank installed.

- Heat trace was installed on the vent to prevent ice accumulation.
