January 18th, 2025

Re: Follow-up Report Spill #2025-007 – Release of 1,000 L of waste oil at the Meliadine Gold Project

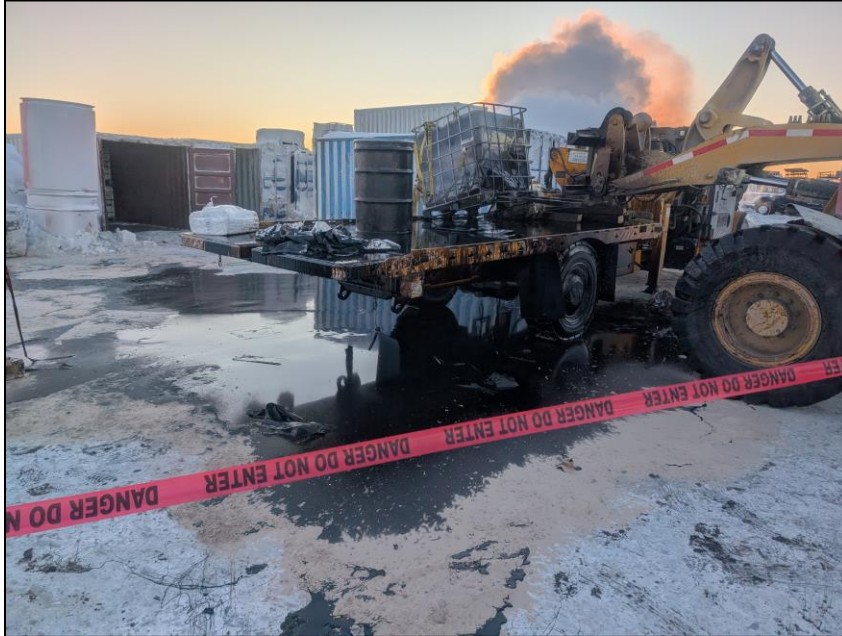
On January 3rd, 2025, at 09:15, a skid steer operator was moving a tote of used oil from a boom truck deck at Dome 3, Portal 1. During the process, the forks punctured the bottom of the tote, causing 1,000 L of used oil to spill onto the ground.

- No spotter was used while attempting to move the used oil tote.

Photo 1: Used oil spill location at Dome 3, Portal 1.

The worker promptly attempted to contain the spill using spill pads and contacted their Supervisor and the Environment Department. Both departments assisted in the cleanup efforts. The cleanup crew primarily used absorbent pads and booms to contain the spread of the oil to reduce the contaminated area. Some contaminated material was shoveled into drums, while the rest was collected by a loader and placed in the contaminated snow cell for treatment through the oil-water separator upon snowmelt, as per the Water Management Plan.

- A toolbox session on the importance of using a spotter when moving totes and drums was conducted during the Mine Construction Daily Meeting.
- Employee to retake telehandler training (includes the importance of using a spotter).
- A toolbox session with the Environment team on the importance of using a spotter is to be held during the Sunday Mine interdepartmental Health and Safety Meeting to be conducted on January 22nd.
