January 24<sup>th</sup>, 2025

**Re: Follow-up Report Spill #2025-020 – Release of 10 L of Hydraulic Oil at the Meliadine Gold Project**

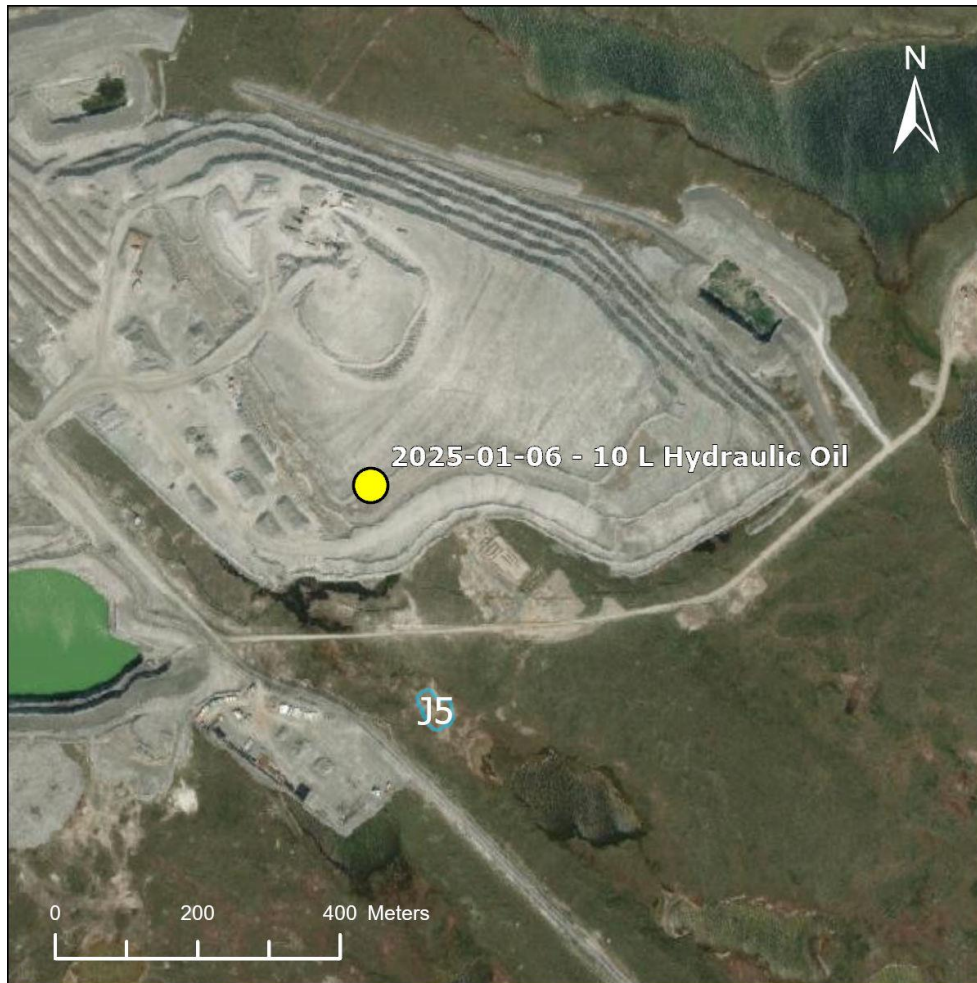
The spill occurred within the site's water management infrastructure, and as such, no waterbodies were impacted by the spill. The closest water body (J5) is approximately 300 meters south, as seen in Figure 1.

**Figure 1:** Location of the spill and proximity to waterbodies.

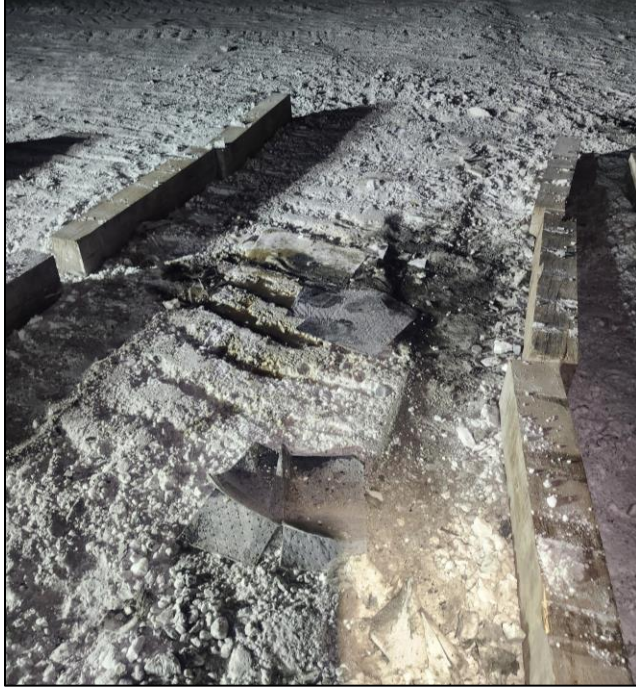
On January 6<sup>th</sup>, 2025, at approximately 14:30, a hydraulic hose leak was discovered on an idling bulldozer which was located on the Waste Rock Storage Facility 3 (WRSF3). As a result, 10 L of hydraulic oil was released onto the WRSF3.

- A loose fitting on a hydraulic hose resulted in the slow leak.
- Extreme cold temperature (-40°C) was a contributing factor.

**Photo 1:** Spill location before remediation.

A Kivalliq Contractor Group (KCG) employee noticed the spill when they approached the bulldozer. They immediately shut down the equipment and deployed a spill kit to avoid further spillage. The employee contacted their supervisor and the Environment department. The contaminated snow was then excavated and transported to Landfarm A, in accordance with the Spill Contingency Plan.

- This bulldozer has received a full hose overhaul by the KCG Maintenance department.

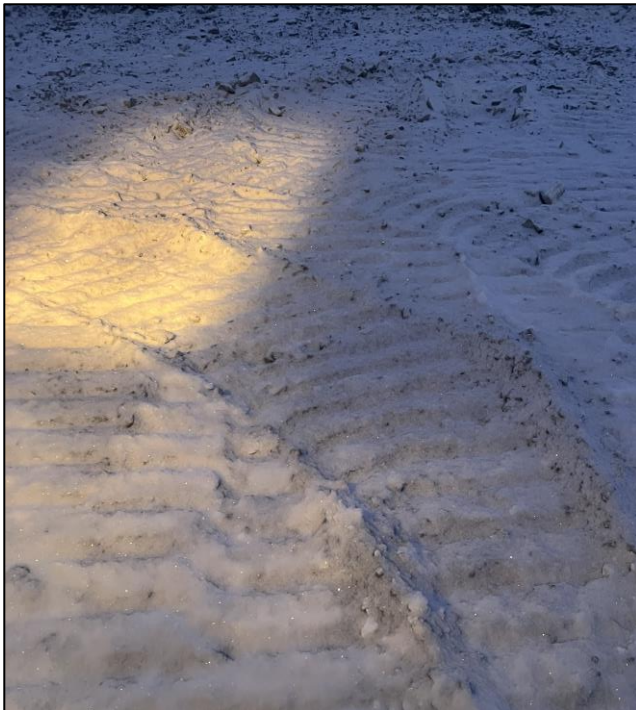
**Photo 2:** Spill location post remediation.
