February 1<sup>st</sup>, 2025

## **Re: Follow-up Report Spill #2025-034 – Release of 200 L of Glycol at the Meliadine Gold Project**

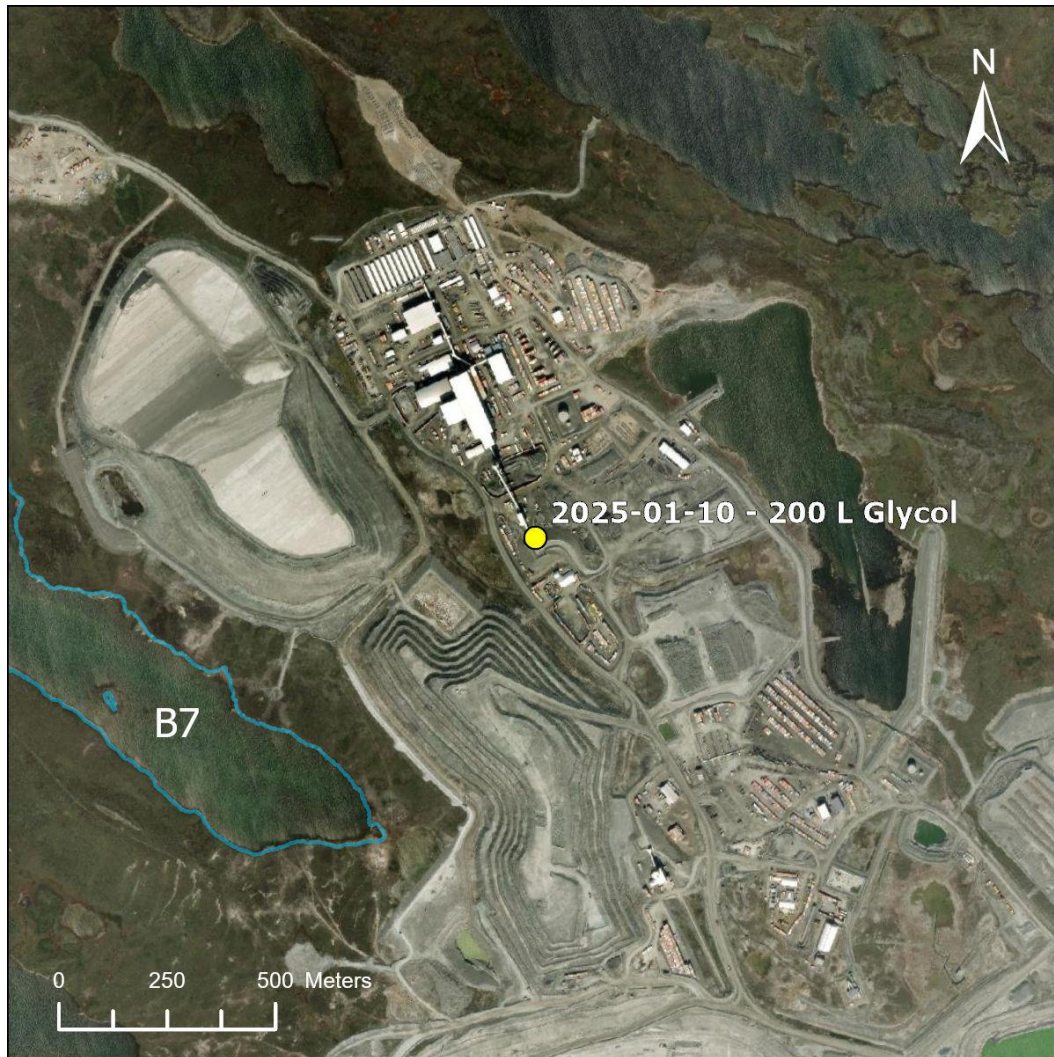
The spill occurred within the site's water management infrastructure, and as such, no waterbodies were impacted by the spill. The closest water body (B7) is approximately 700 meters southwest, as seen in Figure 1.

**Figure 1:** Location of the spill and proximity to waterbodies.

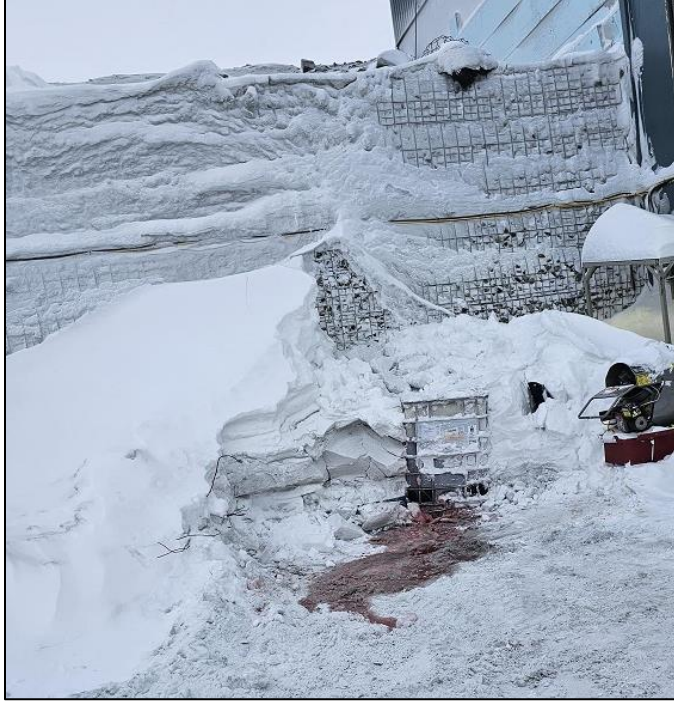
On January 10<sup>th</sup>, 2025, at approximately 11:00AM, a tote containing glycol was punctured by a skid steer at the primary crusher. The glycol tote was completely buried under snow from a recent blizzard, and the operator of the skid steer inadvertently hit and punctured the tote while performing snow removal. As a result, 200 L of glycol was released from the tote onto the industrial pad.

- The tote was improperly stored outside in an unmarked location that lacked secondary containment.

**Photo 1:** Spill location before remediation.

The Process Plant employee who was operating the skid steer immediately called their supervisor who then contacted the Environment department to report the spill. The leaking tote was placed on a secondary containment to avoid further spillage. The contaminated snow was then recovered and placed into a hazardous waste drum and stored at the hazmat laydown, to be sent offsite for disposal at a licensed disposal facility.

- A secondary containment will be installed at the primary crusher for storage of glycol and other hazardous materials.

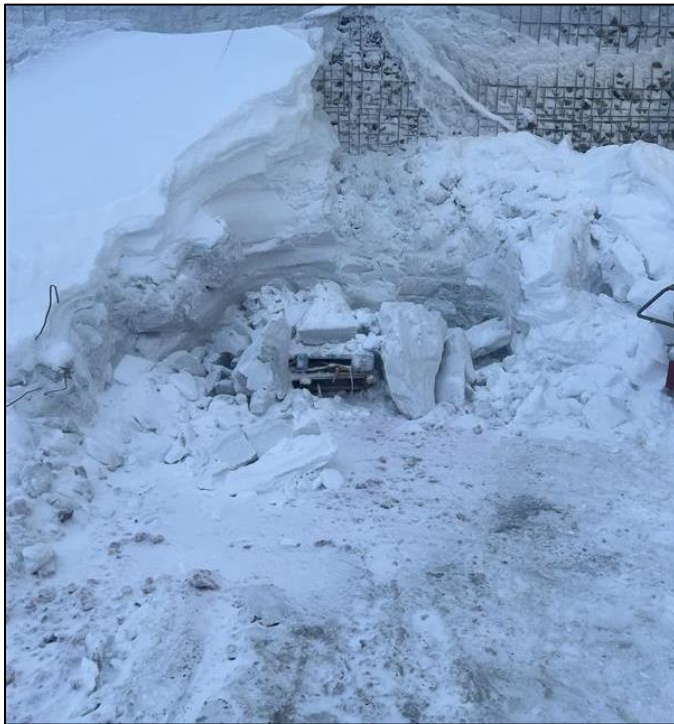
**Photo 2:** Spill location post remediation.
