Re: Follow-up Report Spill #2025-103 — Release of 1135 kg of emulsion at the Meliadine Gold Project

Description of Incident

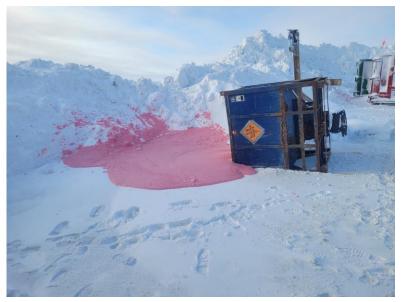
On February 18th, 2025, at approximately 11:00AM, 1135 kg of emulsion was spilled onto the ground at the Dyno Plant laydown. A loader operator from the Underground Construction department was providing Dyno Nobel with assistance in weighing emulsion bins while their loader was down for maintenance.

Photo 1: Emulsion spill location, at the Dyno Nobel Laydown pad.

The Dyno Nobel supervisor called the Environment coordinator to report the spill. Due to the thickness of the emulsion, cold air temperatures, and spill occurring on snow, the spill quickly gelled and was contained on the Dyno Plant pad. Dyno Nobel personnel then commenced remediation by recovering the spilled emulsion with a loader and putting the emulsion in a tote to be recirculated in the emulsion plant.

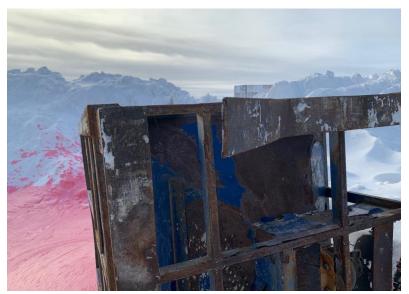
While loading the first bin on the rack, the operator initially thought it was placed too deep. To adjust its position, he attempted to re-lift the bin, causing the bin to move even deeper on the rack and making it impossible to insert the forks into the bin cradle. As he lifted the bin from the ends of the fork to gain more purchase, it began to pivot, causing the base plate to press against the bottom of the forks, which resulted in the base plate breaking and the bin tipping over.

- The Dyno Nobel loader that is usually used for this task was having its engine replaced. As such, the loader being used was not the usual equipment for the task.
- The Dyno Nobel team called the Underground Construction department's loader operator to weigh the full bins and place them on the rack. The new operator was unfamiliar with this task, which led to repeated adjustments that ultimately caused the bin to tip over.
- As the emulsion bin was tipping, the base plate of the bin broke which allowed it to tip fully over.

Photo 2: Broken base plate on the bin.

- Moving forward, in the case that the Dyno Nobel loader is unavailable to complete this task, Dyno Nobel will fill the emulsion bins with less emulsion so that their experienced operators can use their skid steer instead.
- In the case where another loader must be used, the loader will be operated by a Dyno Nobel operator.

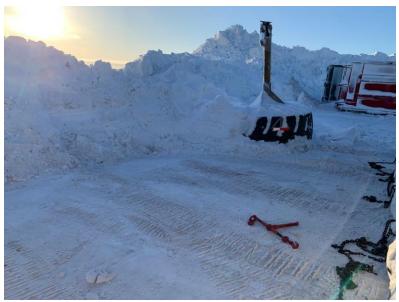
Photo 3: Emulsion spill location, post remediation.
