April 9th, 2025

Re: Follow-up Report Spill #2025-143– Release of 50 L of Sewage at the Meliadine Gold Mine

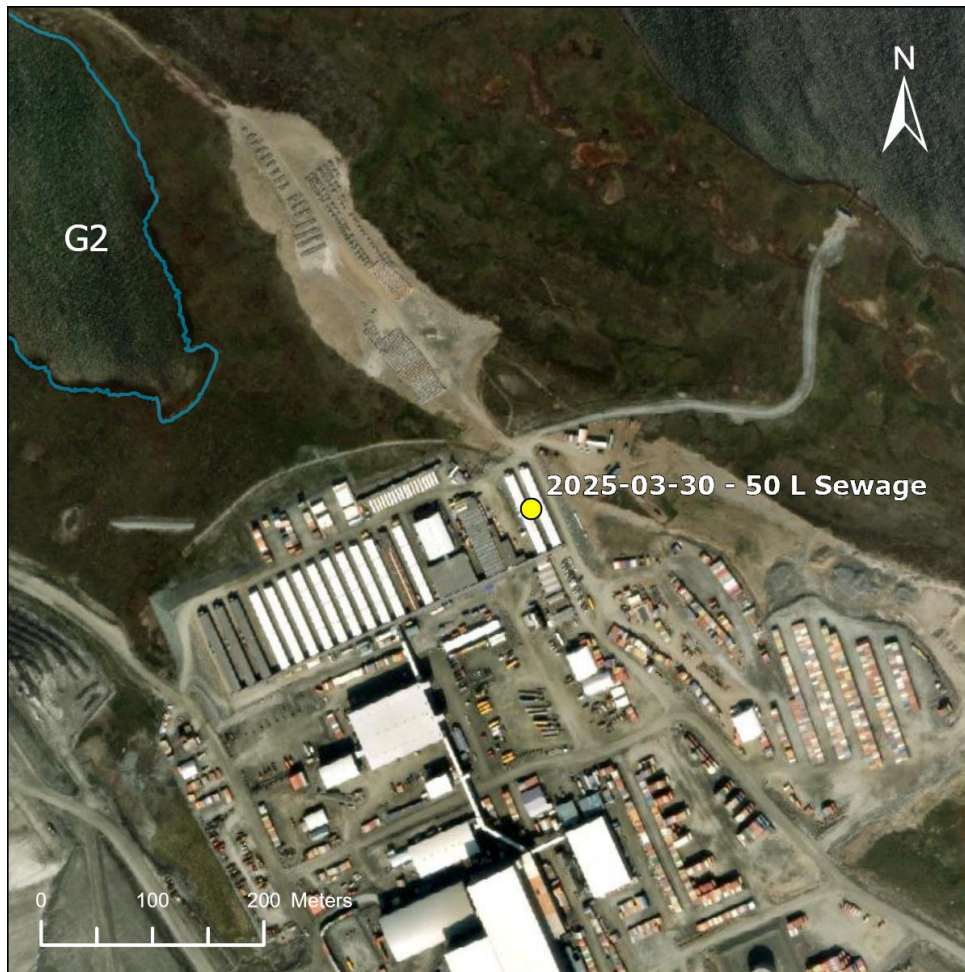
The spill occurred within the site's water management infrastructure, and as such, no waterbodies were impacted. The closest water body (Lake G2) is approximately 260 meters northwest, shown in Figure 1.

Figure 1: Location of the spill and proximity to waterbodies.

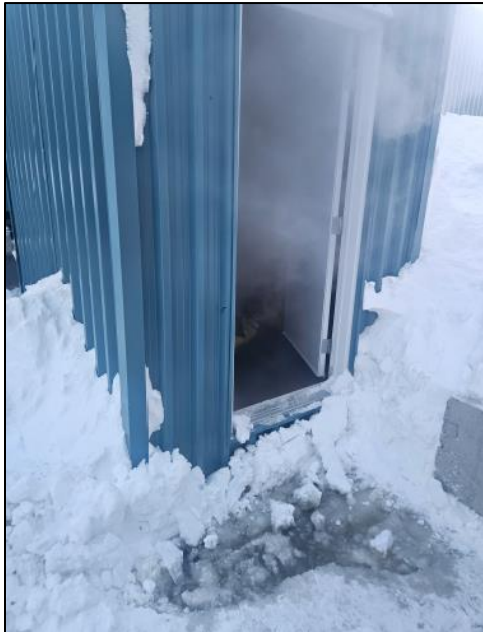
On March 30th, 2025, at approximately 06:30, approximately 50 L of sewage spilled onto the industrial pad outside the Wing 16 lift station. Upon inspection, it was discovered the lift station pump impeller was obstructed by non-compliant material, which led to the pump's failure and the lift station to overflow.

- Non-compliant material had been flushed in a toilet at Wing 16, resulting in the pump impeller being obstructed, which led to the pump's failure and the lift station overflow.

Photo 1: Spill location

- A site wide communication was distributed to remind staff of permissible and prohibited items that can be flushed. The topic was also included in all departments' safety meetings.
- Instructional signs were printed and posted on every room in the affected wing, informing occupants of permissible and prohibited items that can be flushed.
- Supervisors met with the occupants of Wing 16 to emphasize the importance of properly disposing of items that could affect the lift stations.

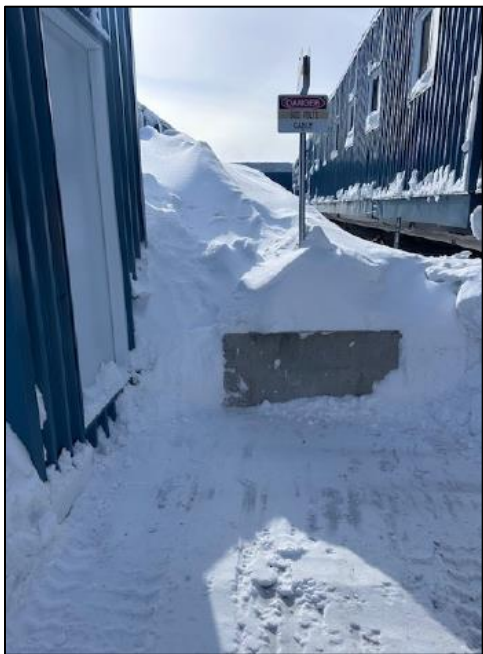
Photo 2: Spill remediation

Upon discovering the spill, a vacuum truck and a plumber were displaced to respond to the spill. The vacuum truck was utilized to empty the contents within the secondary containment. The contaminated material was excavated and transported to Landfarm A in accordance with the Spill Contingency Plan.
