## **Re: Follow-up Report Spill #2025-154 – Release of 30 L of Sewage at the Meliadine Gold Project**

### **Description of Incident**

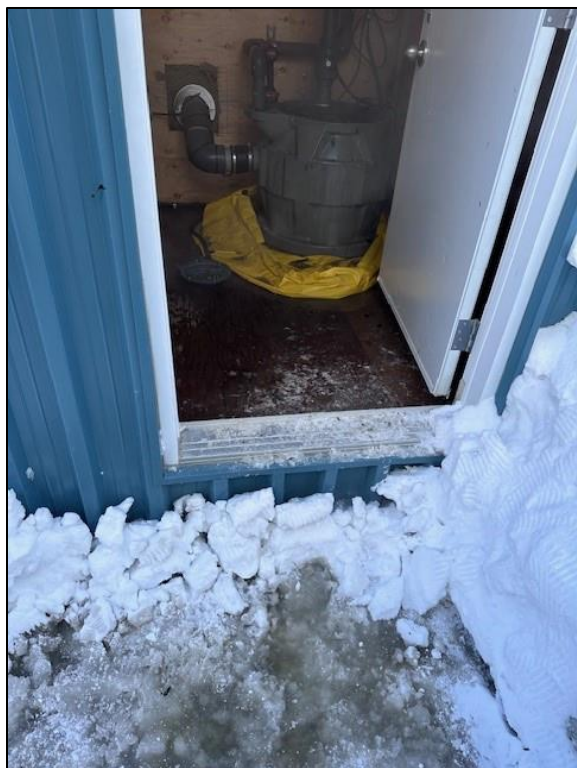
On April 2<sup>nd</sup>, 2025, at approximately 15:30, approximately 30 L of sewage spilled onto the industrial pad outside the Wing 16 lift station. Upon inspection, it was discovered the lift station pump impeller was obstructed by non-compliant material, which led to the pump's failure and the lift station to overflow.

**Photo 1:** Spill location

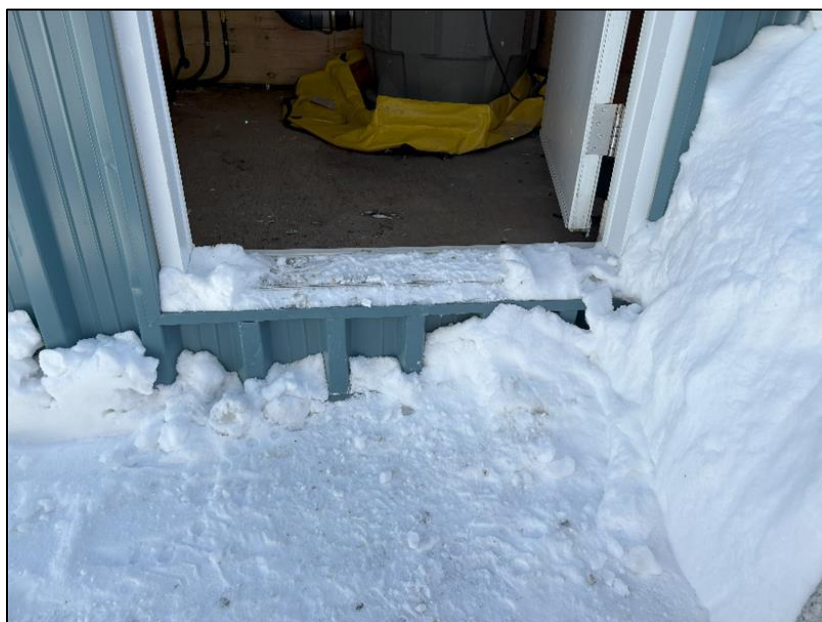
**Photo 2:** Spill remediation

Upon discovering the spill, a vacuum truck and a plumber were dispatched to respond to the spill. The vacuum truck was utilized to empty the contents within the secondary containment. The contaminated material was excavated and transported to Landfarm A in accordance with the Spill Contingency Plan.
