Re: Follow-up Report Spill #2025-144 – Release of 150 m³ of Sewage at the Meliadine Gold Project

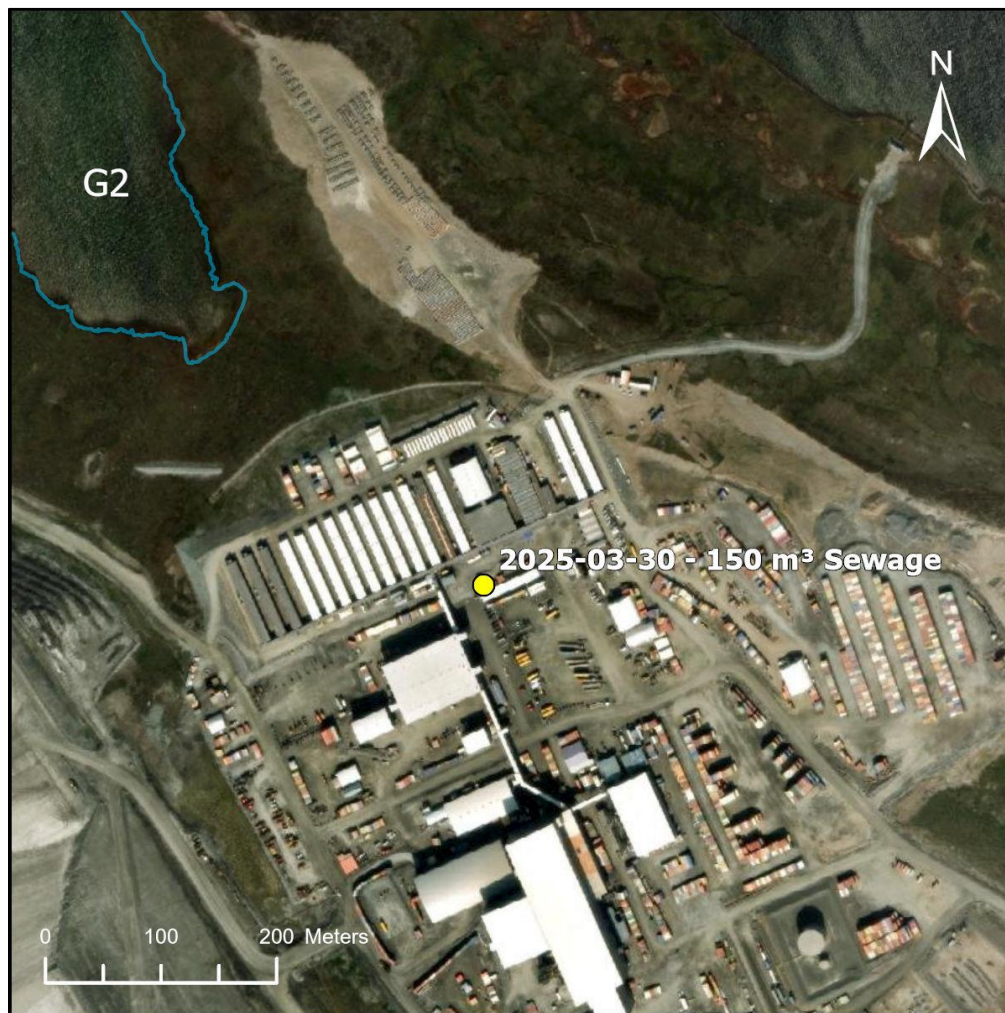
The spill occurred within the site's water management infrastructure, and as such, no waterbodies were impacted by the spill. The closest water body (Lake G2) is approximately 310 meters northwest, as seen in Figure 1.

Figure 1: Location of the spill and proximity to waterbodies.

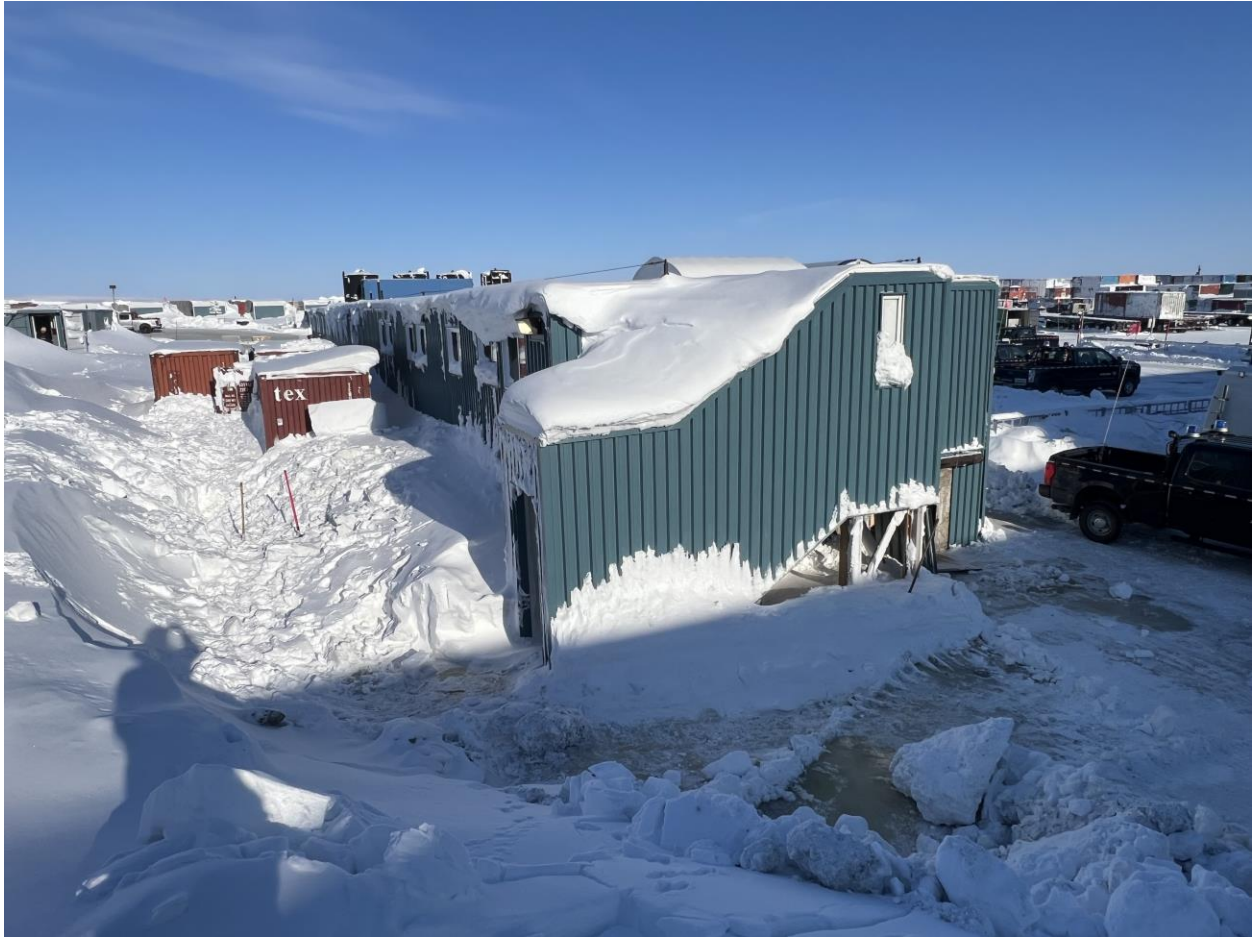
The sewage line connecting the P-Wing lift station to the Main Camp lift station was found to be leaking. Consequently, the sewage began accumulating beneath the P-Wing, forming a thick layer as it froze. An assessment concluded that approximately 150 cubic meters of sewage was released under the P-Wing.

- The heat trace for the sewage line failed, and the light indicating a failure was located under the building, making it invisible for employees conducting inspections due to the snowpack.
- Due to the failed heat trace, the sewage line ruptured.

Photo 1: Sewage spill location

- The sewage line has been rerouted to a temporary holding tank.
- An investigation into how the sewage line that is running under the roadway was protected prior to coverage of material has been scheduled for after snowmelt.
- The heat trace will be repaired following snowmelt once the area is accessible.
- Repair and replace the section of pipe that is broken following snowmelt once the area is accessible.
- Ensure indicator light which signals the operational status of the heat trace is visible for inspection.

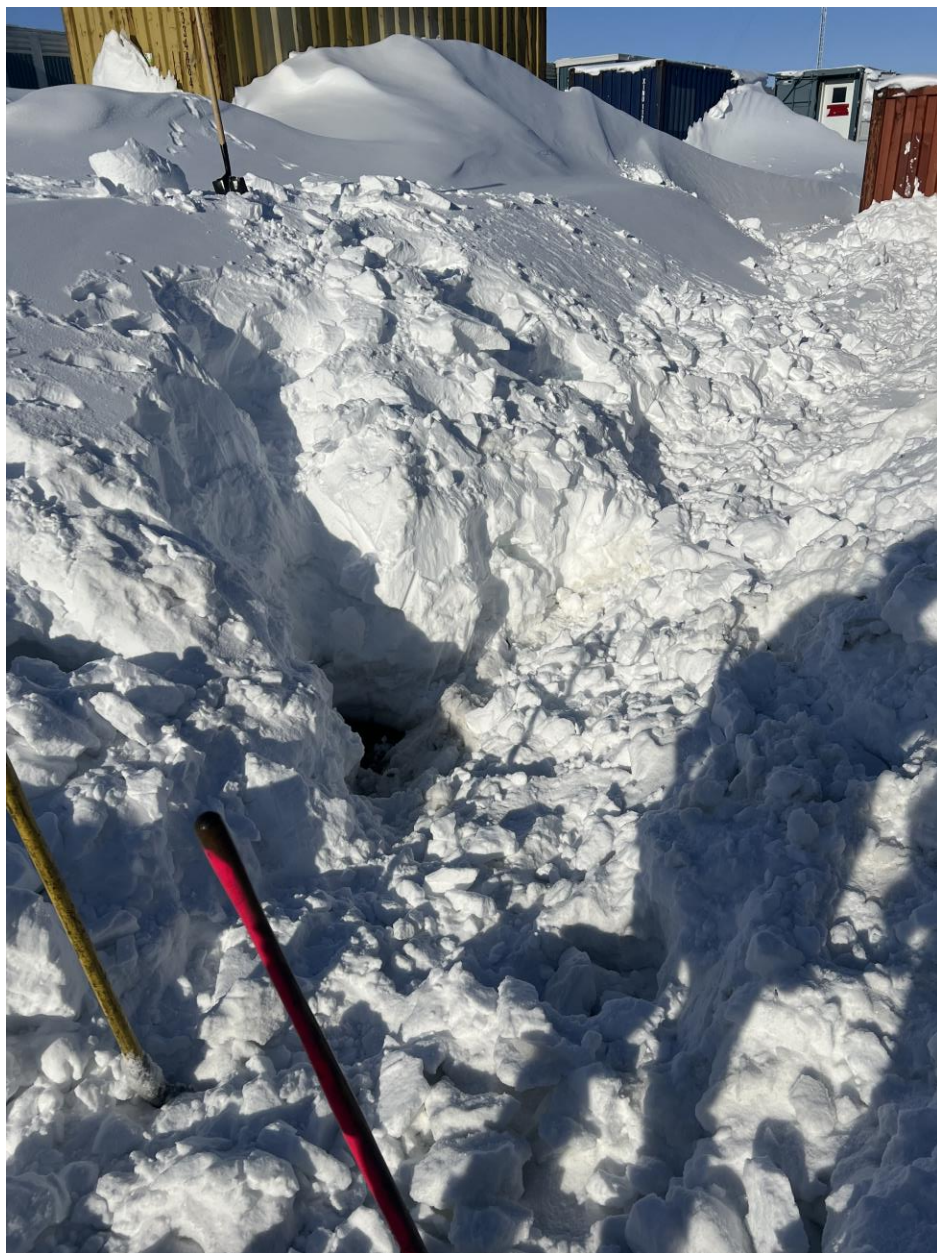
Photo 2: Sewage spill location

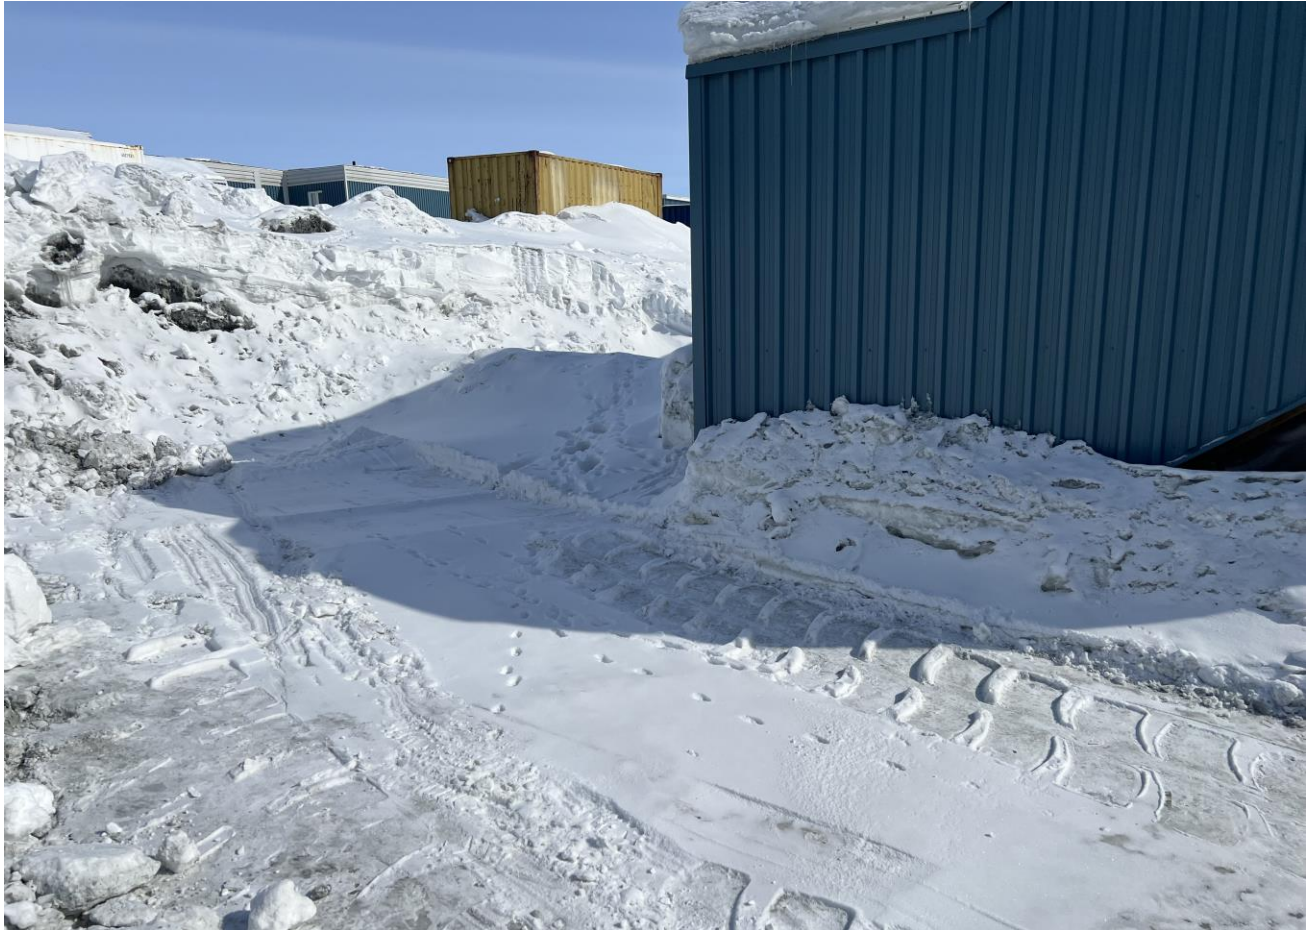
Photo 3: Sewage spill location post excavation of accessible contaminated material

Upon discovering the spill, personnel from the Energy and Infrastructure (E&I) department promptly stopped the flow of sewage from the P-Wing to the Main Camp lift station. A plumber subsequently rerouted the P-Wing sewage line to a temporary holding tank. Due to the spill's location, remediation activities are constrained by the confined space and limited access around and under the building. The Surface Operations team excavated accessible contaminated material around P-Wing and transported it to Landfarm A in accordance with the Spill Contingency Plan. The impacted area will continue to be monitored, and if necessary, a diversion
