April 30<sup>th</sup>, 2025

## **Re: Follow-up Report Spill #2025-169 – Release of 38 L of Sewage at the Meliadine Gold Project**

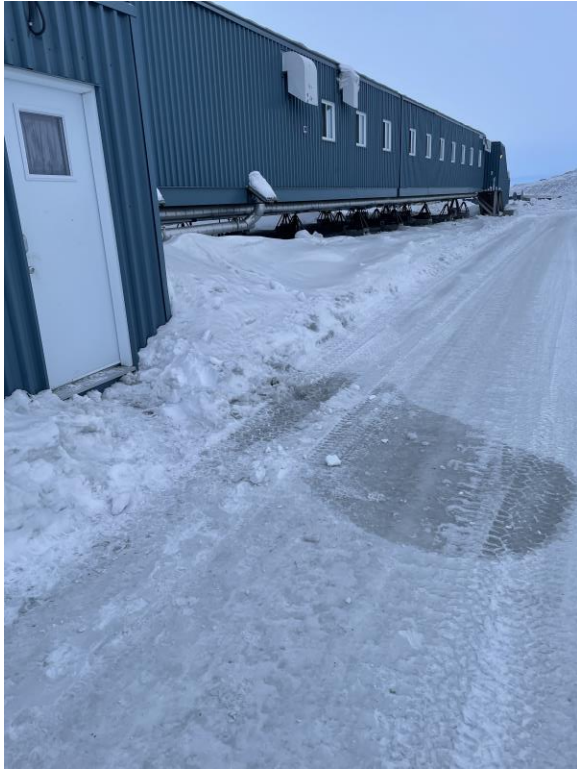
On April 10<sup>th</sup>, 2025, at 06:30, approximately 38 L of sewage spilled onto the industrial pad outside the Wing 14 lift station. Upon inspection, it was discovered the lift station pump impeller was obstructed by non-compliant material, which led to the pump's failure and the lift station to overflow.

**Photo 1:** Spill location

Upon discovering the spill, a vacuum truck and a plumber were dispatched to respond to the spill. The vacuum truck was utilized to empty the contents within the secondary containment. The contaminated material was excavated and transported to Landfarm A in accordance with the Spill Contingency Plan.

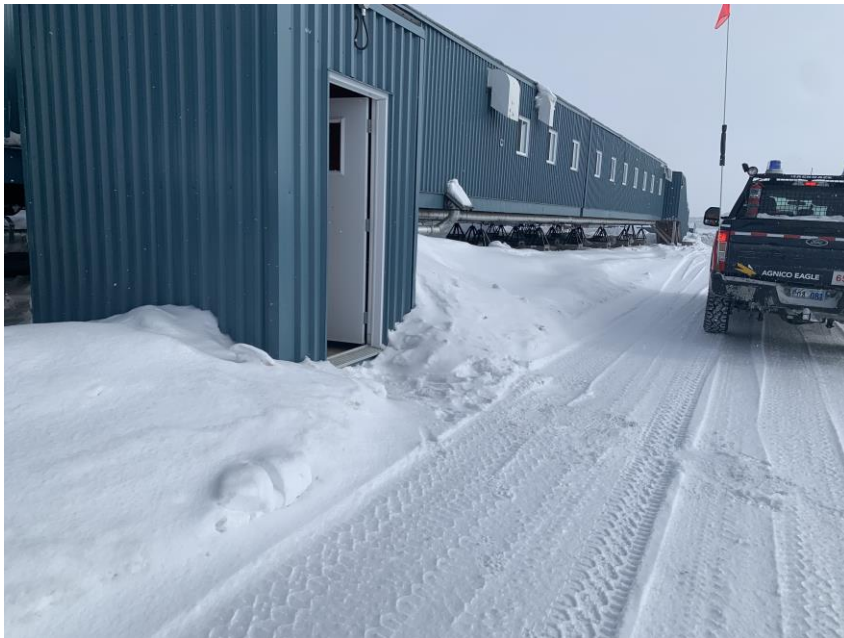
**Photo 2:** Spill location post remediation
