April 30th, 2025

Re: Follow-up Report Spill #2025-170 – Release of 38 L of Sewage at the Meliadine Gold Project

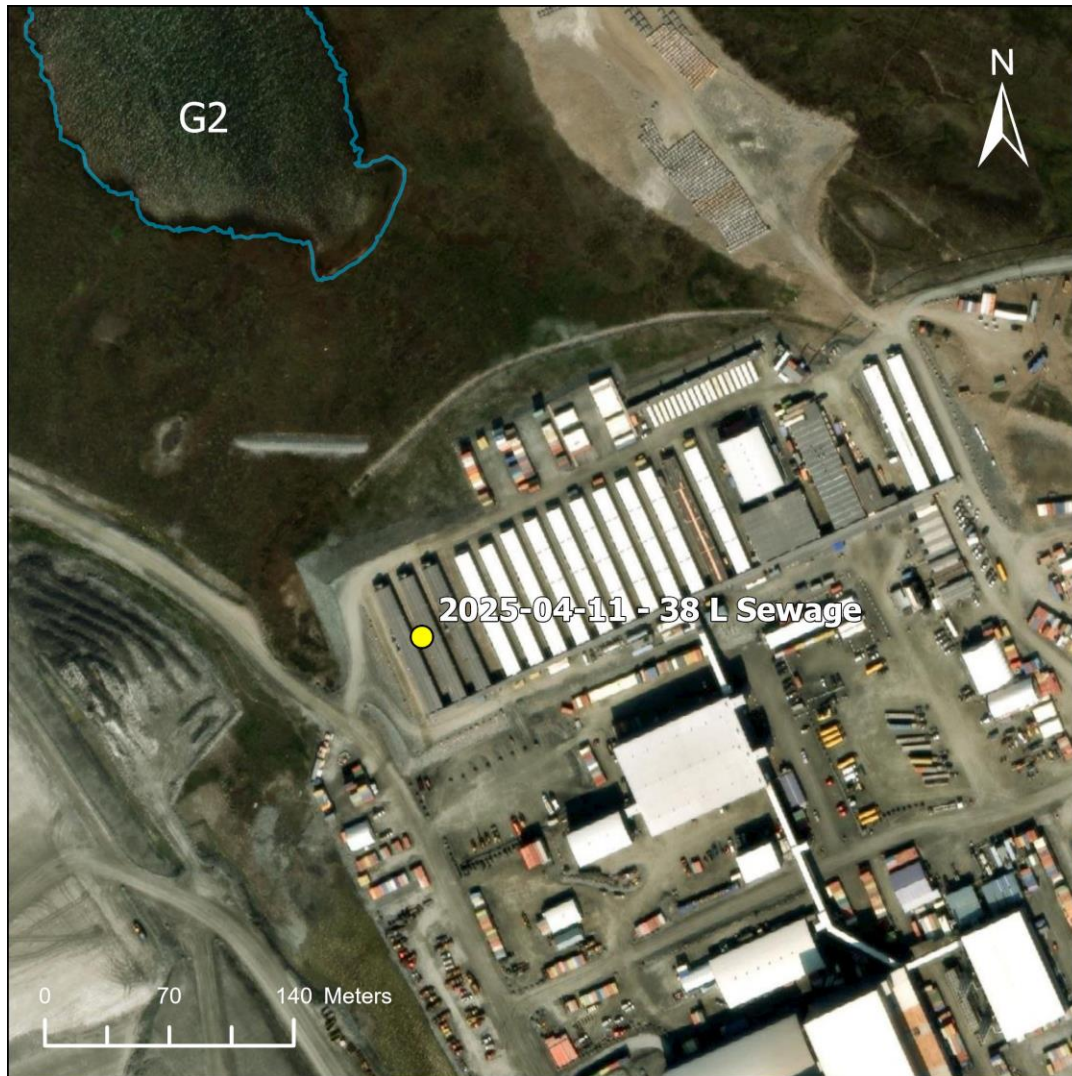
The spill occurred within the site's water management infrastructure, and as such, no waterbodies were impacted by the spill. The closest water body (Lake G2) is approximately 207 meters north, as seen in Figure 1.

Figure 1: Location of the spill and proximity to waterbodies.

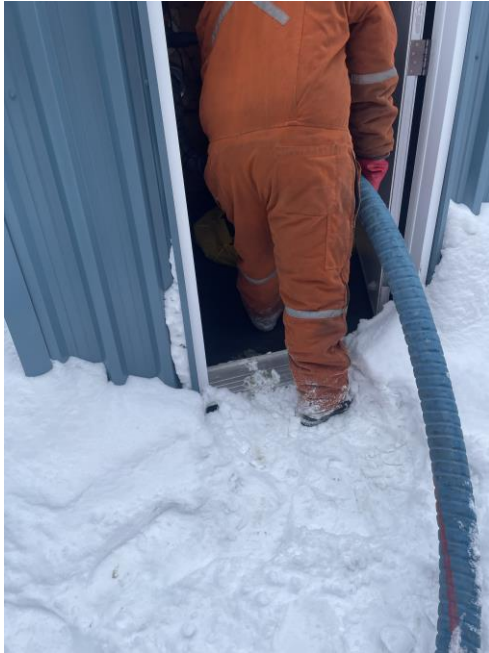
On April 11th, 2025, at 07:30, approximately 38 L of sewage spilled onto the industrial pad outside the Wing 13 lift station. Upon inspection, it was discovered the lift station pump impeller was obstructed by non-compliant material, which led to the pump's failure and the lift station to overflow.

- Non-compliant material had been flushed in a toilet at Wing 13, resulting in the pump impeller being obstructed, which led to the pump's failure and the lift station overflow.

Photo 1: Spill location

- A site wide communication was distributed to remind staff to flush only toilet paper. The topic was also included in all departments' safety meetings.
- Instructional signs were printed and posted on every room in the affected wing, informing occupants of permissible and prohibited items that can be flushed.
- Supervisors met with the occupants of Wing 13 to emphasize the importance of properly disposing of items that could affect the lift stations.
- The high-level alarm programming in Wing 13 lift station was tested for performance.
- Implementation of additional lift stations inspections after water consumption peaks (3-4 times per day).

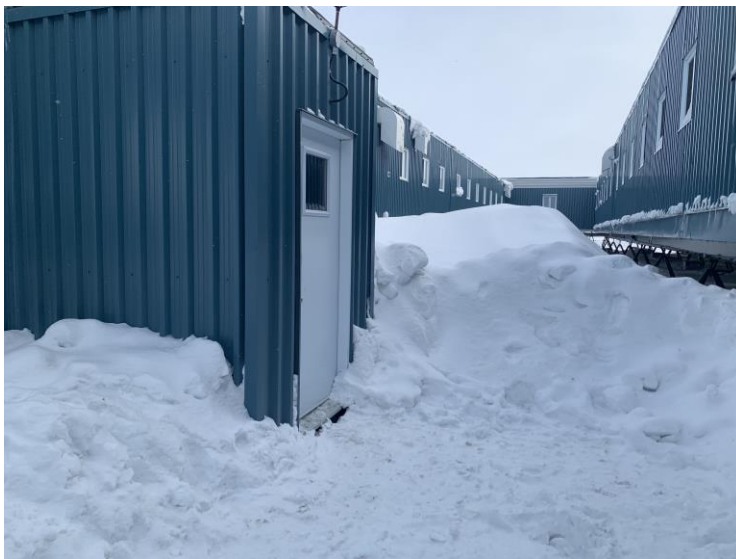
Photo 2: Spill remediation

Upon discovering the spill, a vacuum truck and a plumber were dispatched to respond to the spill. The vacuum truck was utilized to empty the contents within the secondary containment. The contaminated material was excavated and transported to Landfarm A in accordance with the Spill Contingency Plan.
