May 3<sup>rd</sup>, 2025

**Re: Follow-up Report Spill #2025-172 – Release of 750 L of Sewage at the Meliadine Gold Project**

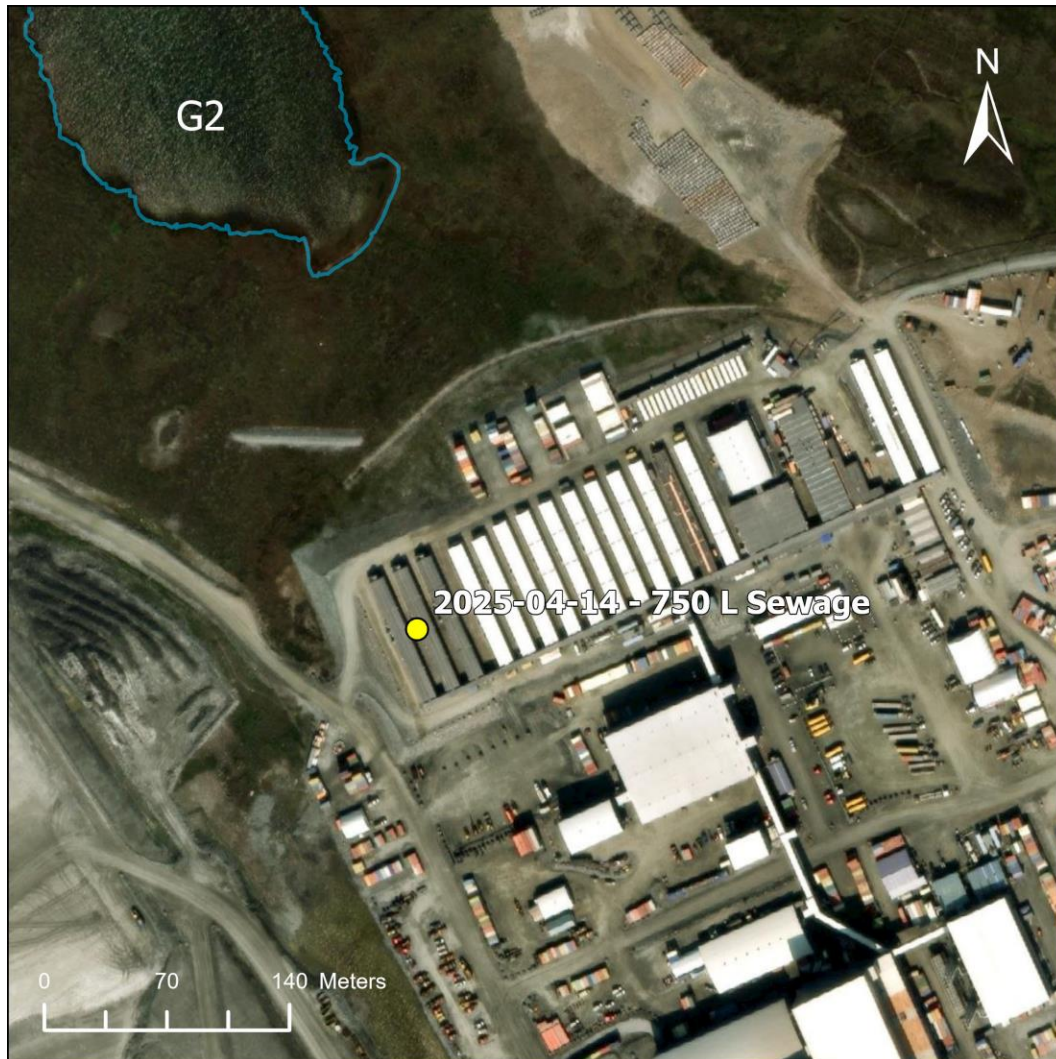
The spill occurred within the site's water management infrastructure, and as such, no waterbodies were impacted by the spill. The closest water body (Lake G2) is approximately 207 meters north, as seen in Figure 1.

**Figure 1:** Location of the spill and proximity to waterbodies.

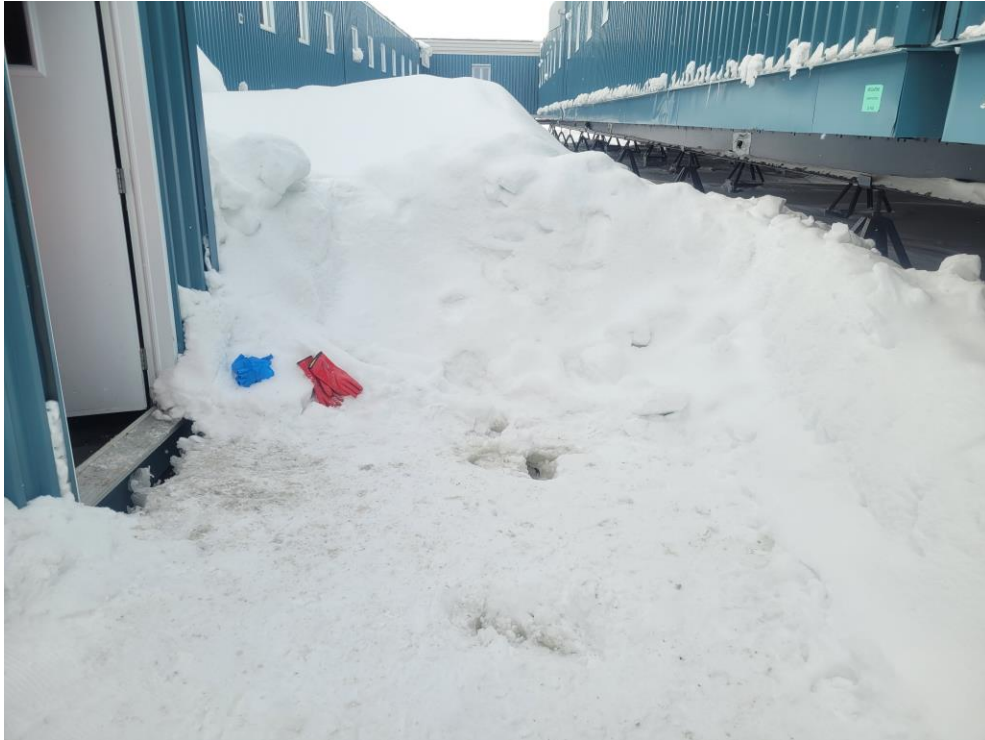
On April 14<sup>th</sup>, 2025, at 07:00, approximately 750 L of sewage spilled onto the industrial pad outside the Wing 13 lift station. Upon inspection, it was discovered the lift station pump impeller was obstructed by non-compliant material, which led to the pump's failure and the lift station to overflow.

- Non-compliant material had been flushed in a toilet at Wing 13, resulting in the pump impeller being obstructed, which led to the pump's failure and the lift station overflow.

**Photo 1:** Spill location (spill covered in snow layer)

- A site wide communication was distributed to remind staff to flush only toilet paper. The topic was also included in all departments' safety meetings.
- Instructional signs were printed and posted on every room in the affected wing, informing occupants of permissible and prohibited items that can be flushed.
- Supervisors met with the occupants of Wing 13 to emphasize the importance of properly disposing of items that could affect the lift stations.
- The high-level alarm programming in Wing 13 lift station was tested for performance.
- Implementation of additional lift stations inspections after water consumption peaks (3-4 times per day).

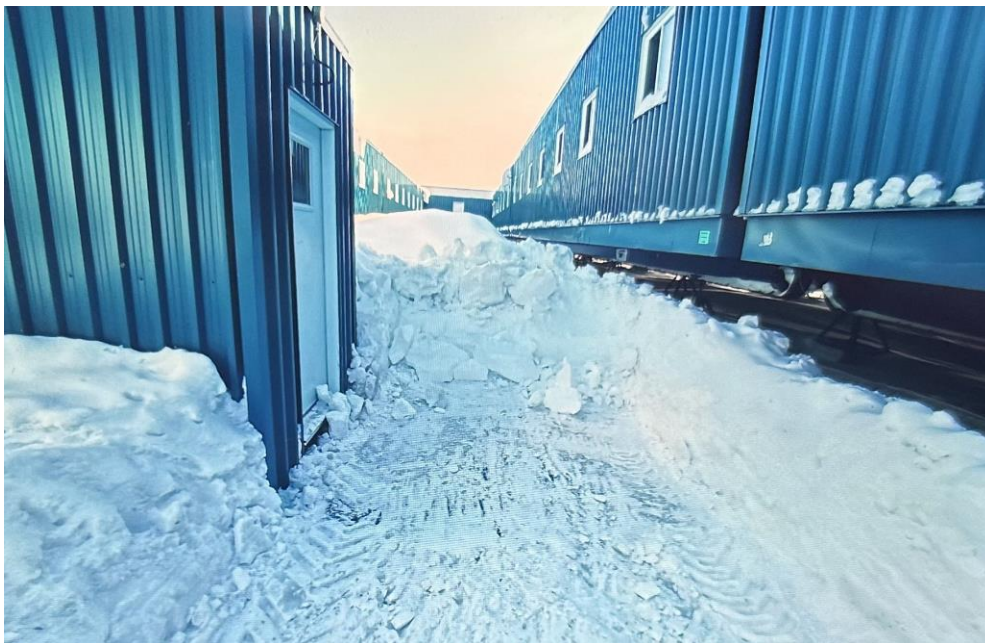
**Photo 2:** Spill remediation

Upon discovering the spill, a vacuum truck and a plumber were dispatched to respond to the spill. The vacuum truck was utilized to empty the contents within the secondary containment. The contaminated material was excavated and transported to Landfarm A in accordance with the Spill Contingency Plan. Remediation will occur in the spring, after snowmelt.
