May 8th, 2025

Re: Follow-up Report Spill #2025-188 – Release of 10 L of Sewage at the Meliadine Gold Project

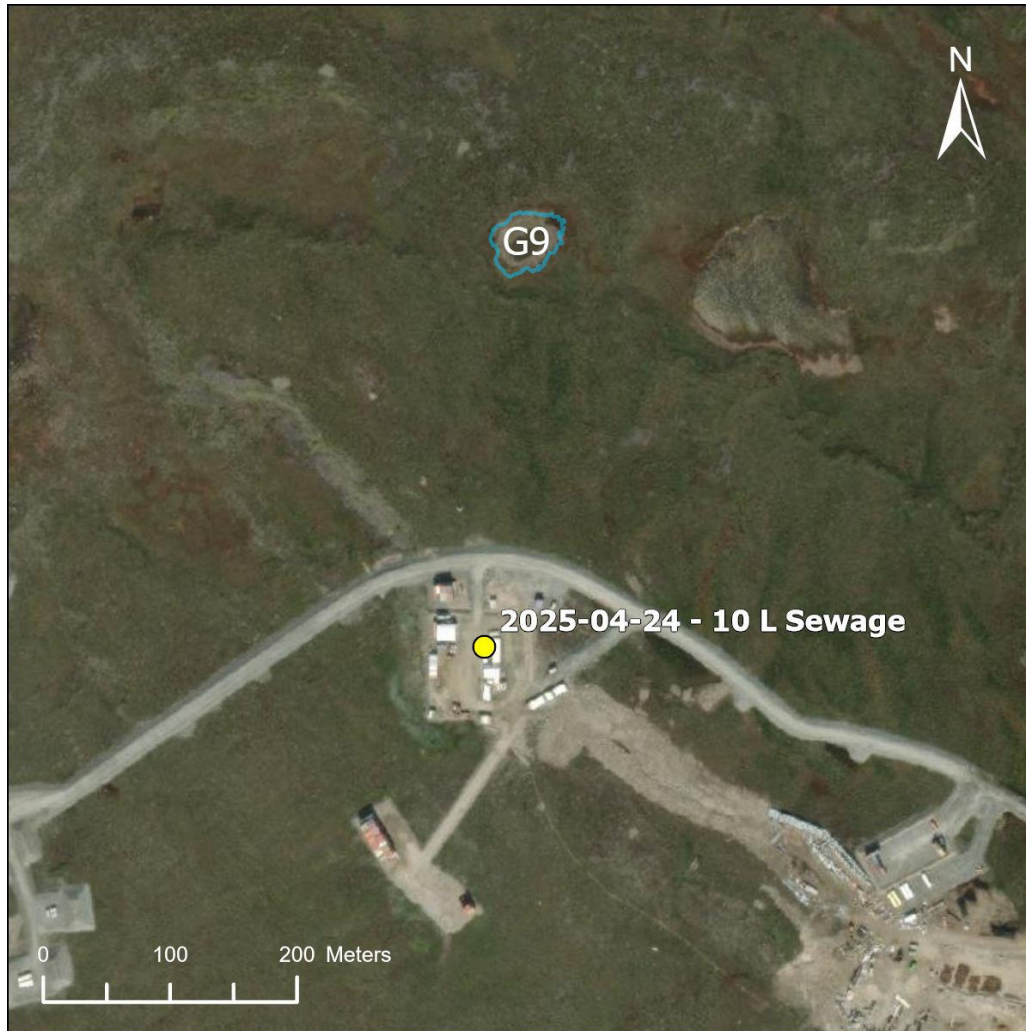
The spill occurred within the site's water management infrastructure, and as such, no waterbodies were impacted by the spill. The closest water body (Lake G2) is approximately 207 meters north, as seen in Figure 1.

Figure 1: Location of the spill and proximity to waterbodies.

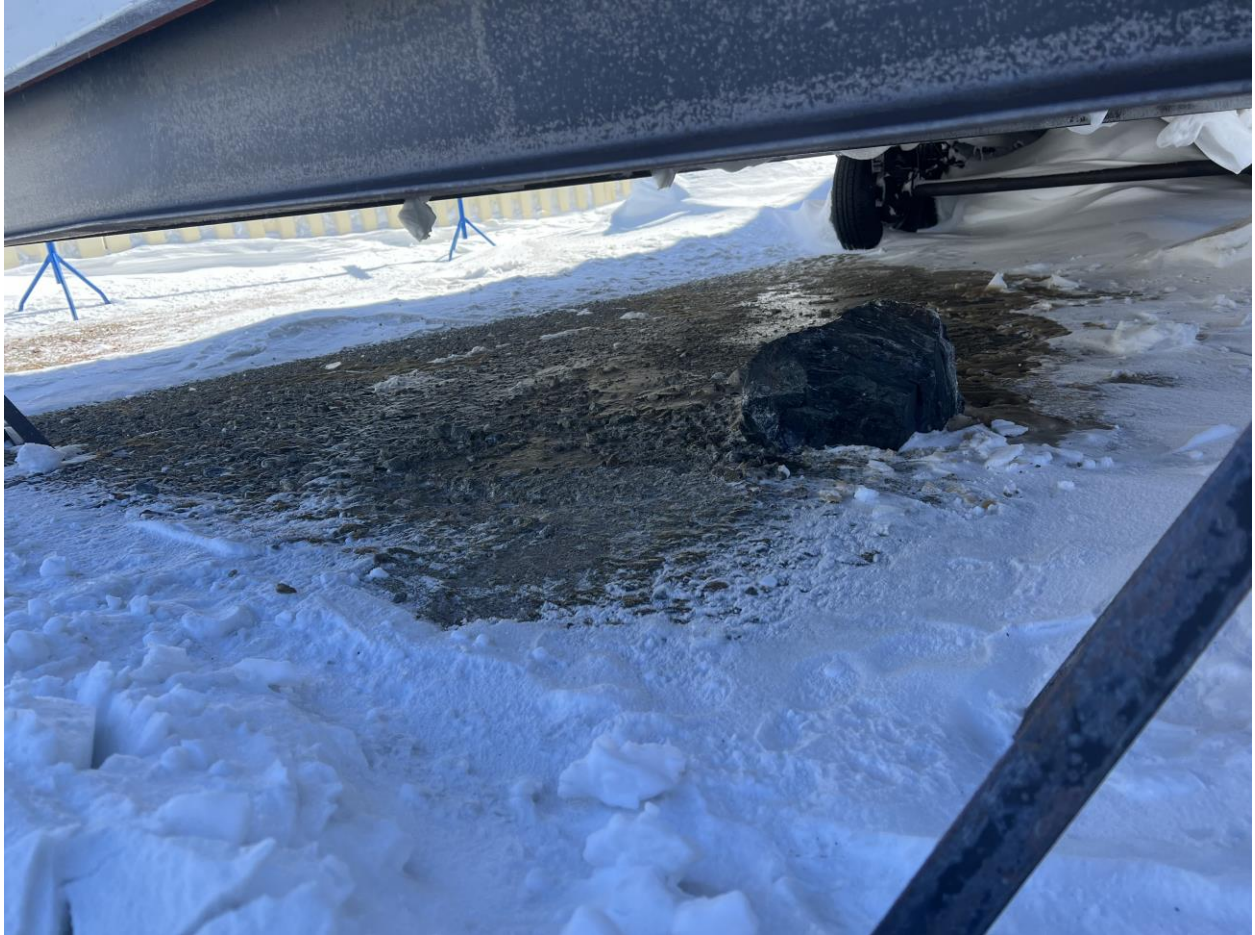
On April 24th, 2025, at 09:00, approximately 10 L of sewage spilled onto the ground underneath the Dyno Plant office trailer. An Energy and Infrastructure (E&I) maintenance worker was conducting routine sewage collection at the Dyno Plant sewage holding tank. The employee accidentally opened the incorrect valve on the holding tank, which resulted in the spill.

- The E&I employee was not focused on the task at hand and mistakenly opened the incorrect valve on the sewage holding tank.

Photo 1: Spill location

The E&I personnel who were at the scene immediately called their supervisor and the environment department. The spilled material accumulated underneath the Dyno office trailer and froze. A frost fighter was later deployed to thaw the material so that it could be collected. The contaminated material was hand excavated and transported to Landfarm A in accordance with the Spill Contingency Plan.

- The valve that was accidentally opened has been locked out to avoid any future mistakes.

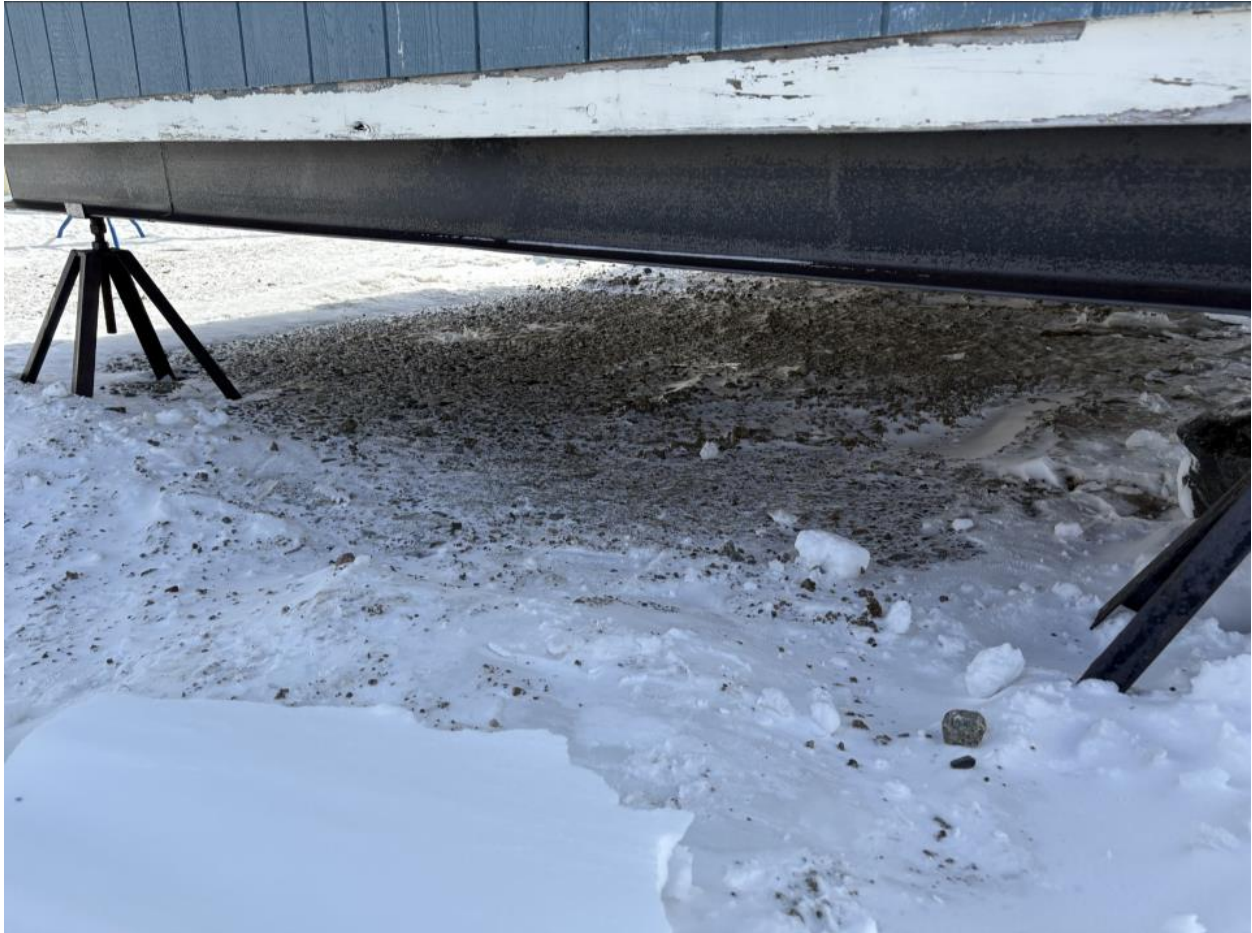
Photo 2: Spill location post remediation
