Re: Follow-up Report Spill #2025-223 – Release of 120 L of Sewage at the Meliadine Gold Project

Description of Incident

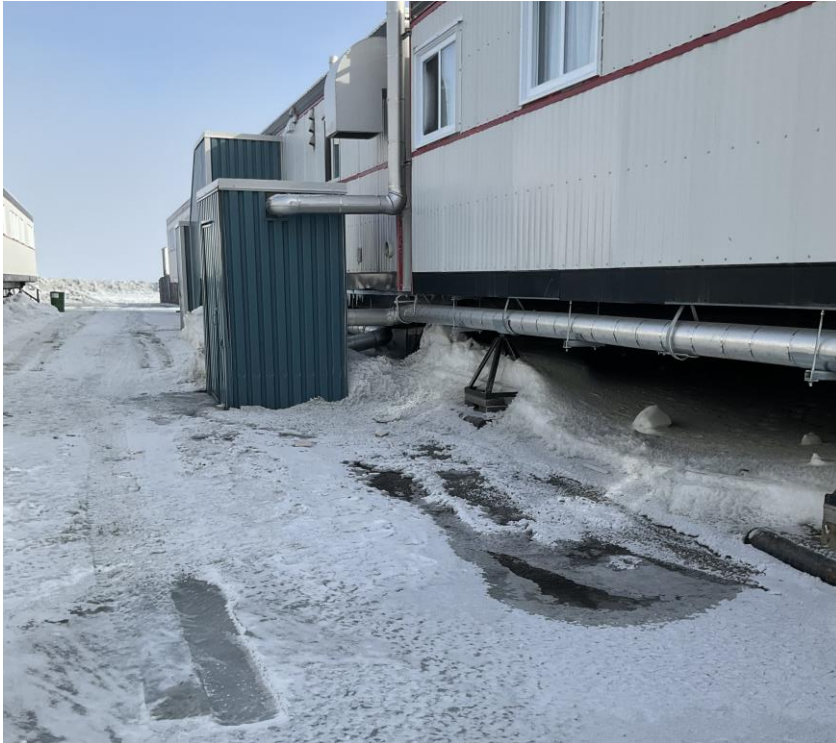
On May 23rd, 2025, at 06:30, approximately 120 L of sewage spilled onto the industrial pad outside the Wing 6 lift station. Upon inspection, it was discovered the lift station pump impeller was obstructed by non-compliant material, which led to the pump's failure and caused the lift station to overflow.

- Non-compliant material was flushed down a toilet in Wing 6. This resulted in the pump's impeller being obstructed, which led to the pump's failure and the lift station overflow.

Photo 1: Spill location

Upon discovering the spill, a vacuum truck and a plumber were dispatched to respond to the spill. The vacuum truck was utilized to empty the contents within the secondary containment. The contaminated material was excavated and transported to Landfarm A in accordance with the Spill Contingency Plan.

- Supervisors met with employees during the daily toolbox meeting and emphasized the importance of not flushing non-complaint material in the toilets.
- Instructional signs were printed and posted on every room in the affected wing, informing occupants of permissible and prohibited items that can be flushed.
- The lift station pump blades for Wing 6 are being sent to the manufacturer for analysis to evaluate the feasibility of upgrading the blades on our lift station pumps.

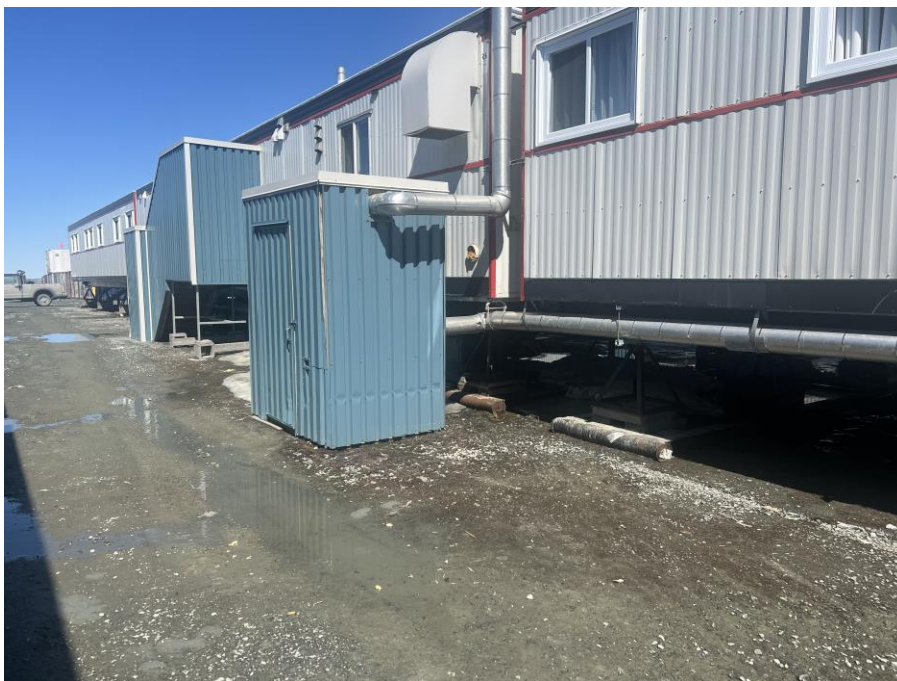
Photo 2: Spill location post remediation
