Re: Follow-up Report Spill #2025-249 – Release of 200 L of Process water at the Meliadine Gold Project

Description of Incident

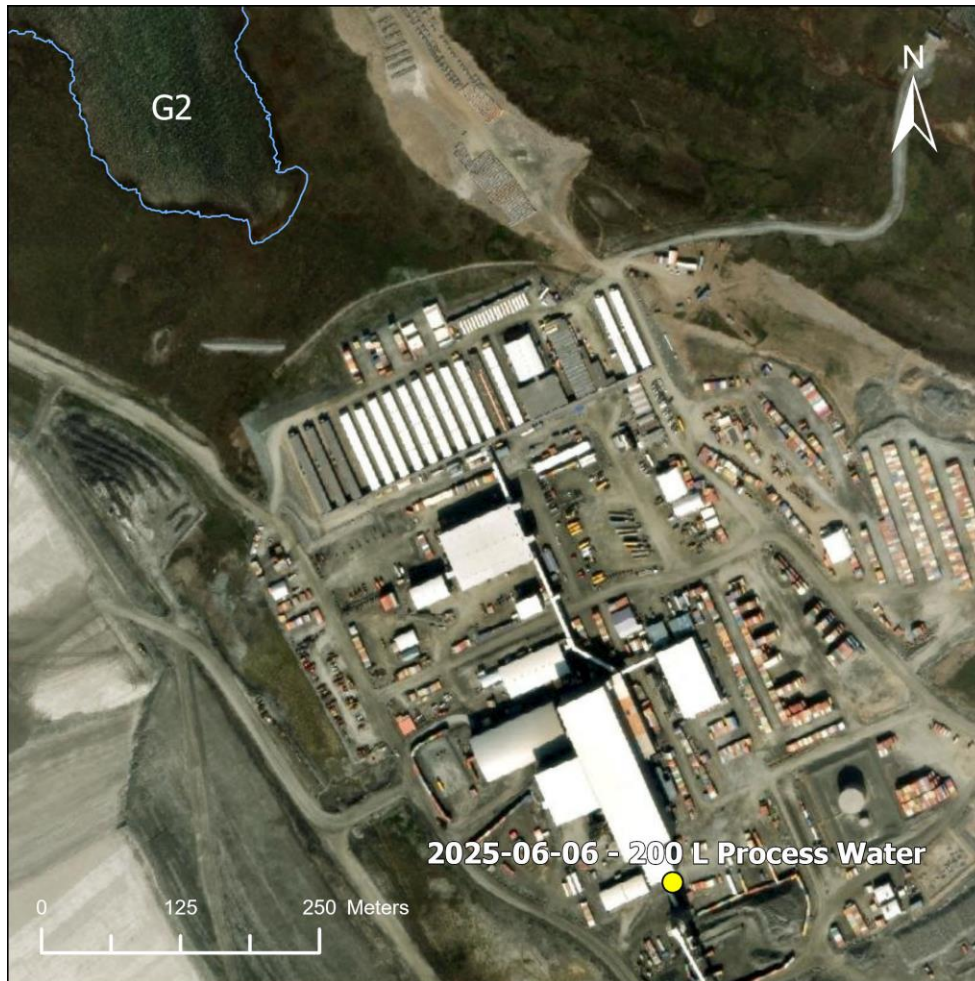
The spill occurred within the bounds of the site's runoff collection system, and as such, no water bodies were impacted by the spill. The closest water body (Lake G2) is approximately 650 meters northwest, as seen in Figure 1.

Figure 1: Location of the spill and proximity to waterbodies.

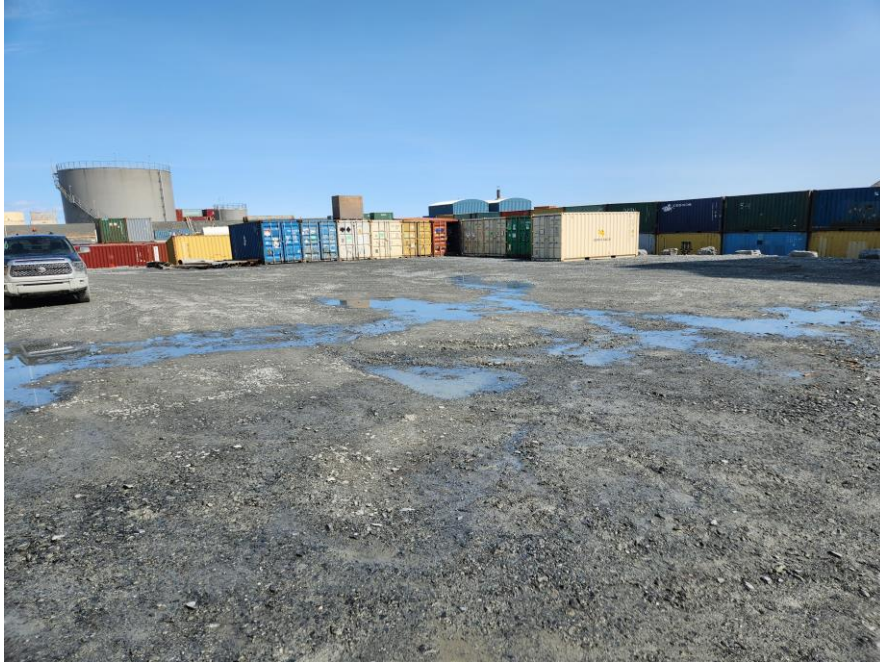
On June 6th, 2025, at approximately 2:00 PM, 200 L of Process water was released onto the industrial pad, at the south yard of the Process Plant. During a mill shutdown, process water was added to the Vertimill to clean it. During the cleaning process, the sump pump that was controlling the water level inside the Vertimill failed due to a power outage. The Vertimill then began overflowing inside the Process Plant. The garage door leading to the south yard was left open and some of the process water escaped the building, resulting in the spill.

- A power outage occurred during the Vertimill cleaning operation. This caused the Vertimill sump pump to fail and the water to overflow from the Vertimill, eventually spilling outside the south garage door.

Photo 1: Spill location

- The Process Plant department will update their procedure to include closing the garage door and installing small berms at the bottom of the garage door and the man doors when cleaning the Vertimill.
- An operator will also have to be present in the vicinity anytime maintenance operation on the Vertimill is occurring to operate a diesel pump if needed.

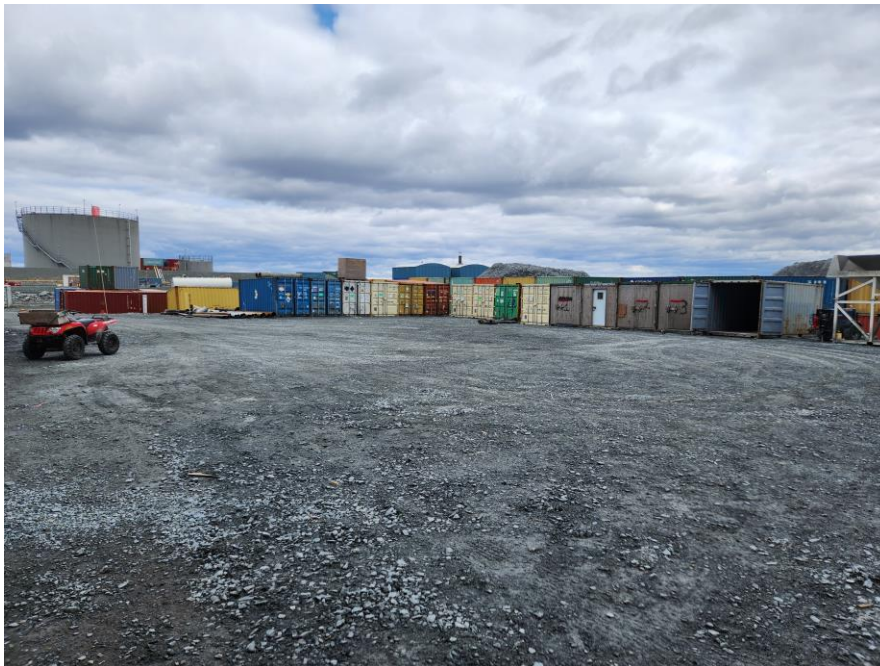
Photo 2: Spill remediation

When a Process Plant operator noticed the overflow and spill, they immediately notified their supervisor and stopped the flow of process water going into the Vertimill, which in turn stopped the spill. The ground surface outside of the Process Plant south yard garage door was scrapped and collected to be reintroduced into the mill feed. The water inside the Process Plant was recovered and reintroduced into the system through the sump.
