August 28th, 2025

Re: Follow-up Report Spill #2025-275 – Release of 250 L of waste hydraulic oil at the Meliadine Gold Project

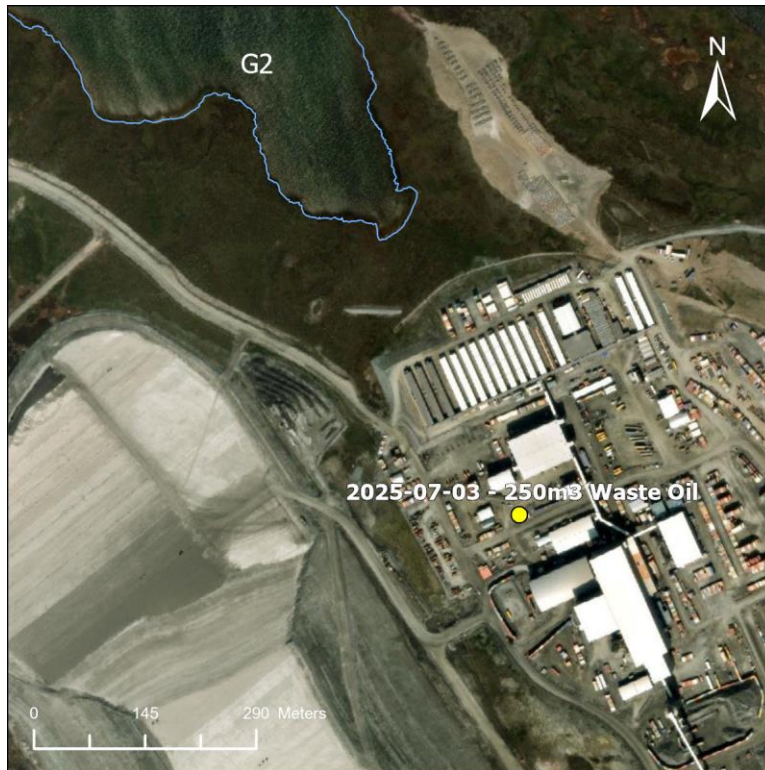
The spill occurred within the bounds of the site's runoff collection system, and as such, no water bodies were impacted by the spill. The closest water body (Lake G2) is approximately 400 meters west, as seen in Figure 1.

Figure 1: Location of the spill and proximity to waterbodies.

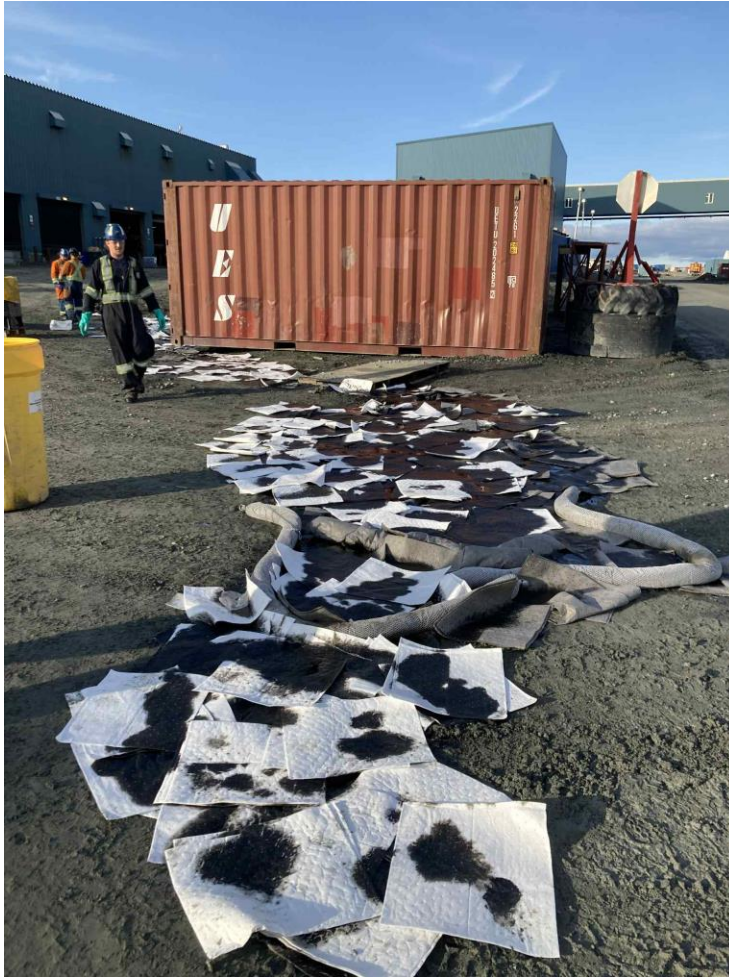
On July 3rd, 2025, at approximately 8:00PM, a skid steer operator was bringing a waste oil tote for storage in a sea can. When he put the tote down in the sea can, the bottom valve of the tote popped out. The entire waste oil tote emptied in the sea can and migrated outside, thus creating the spill.

- The valve on the tote was damaged and the operator did not inspect the tote before moving it.

Photo 1: Spill location.

- The Maintenance supervisor went through the oil tote handling procedure with the crew to remind them of good practices and proper inspection.
- Maintenance added a few 55 gallons drum spill kits in the area for a faster response in case of future spills.

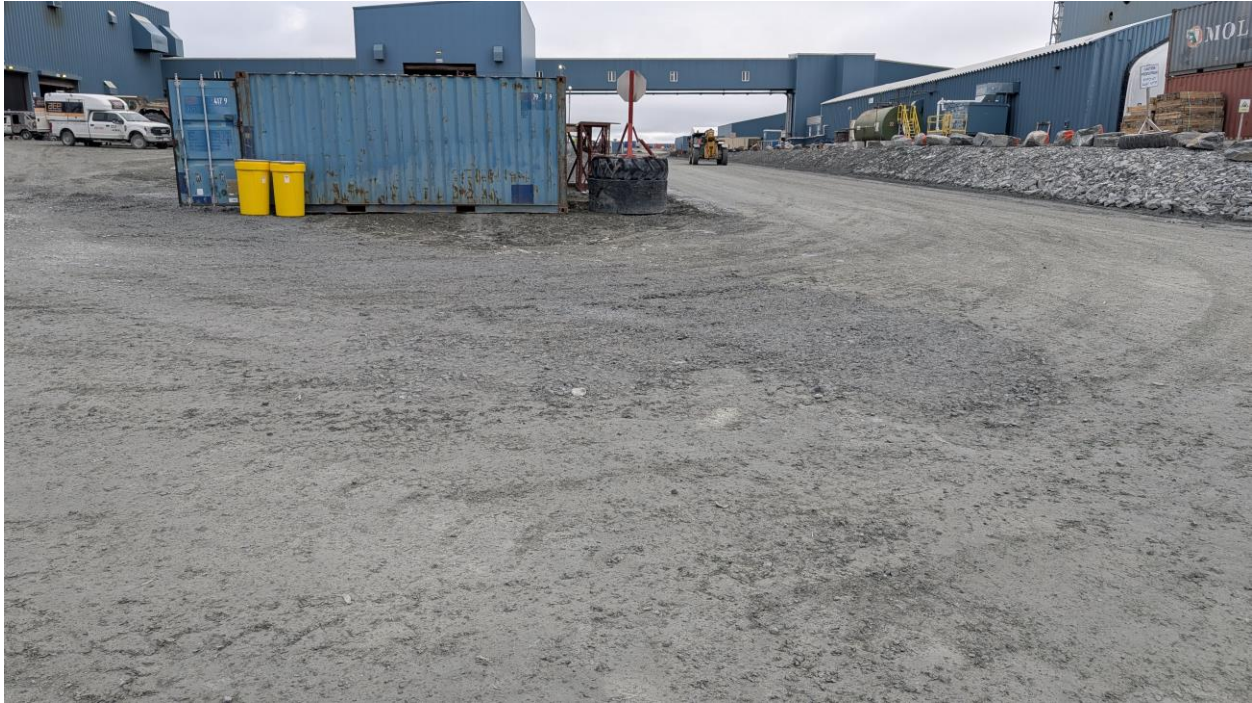
Photo 2: Spill remediation.

Following the incident, the operator promptly deployed a spill kit to contain the release. The Surface Operations department was contacted to initiate the remediation efforts utilizing an excavator. A total of five quatrex bags containing contaminated soil were collected and securely stored in the Maintenance departments oily solids sea-can. This sea-can is scheduled to be inspected and shipped south for remediation.
