August 11<sup>th</sup>, 2025

**Re: Follow-up Report Spill #2025-283 – Release of 5,000 m<sup>3</sup> of TIRI01 pit water at the Meliadine Gold Project**

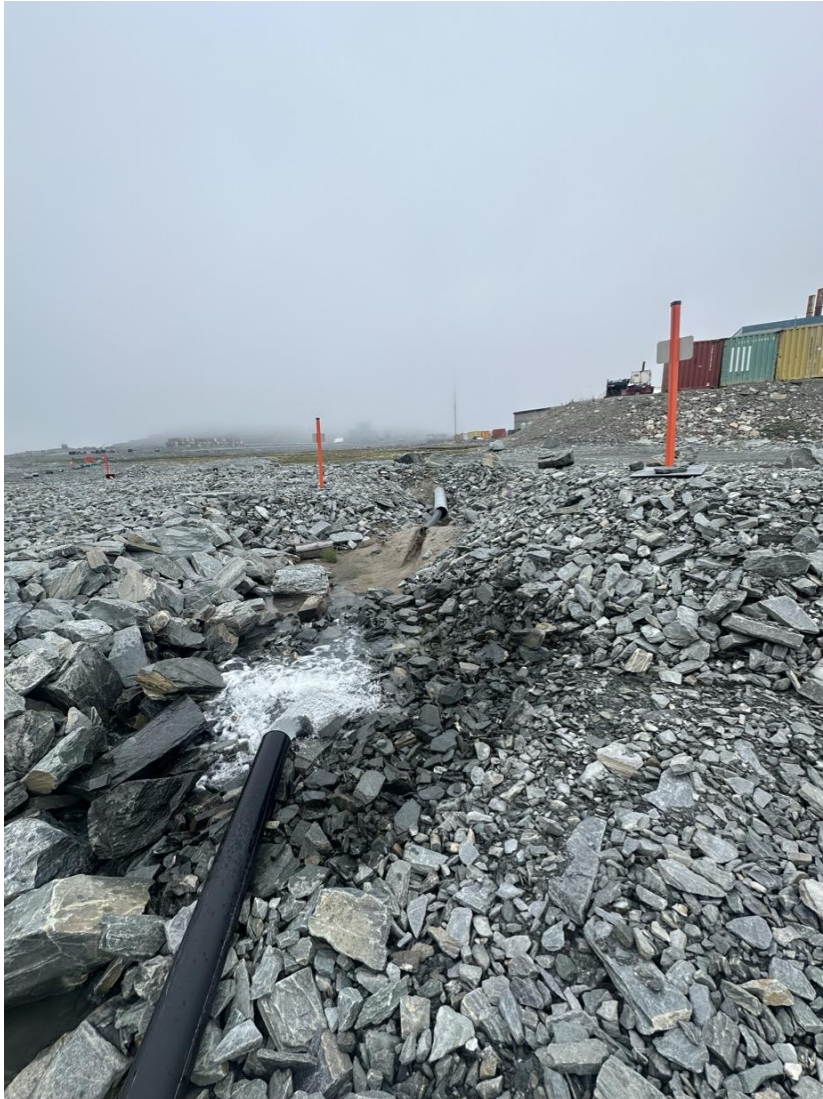
On July 12<sup>th</sup>, 2025, at approximately 10:30AM, an Energy & Infrastructure (E&I) Supervisor observed that water from the TIRI01 sump was not discharging into Saline Pond 1 (SP1) as intended. Upon inspection, it was found that the water was exiting the pipeline where it crosses Channel 5 and flowing into Collection Pond 5 (CP5).

- The pipeline from TIRI01 to SP1 had been disconnected during maintenance and was not reconnected afterward; water was unintentionally discharged to CP5 instead of SP1.
- Between July 5 and July 12, approximately 5,000 m<sup>3</sup> of water from the TIRI01 sump was discharged to CP5.

**Photo 1:** Spill location.

Once the issue was identified, the TIRI01 sump pump was shut down. The inactive pump in CP5, which transfers water to Collection Pond 1 (CP1), was also locked out until water quality could be assessed. No water was pumped from CP5 to CP1 between July 1 and July 12, confirming that no water from TIRI01 reached CP1 during this period.

- An inspection procedure of the water pipeline network, focusing on flanges and potential leaks following maintenance work, will be drafted before December 2025.

- It will be added in the pipeline inspection procedure to have 2 employees walking the line at the same time from opposite ends to rapidly catch any leaks upon water management plant start up.
