2025-07-30 WTM 200L Diesel Fuel

GN reference #: 2025-329

Please find the following information as a follow up to the Spill report submitted July 31st, 2025, by Agnico Eagle Meadowbank division. This detailed report is submitted to the Inspector in compliance with the conditions under the Nunavut Water Board License 2AM-WTP1830, Part H, Item 8c.

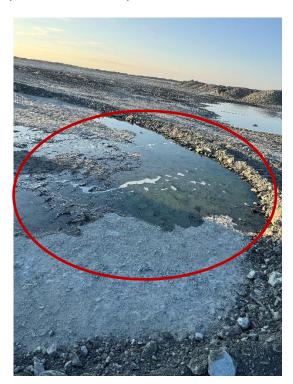
During operations at the Whale Tail Mine, a haul truck was offloading material at the Whale Tail rock facility when a dozer attempted to assist by lifting the truck box using the corner of its blade. During this maneuver, the dozer blade struck and damaged the fuel tank's wigging attachment, resulting in a diesel spill of approximately 200 liters onto the pad surface. The spill occurred within an active deposition area.

The spill remained within the mine operations footprint. There were no off-site impacts or discharges. Distance to the closest water body is ≈700m to Kangislulik

Human error

The incident will be reviewed with all operators to reinforce the importance of adhering to established procedures and authorized practices. Additionally, an investigation is underway in collaboration with the Health and Safety department to identify and implement best practices moving forward.
