August 16th, 2025

Re: Follow-up Report Spill #2025-295 – Release of 50 L of Sewage at the Meliadine Gold Project

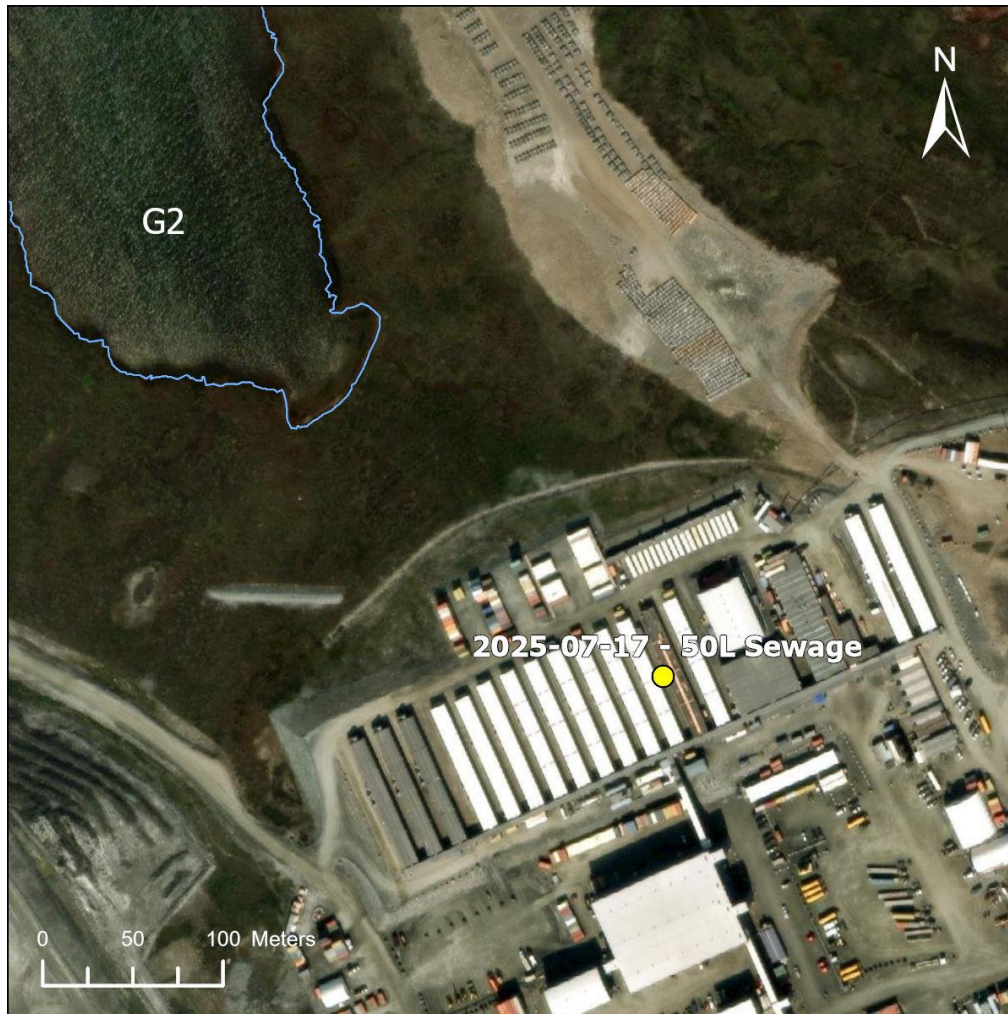
The spill occurred within the site's water management infrastructure, and as such, no waterbodies were impacted by the spill. The closest water body, Lake G2, is approximately 230 meters northwest, as seen in Figure 1.

Figure 1: Location of the spill and proximity to waterbodies.

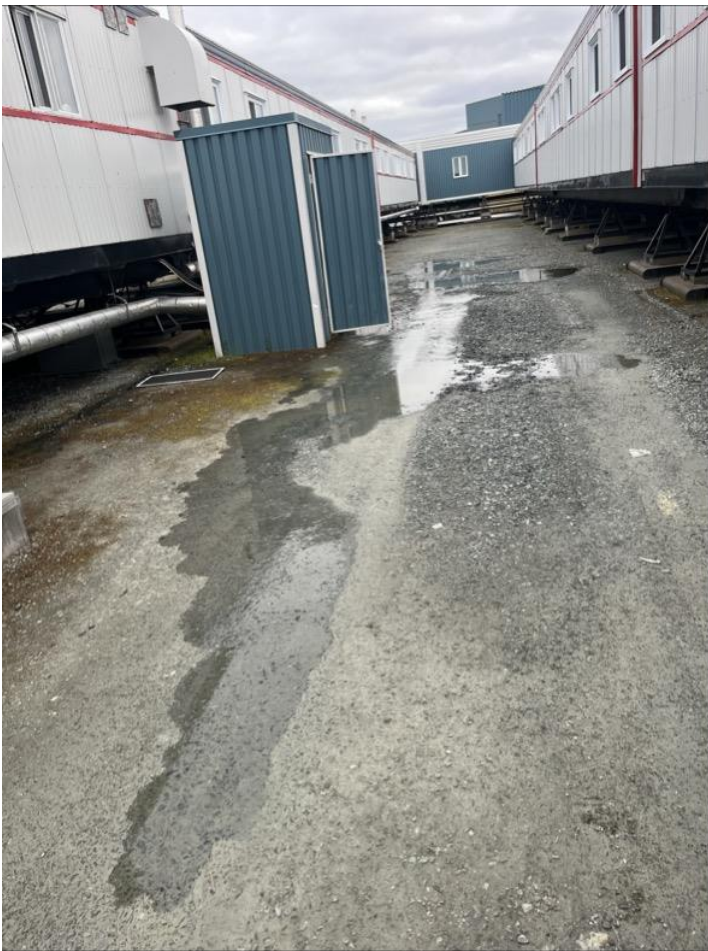
On July 17th, 2025, at 18:30, approximately 50 L of sewage spilled onto the industrial pad outside the Wing 2 lift station. Upon inspection, it was determined that this spill was caused by the loss of power at the lift station pump, causing the lift station to back up and overflow.

- Supervisors were notified of the high-water level at the lift station via email and HMI page alarm; however, these notifications were not seen in time to prevent the spill.

Photo 1: Spill location

- All radios and email lists were tested, fixed and validated in the lift station surveillance team.
- Additional personnel were added to the distribution list for radio and email notifications regarding lift station alarms, including sewage treatment plant operators and environmental personnel. An internal audit of personnel is being conducted to identify other key stakeholders that would benefit from notifications of alarms and/or equipment failures.

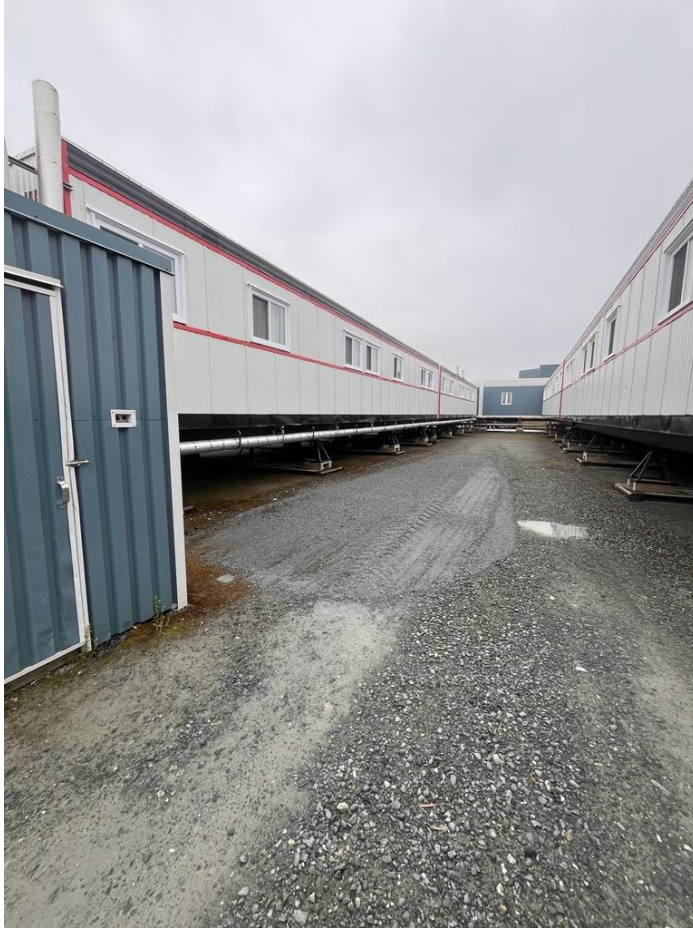
Photo 2: Spill location post remediation

Upon discovering the spill, a vacuum truck and an electrician were dispatched to respond to the spill. The pump was turned back on to prevent further spillage at the lift station. The vacuum truck was utilized to empty the contents within the secondary containment. The contaminated material on the ground was excavated and transported to Landfarm A in accordance with the Spill Contingency Plan.
